Seismological and geotechnical aspects of the $M_w=6.3$ L'Aquila earthquake in central Italy on 6 April 2009

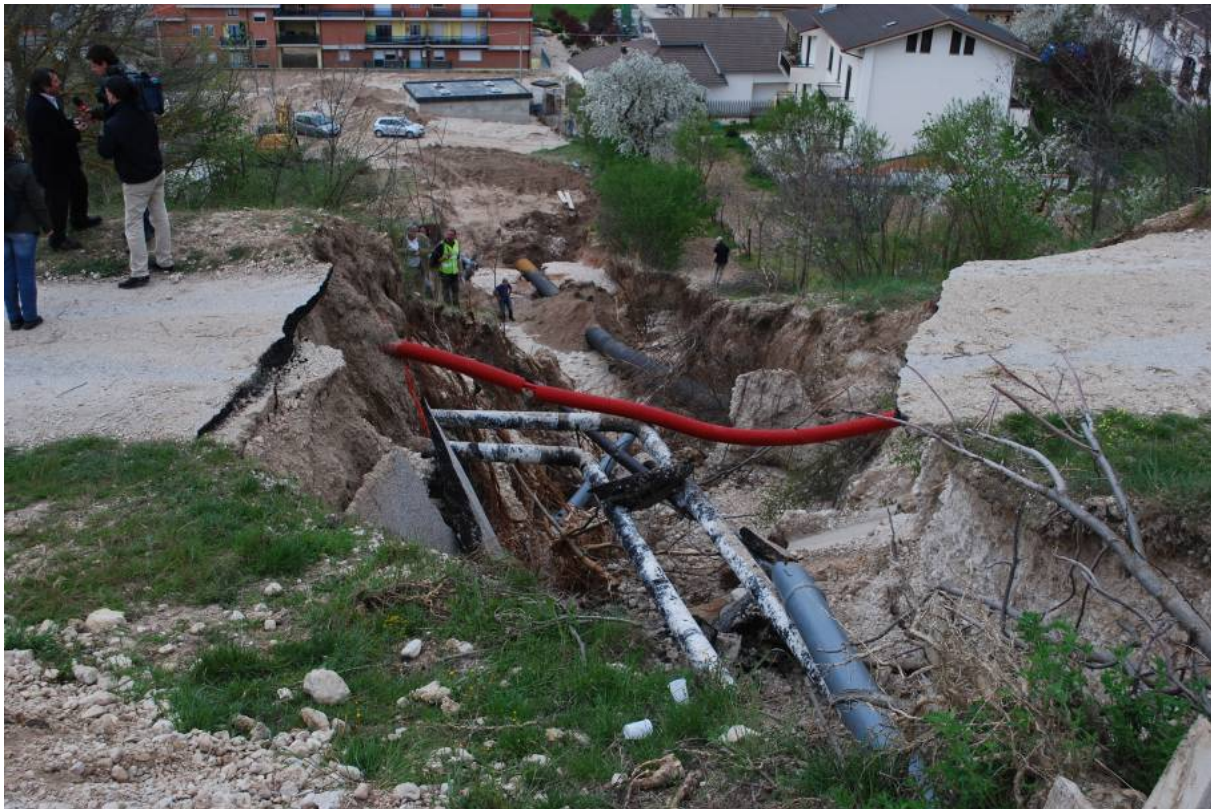
Figure 27. Paganica village: broken major water pipe (repaired) due to co-seismic rupture (Lat. 42,36537N Long. 13,46803E) (Photo by Mylonakis G).

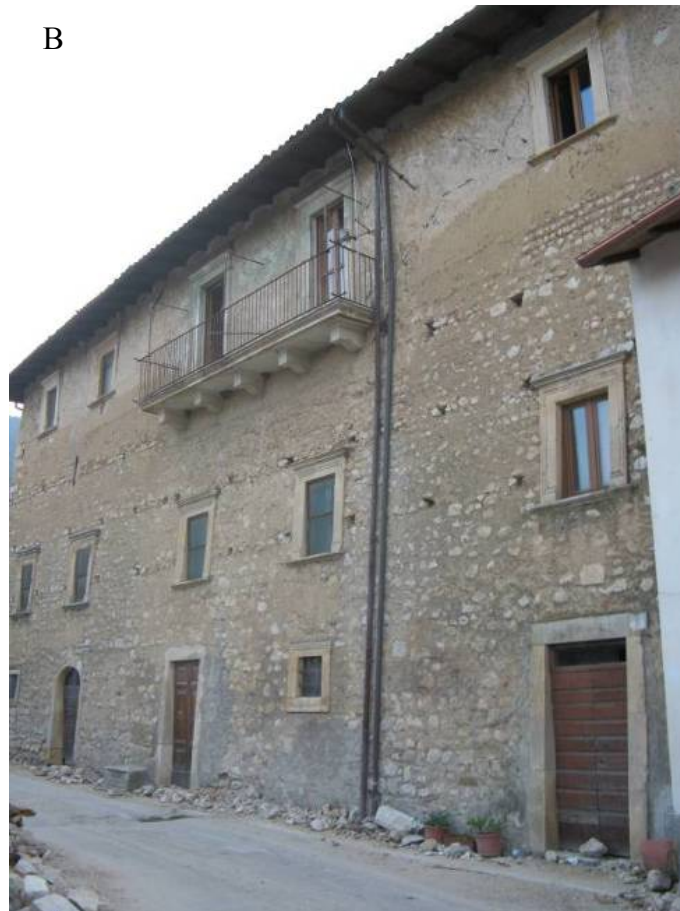
Figure 88. Villa S. Angel. (B) Reinforced masonry in the historic center with minor cracks in the highest story (D2).

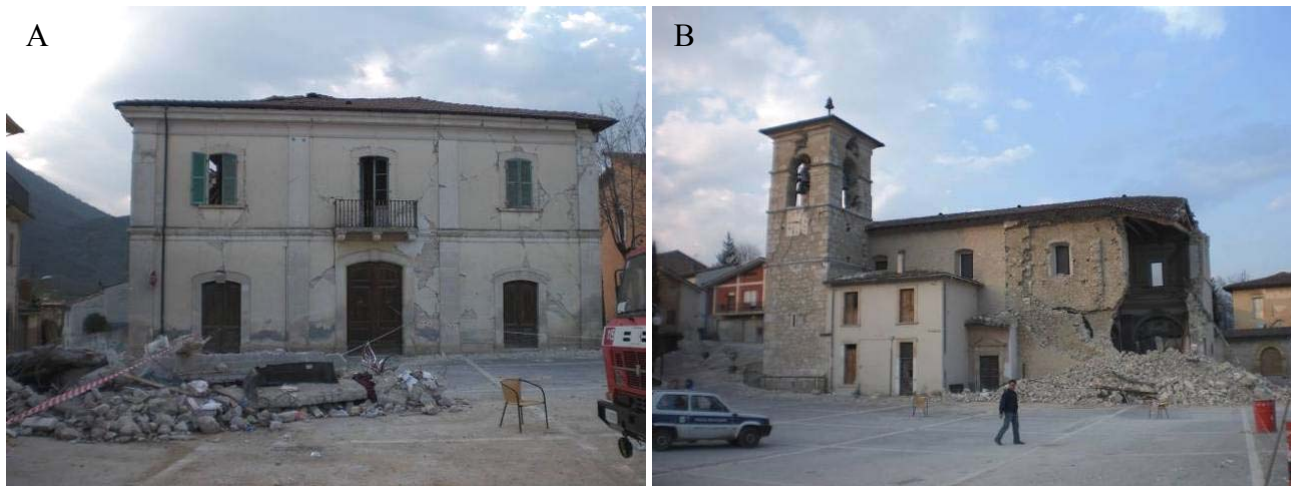
Figure 89. Villa S. Angelo, historic center with (A) masonry building crack,; (B) partly collapsed church.

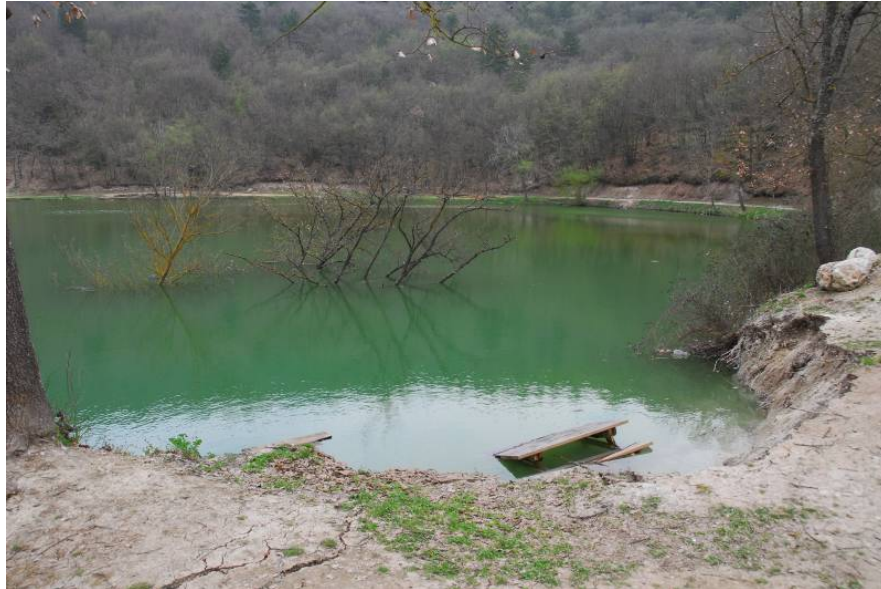
Figure 160. Submerged trees located several meters from the western margin of Lake Sinizzo; picnic table within arcuate landslide scar at shoreline. (42.291N 13.576).

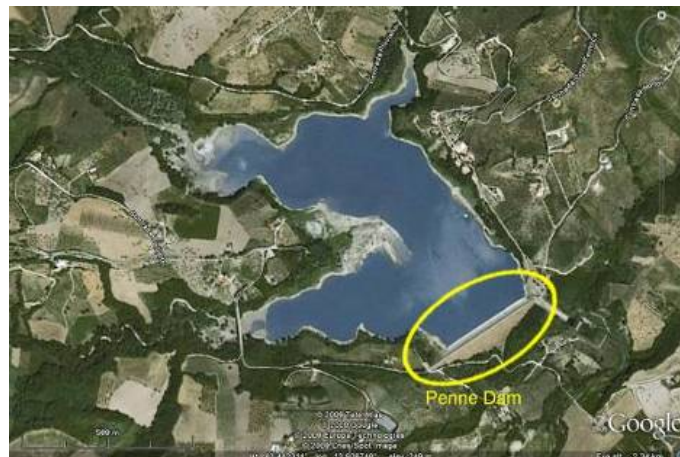
Figure 184. Location map for Penne reservoir and dam (42.438809°N, 13.913265°E).

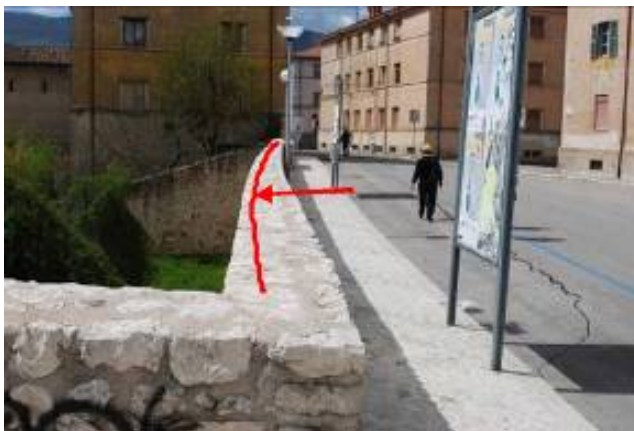
Figure 186. Stone masonry wall at L'Aquila city (42.348710°N, 13.403900°E). Note the (tolerable) outward movement at the center of the wall and the pavement cracks behind the wall.
