Seismological and geotechnical aspects of the $M_w=6.3$ L'Aquila earthquake in central Italy on 6 April 2009

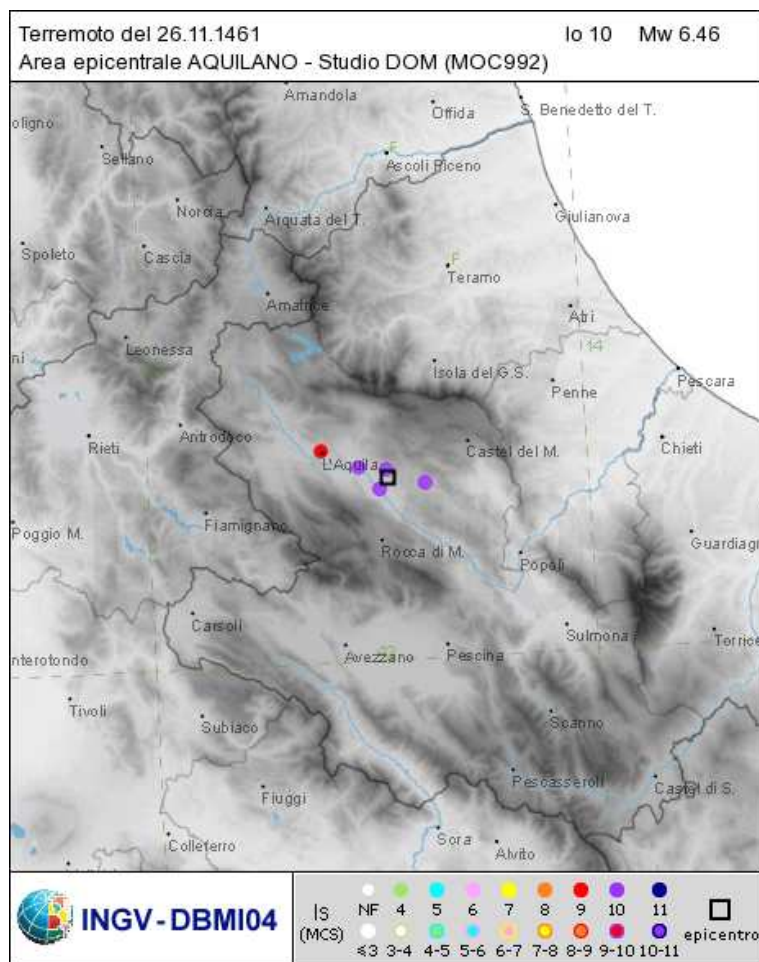
Figure 19. Macroseismic intensity distribution determined for 1461 earthquake (Stucchi et al., 2007).

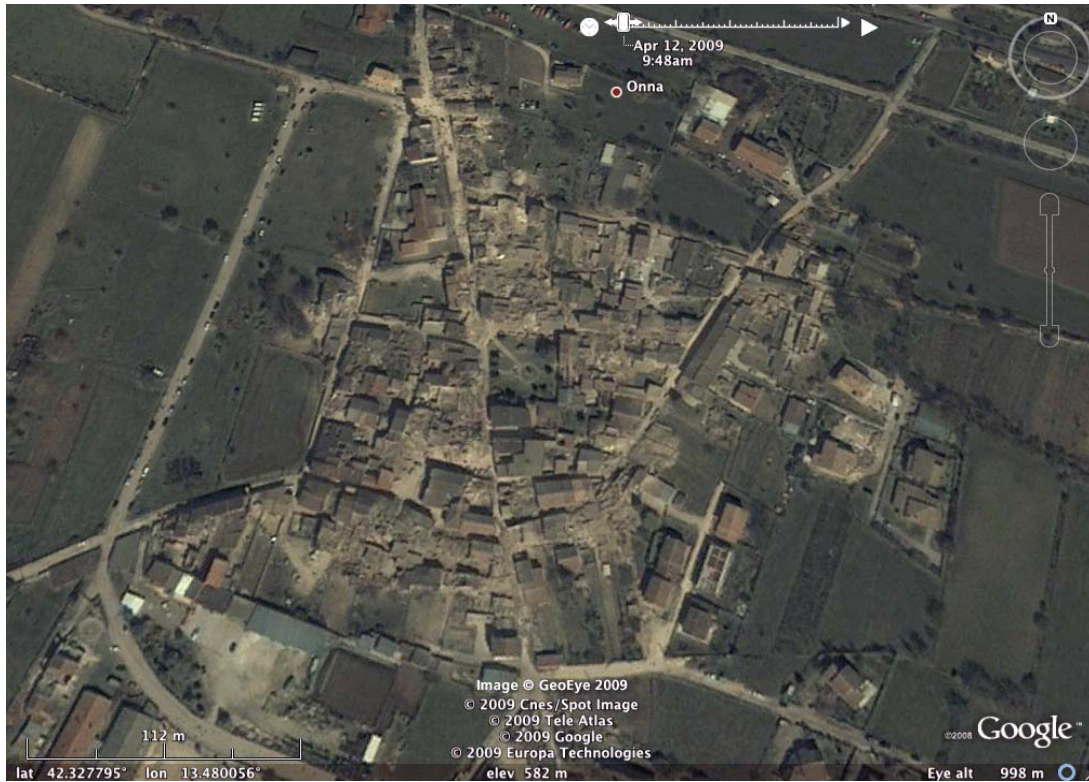
Figure 64. The village of Onna suffered D4–D5 damage in most of the unreinforced masonry structures. Reinforced concrete structures at the margins of the village performed well with only minor damage (D0-D2).

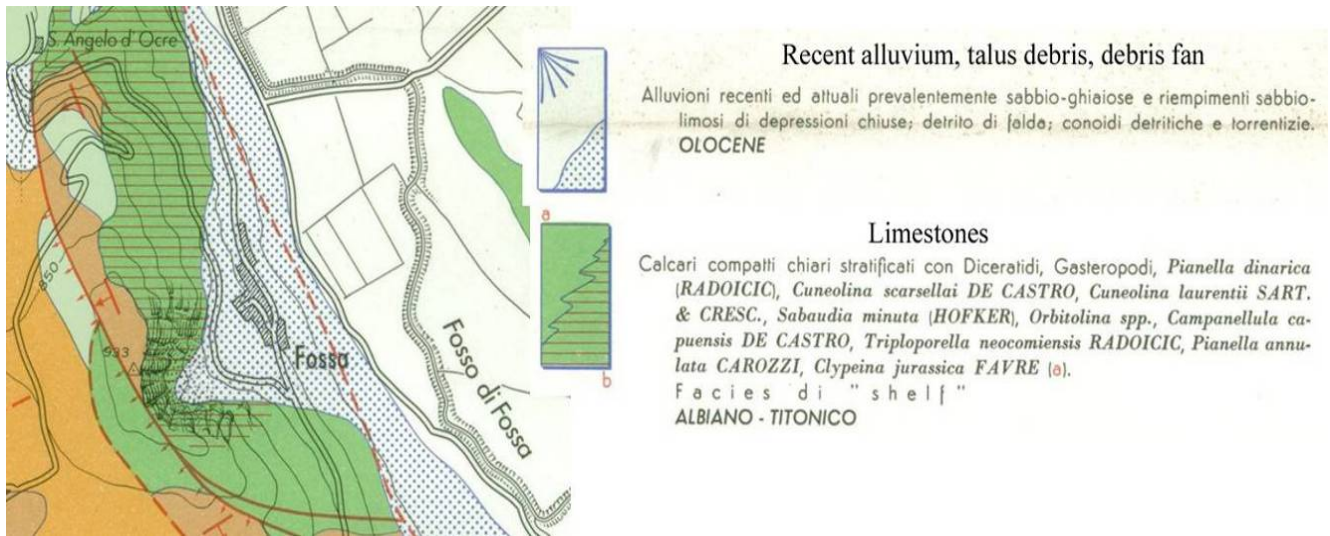
Figure 76. Geological map of Fossa (after Bosi and Bertini, 1970).

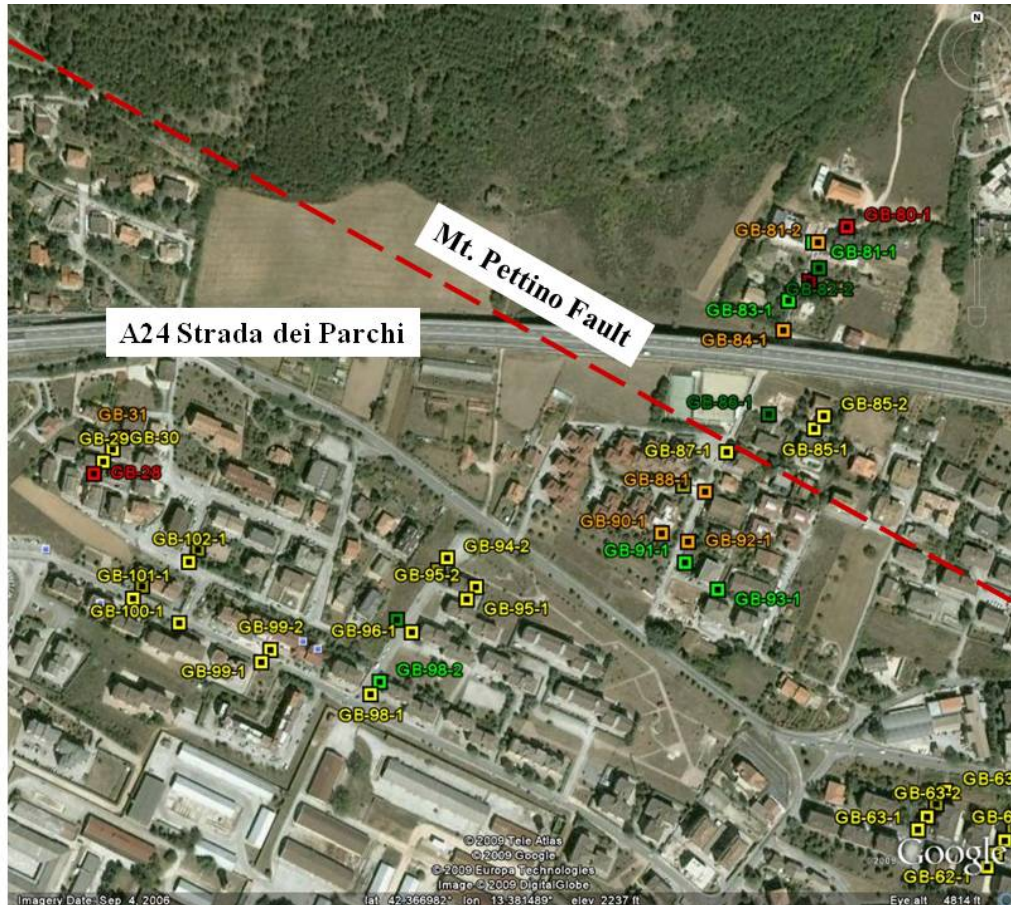
Figure 103. Zone (a) of the building damage survey along the Mt. Pettino Fault.

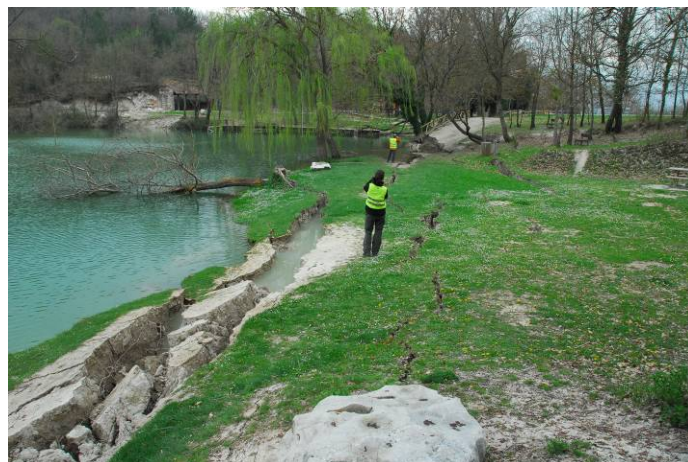
Figure 158. Ground cracks along the northwestern perimeter of Lake Sinizzo (42.291N, E13.576).
