Seismological and geotechnical aspects of the $M_w=6.3$ L'Aquila earthquake in central Italy on 6 April 2009

Giuseppe Lanzo, Professor, University of Rome, Italy; email: giuseppe.lanzo@uniromal.it

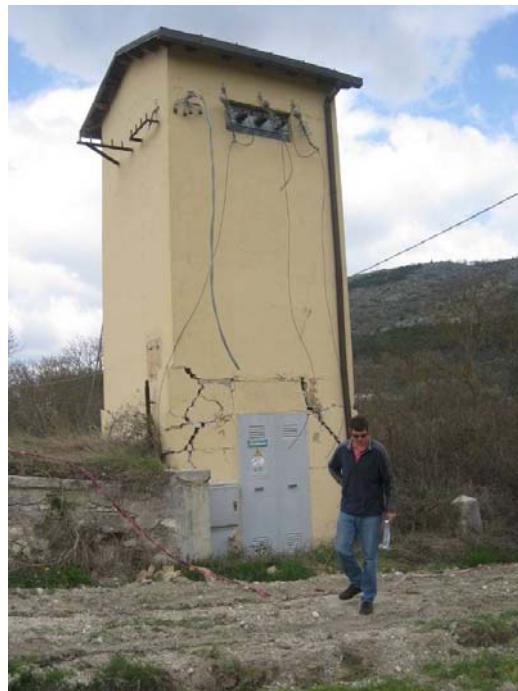
Figure 57. Heavily damaged seismometer station box (not in use at the time of the earthquake, no recording) on the northeast valley beneath the town of Castelnuovo. (42.2982°, 13.6295°).

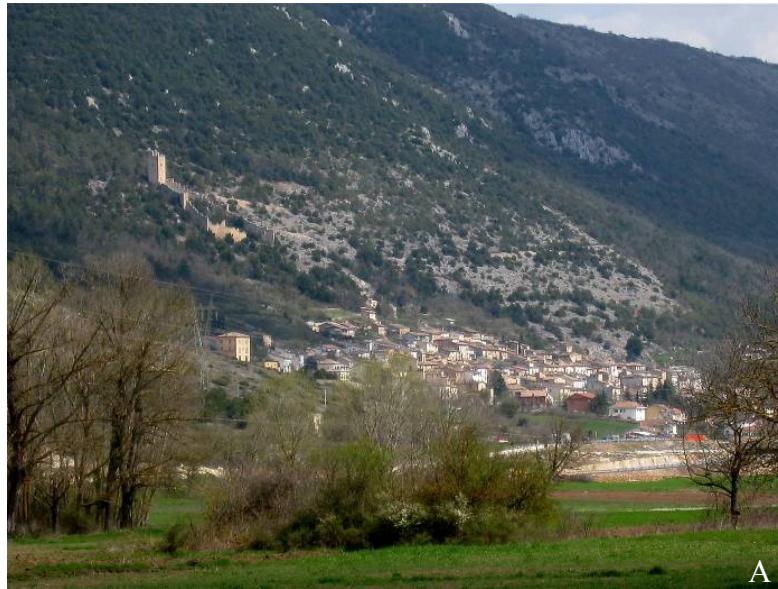
Figure 61. (A) The village of San Pio delle Camere built on Mesozoic limestone. This picture was taken from the lower flanks of Castelnuovo (from location 42.2898°, 13.6297° looking southeast).

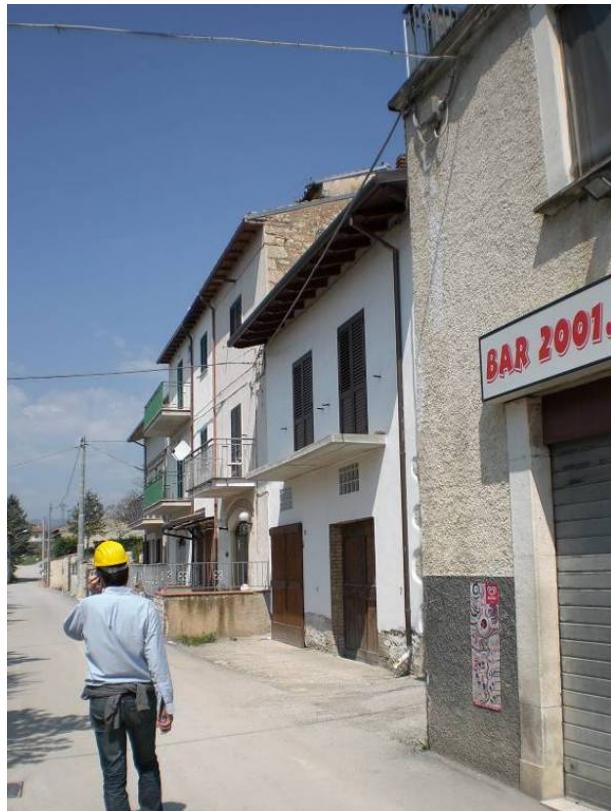
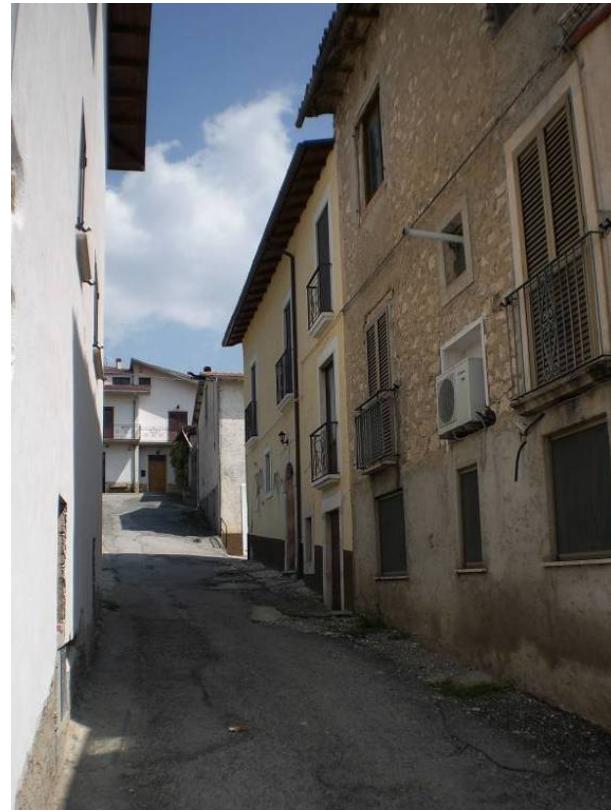
Figure 73. San Gregorio western part: masonry buildings with minor damages.

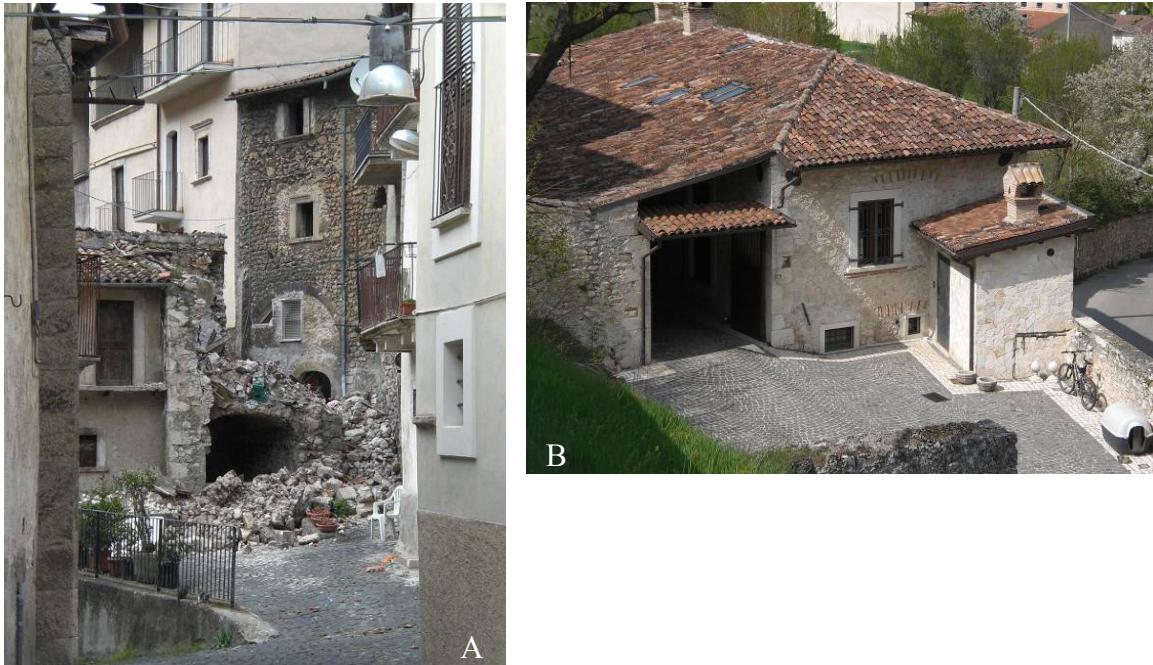
Figure 77. Fossa. (A) Collapse of masonry constructions in the historic center, (B) Strengthened masonry construction with no damage.

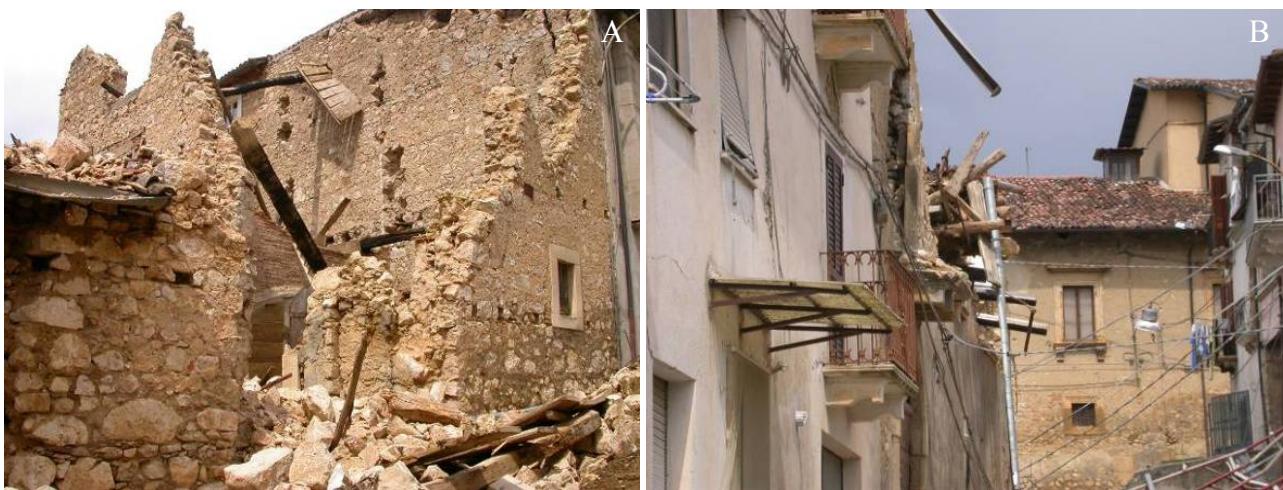
Figure 80. S. Eusanio Forconese. (A) Collapse of old masonry building (D5), (B) Partial collapse of masonry building (D4).

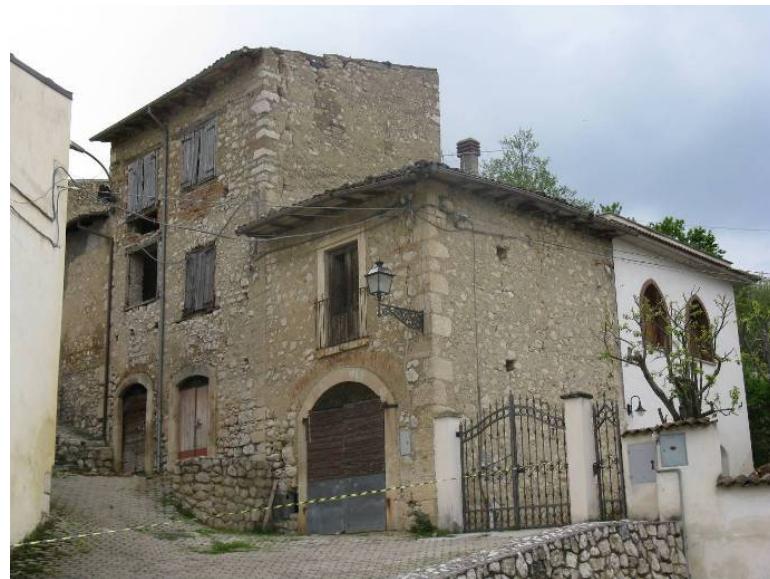
Figure 83. Casentino masonry buildings with some wall cracks.

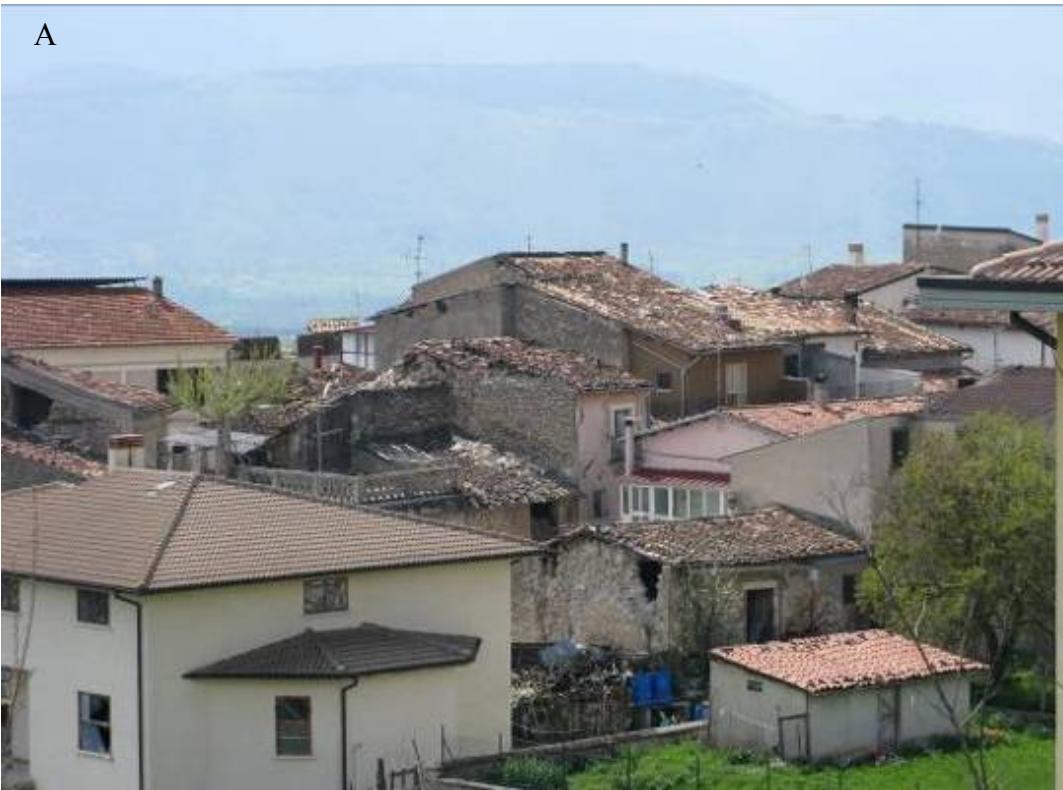
Figure 86. Poggio Picenze. (A) Variable damage (D3-D4) on masonry buildings of different style.

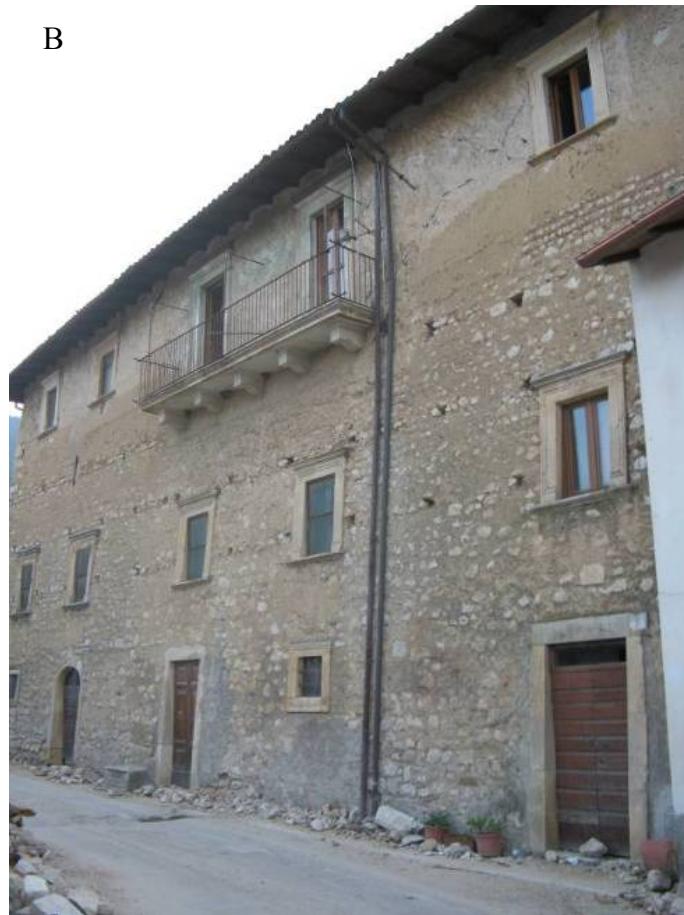
Figure 88. Villa S. Angel. (B) Reinforced masonry in the historic center with minor cracks in the highest story (D2).

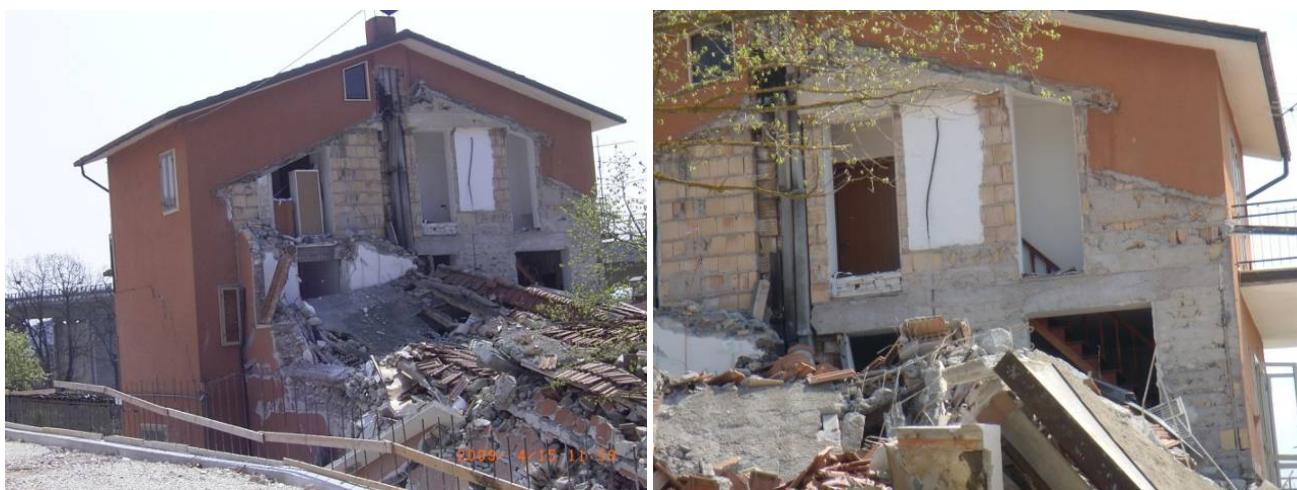
Figure 104. Masonry structure at waypoint GB-82-1.

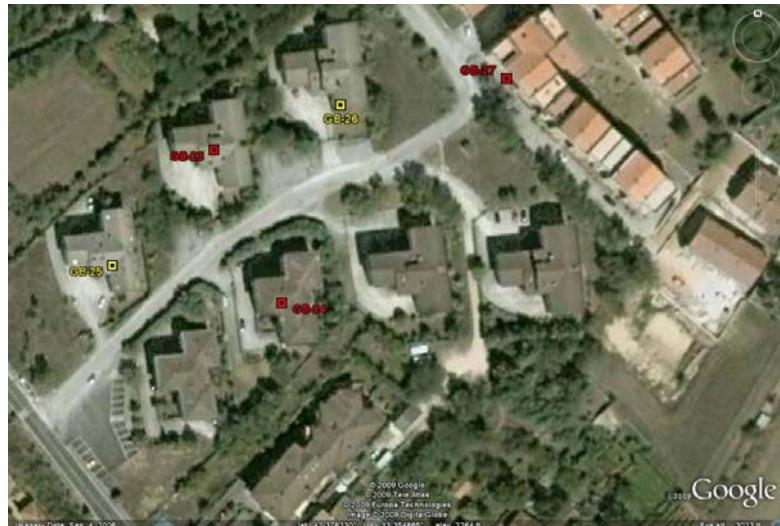
Figure 108. Cluster of damage in zone (d).

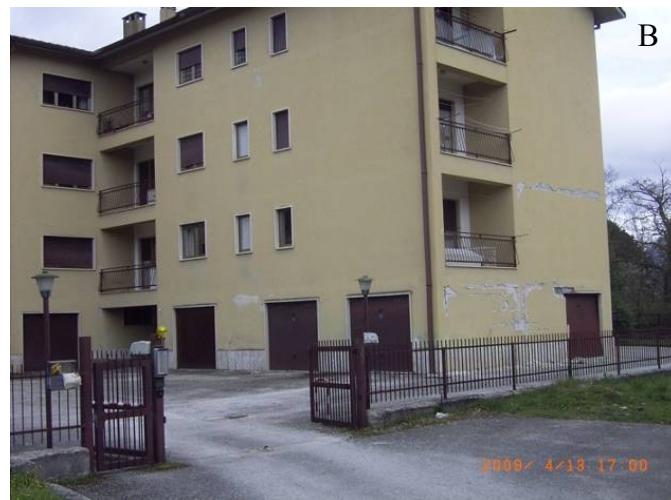
Figure 110. Damage on the structures in the cluster in zone (d). (B) Waypoint GB-25-1 (D2).

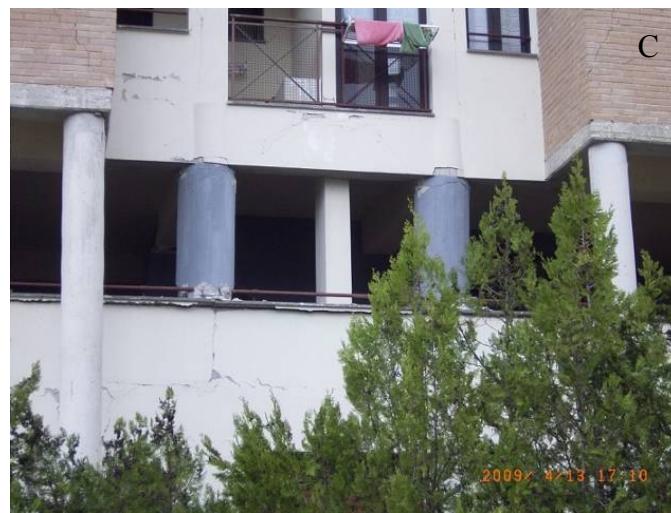
Figure 110. Damage on the structures in the cluster in zone (d). (C) Waypoint GB-26-1 (D2).

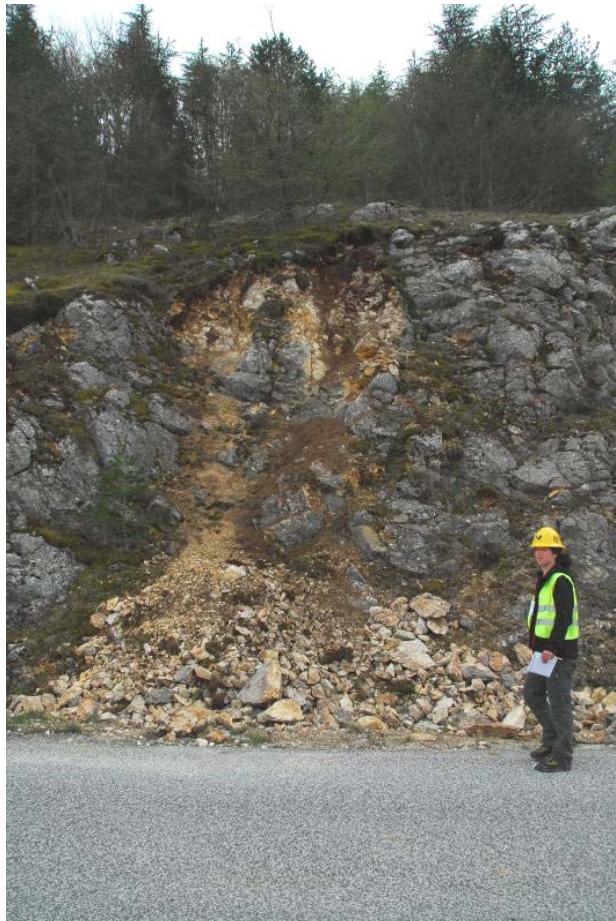
Figure 118. Shallow ravelling-type failure of weathered limestone blocks (42.278N, 13.468E).

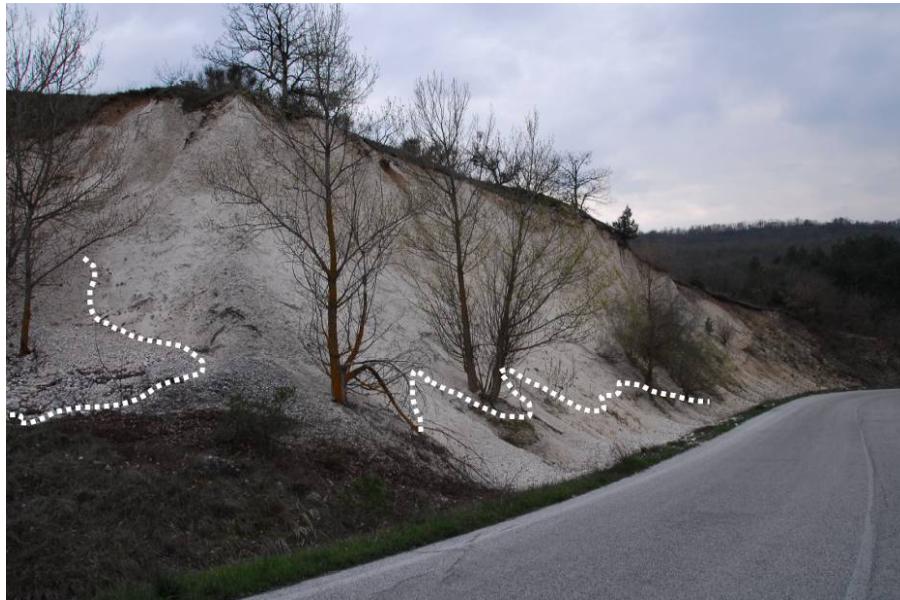
Figure 121. Minor ravelling of weakly cemented sand and gravel; dashed lines indicate the extent of freshly deposited talus along the base of road cut (Via Opi N42.261, E13.581).

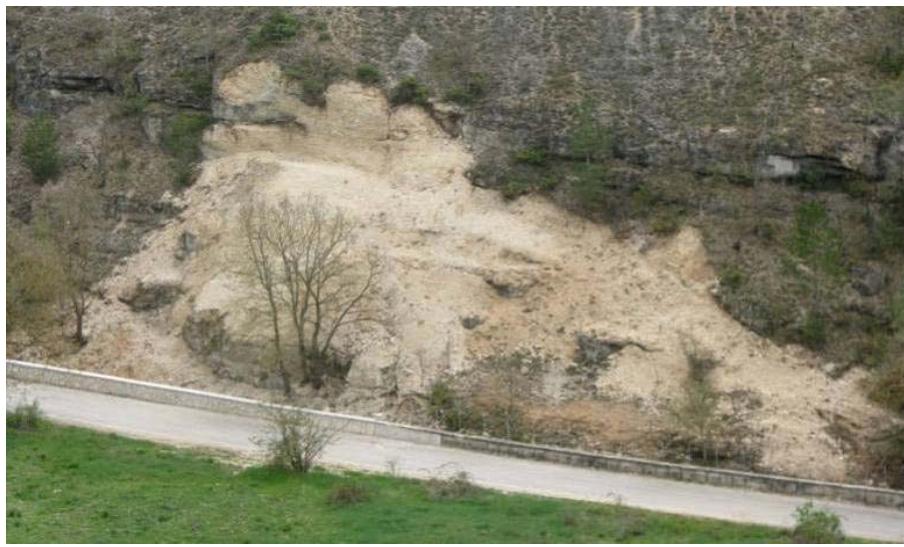
Figure 122. Ravelling along the road from S. Demetrio to Lake Sinizzo (42.28845N, 13.56442E).

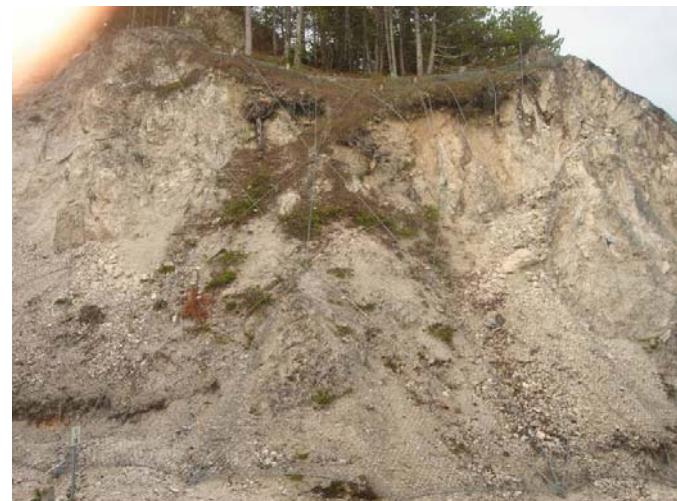
Figure 131. Ravelling in pervasively fractured/cataclastic limestones on a road cut retained by steel-net protections on SS80 at km 18.2: (DC-18-1) (42.4281N, 13.3460E).

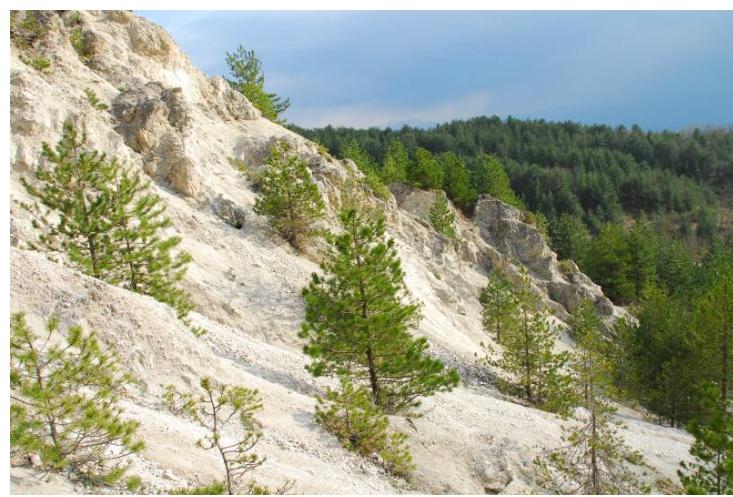
Figure 132. Characteristic erosional scars developed in cataclasite (42.434N, 13.334E).

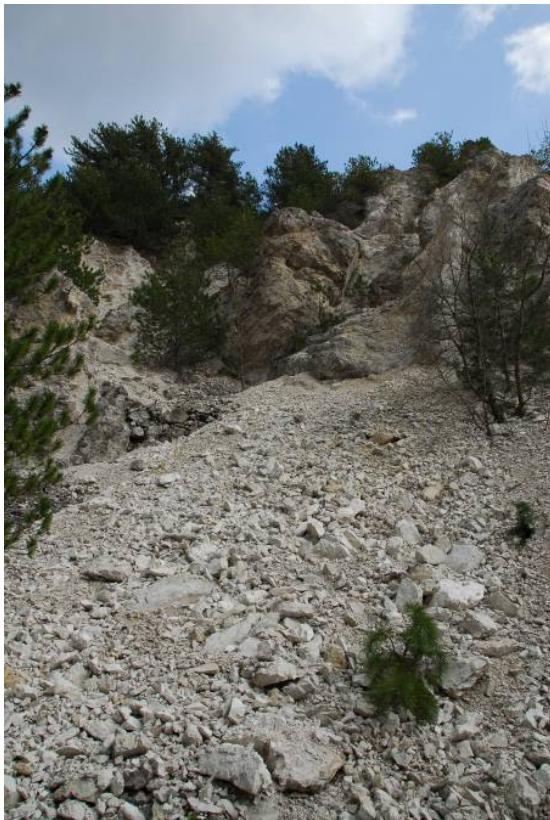
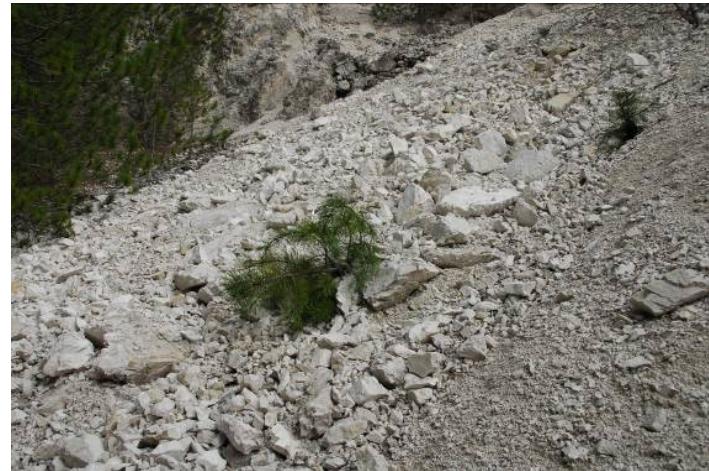
Figure 133. Characteristic ravelling-type failure in natural outcrops of cataclasite; partially buried pine trees evidence recent movement (42.434N, 13.334E).

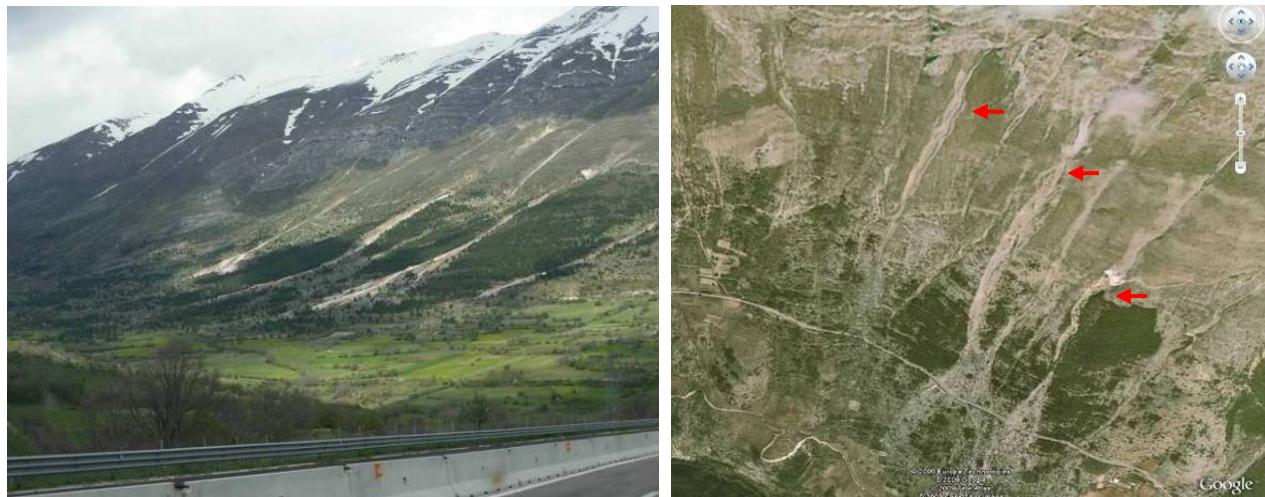
Figure 136. Left view of the Mt. San Franco flank on 4-30-2009. Right: image from Google Earth taken before the earthquake showing the debris flows (42.4368N, 13.5796E).

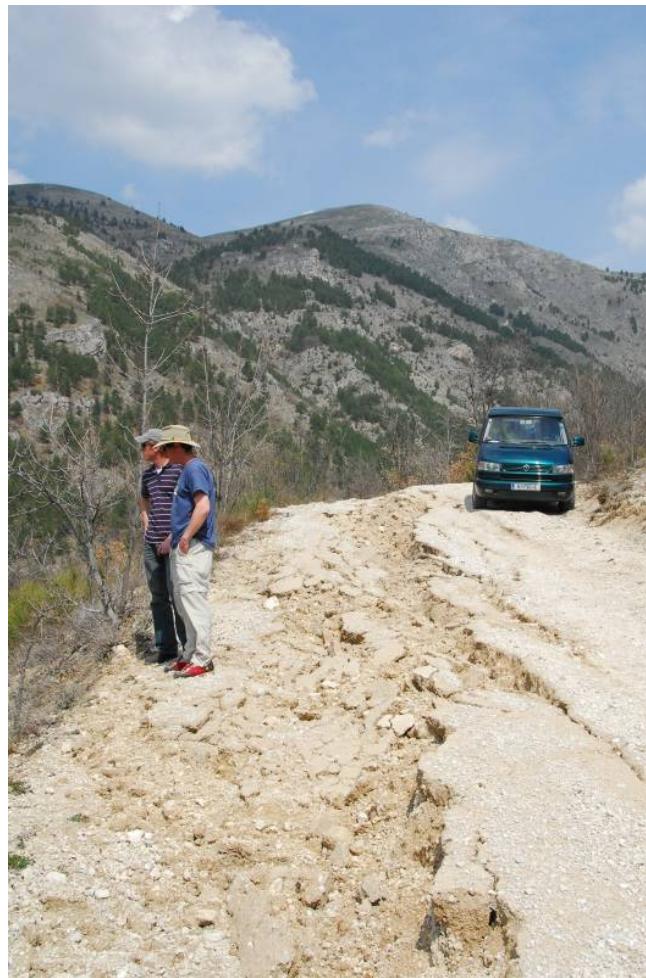
Figure 139. Failure of side-hill fill embankment (42.420N 13.376E).

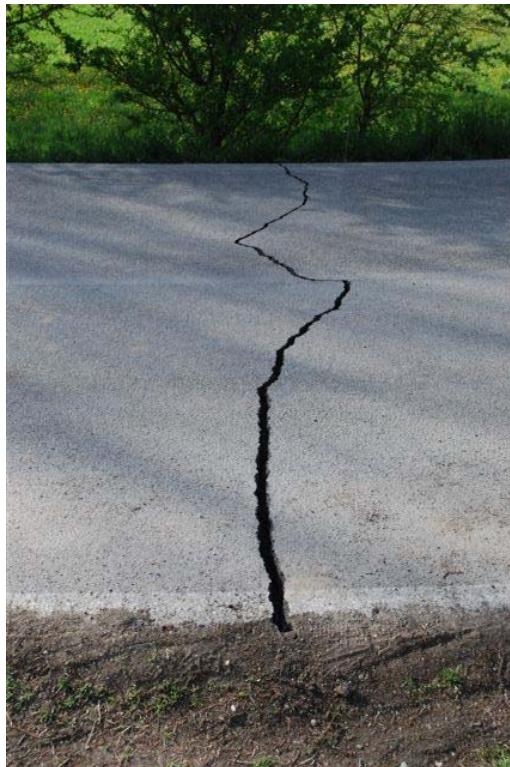
Figure 142. Typical tensile condition of road cracks, not extending into neighboring sub-base or approach fill embankment (42.324N, 13.478E).

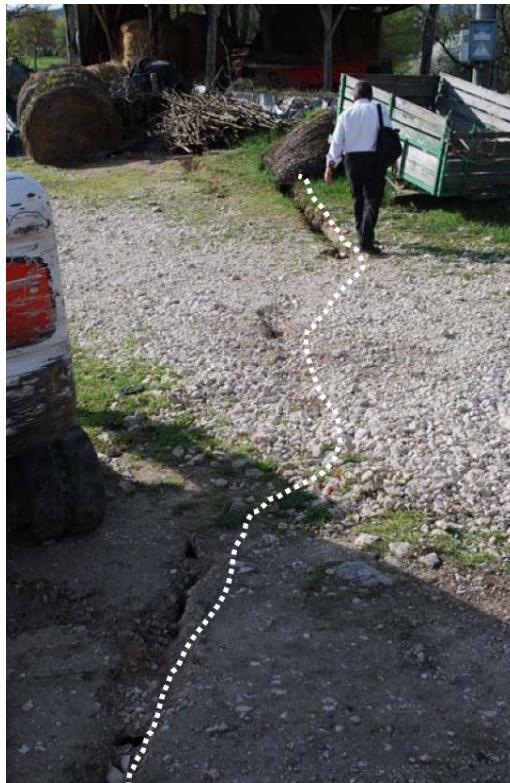
Figure 143. Ground cracks up to 1.0 m deep, 20 m long, and with maximum of 15 cm vertical displacement (down-dropped toward river) developed directly adjacent to bridge abutment (42.324N, 13.478E).

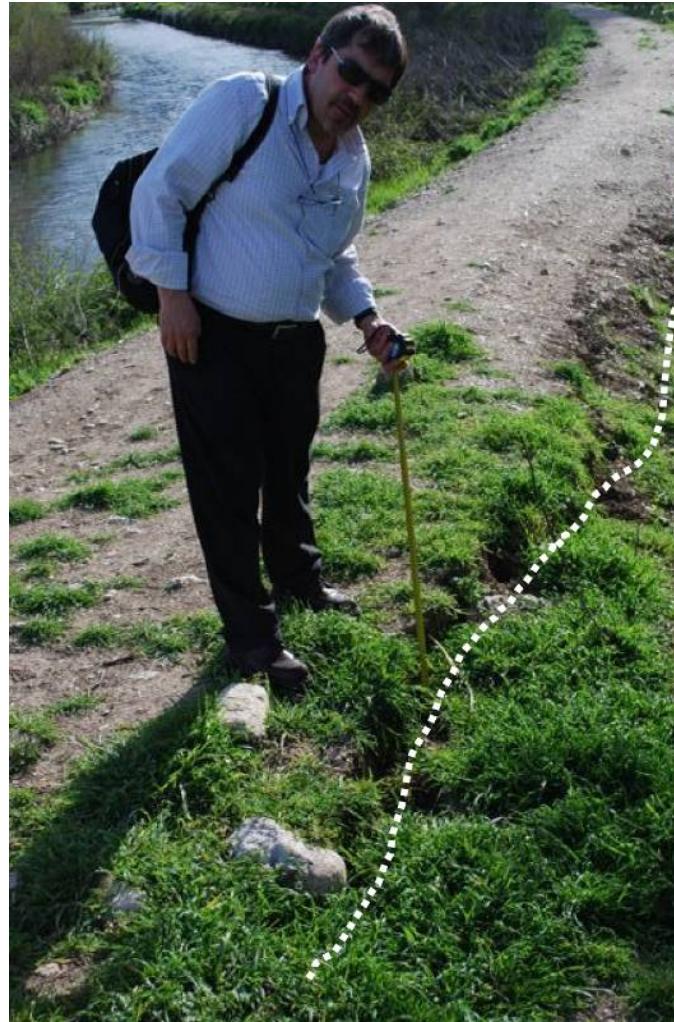
Figure 144. Ground cracks developed along levee crest adjacent to bridge abutment (42.324N, 13.478E).

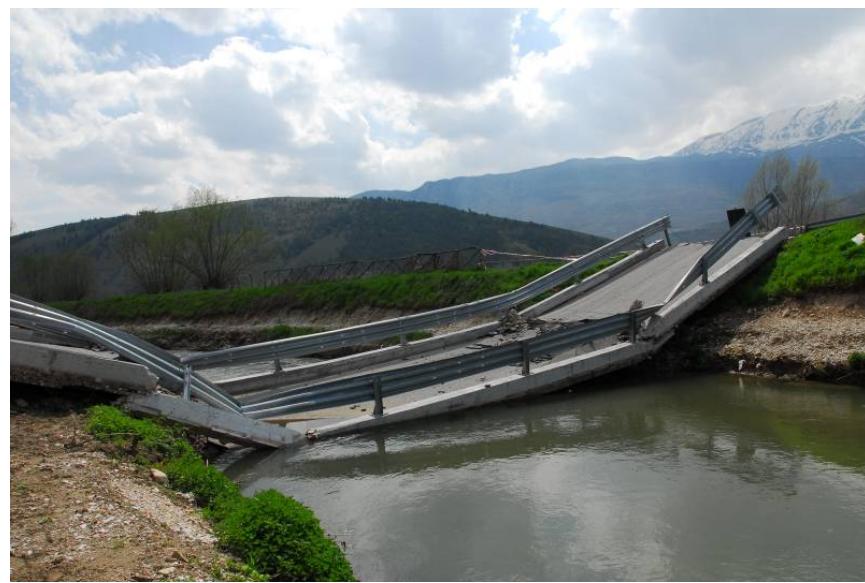
Figure 145. Bridge collapse along the Aterno River, approximately 450 m north of Monticchio (42.325N, 13.463E).

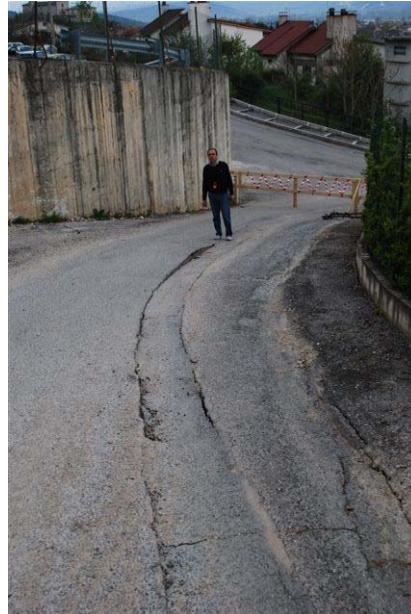
Figure 155. Seismic compression of trench backfill in the town of Paganica (42.365N, 13.465E).

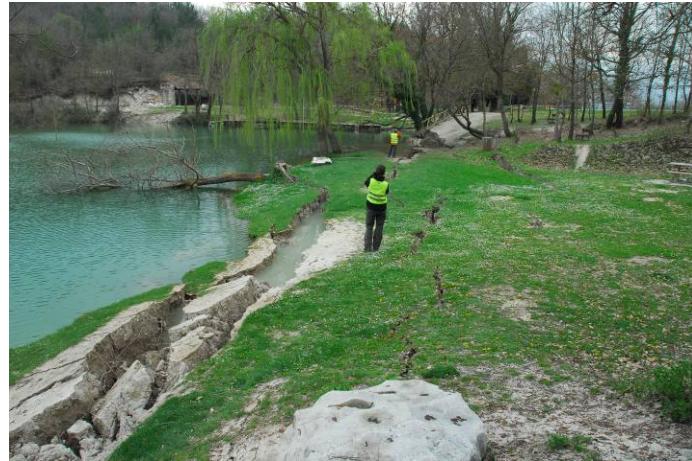
Figure 158. Ground cracks along the northwestern perimeter of Lake Sinizzo (42.291N, E13.576).

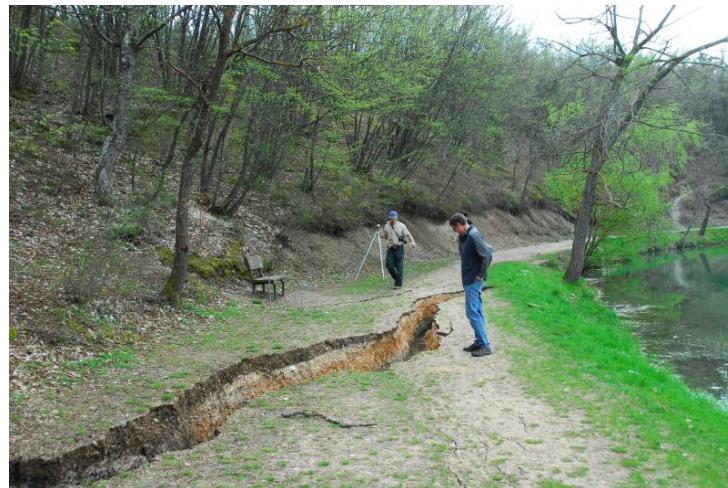
Figure 159. Ground cracks along the eastern perimeter of Lake Sinizzo (42.291N, E13.576).

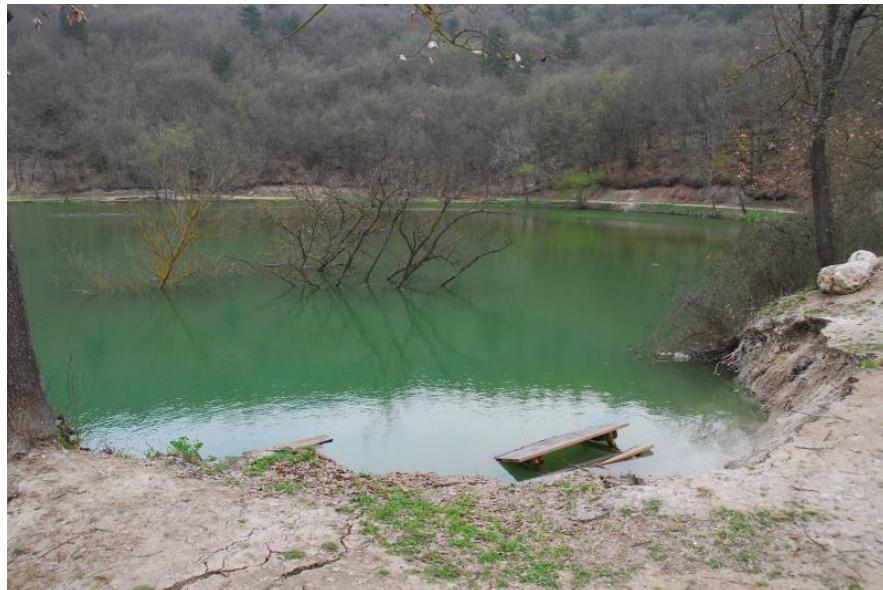
Figure 160. Submerged trees located several meters from the western margin of Lake Sinizzo; picnic table within arcuate landslide scar at shoreline. (42.291N 13.576).

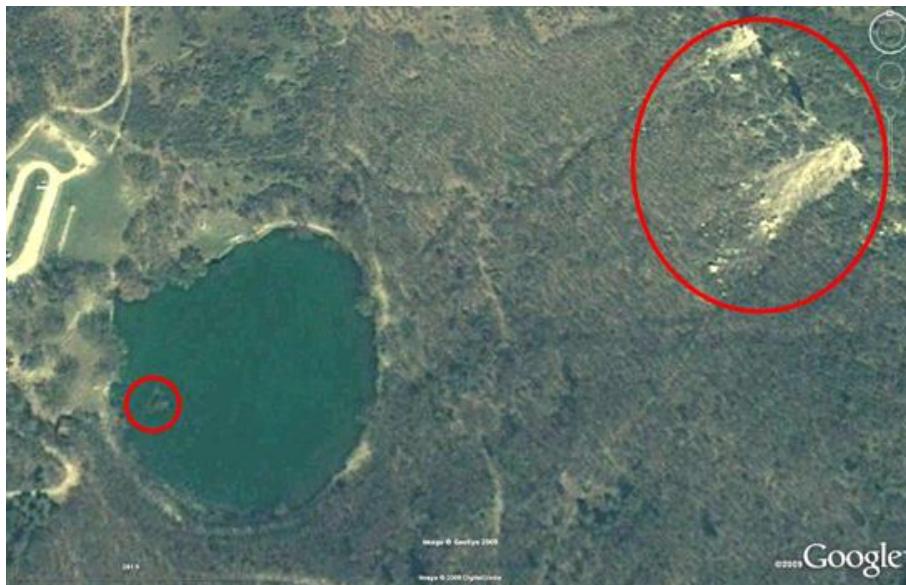
Figure 161. Post earthquake satellite imagery showing submerged trees within small circle and rock slope failures within large circle; compare to pre-earthquake imagery shown in Figure 146 (42.291N 13.576).

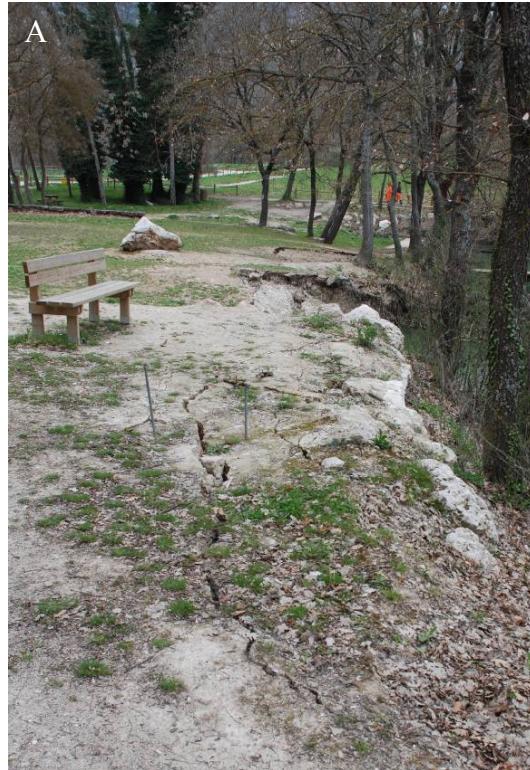
Figure 162. Ground cracks at the southwest corner of Lake Sinizzo (location WP 18) as observed on (A) 11 April 2009.

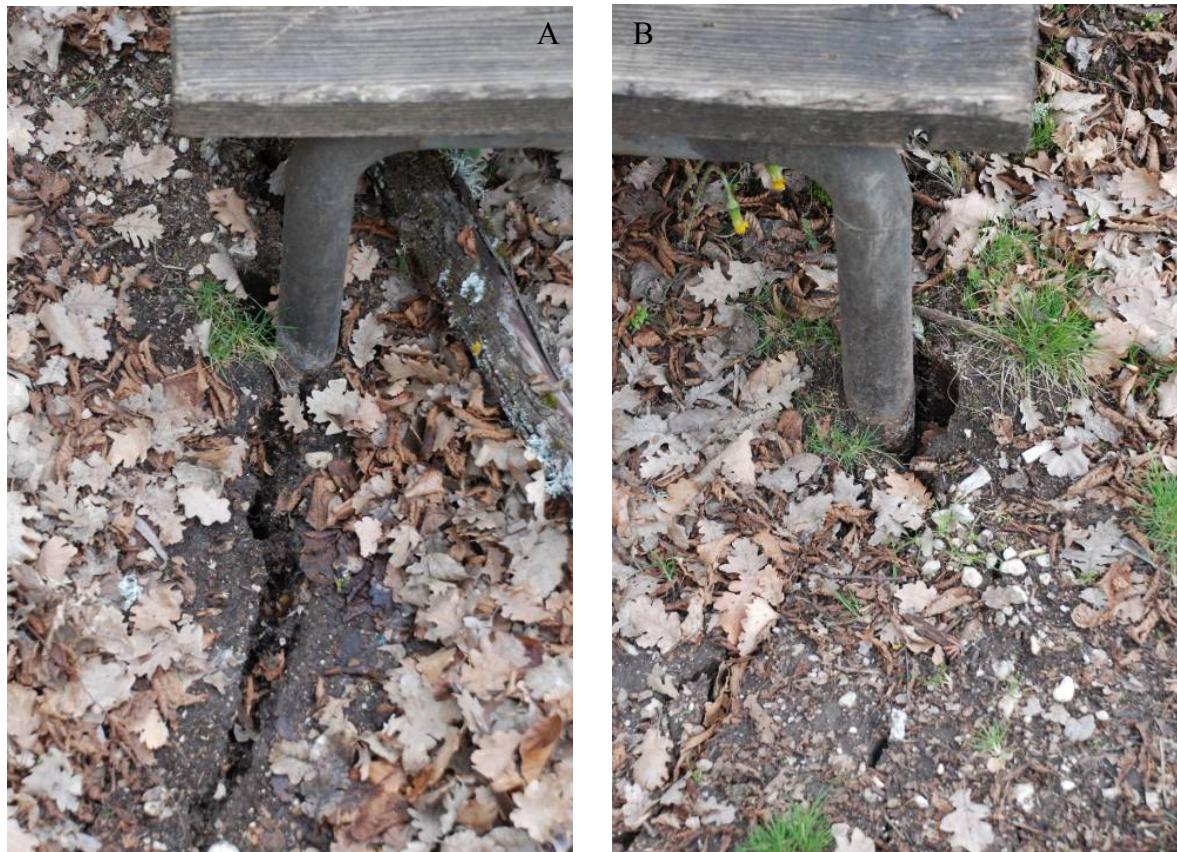
Figure 167. Characteristic deformations associated with the corners of the park bench at WP 31. (A) corner C2, (B) corner C3.
