Assessment of Stability Conditions of Ancient Underground Quarries using On-Site Monitoring and Numerical Modeling

KEYWORDS: Stability, underground quarries, monitoring, numerical modeling

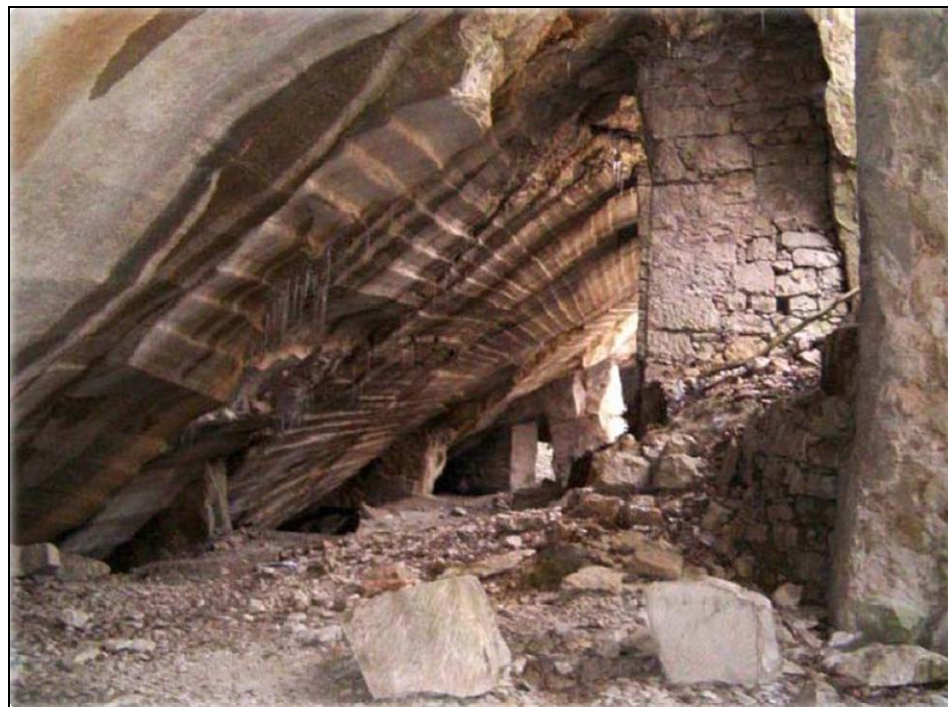
Figure 3. View of upper entrance of Danzi quarry.
