Assessment of Stability Conditions of Ancient Underground Quarries using On-Site Monitoring and Numerical Modeling

ABSTRACT: *This work, carried out by members of the University of Parma's Department of Civil and Environmental Engineering and Architecture, analyzes the stability of the ancient underground quarries at Viggìù (Varese, Italy). The objective of the study was to verify the actual structural predisposition to instability phenomena in the ancient ornamental stone quarries for a historical and cultural valorization as well as the recovery of the Danzi and Beltrami quarries. Although completely abandoned, these sites could be used as a tourist attraction and/or as a teaching environment. They are a wonderful example of industrial architecture, presenting audacious compositions of filled-in trenches and room and pillar techniques (Hedley and Grant, 1972). With such objectives in mind, a monitoring system that aims to control the most significant joints and discontinuities of the site has been realized. A numerical model of the entire rock mass has been developed in order to analyze the stability of the underground openings. A route for visitors has also been identified.*

R

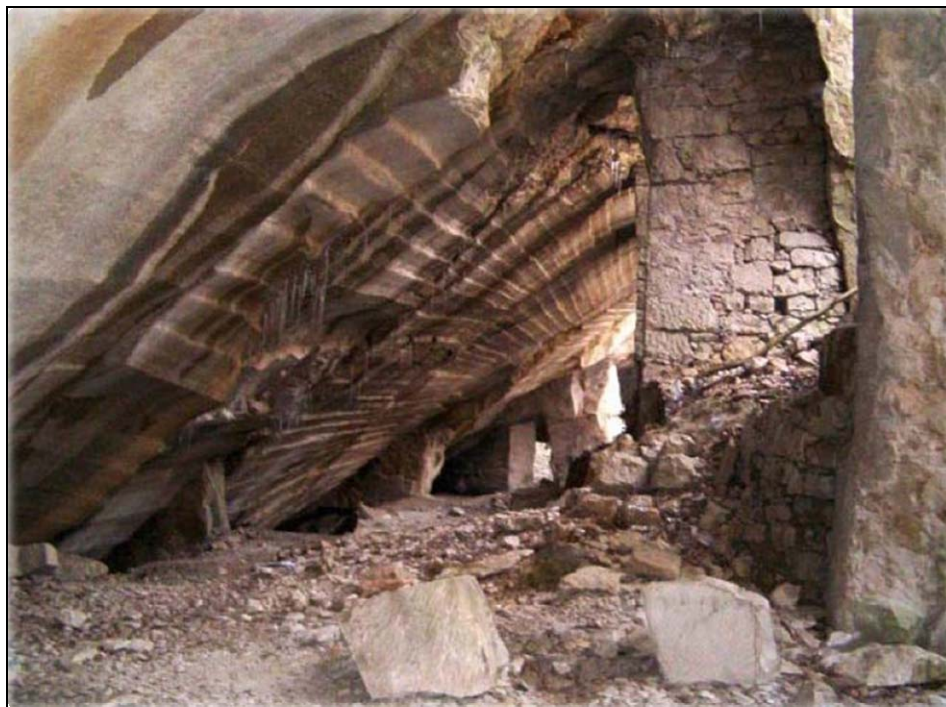
Figure 3. View of upper entrance of Danzi quarry.

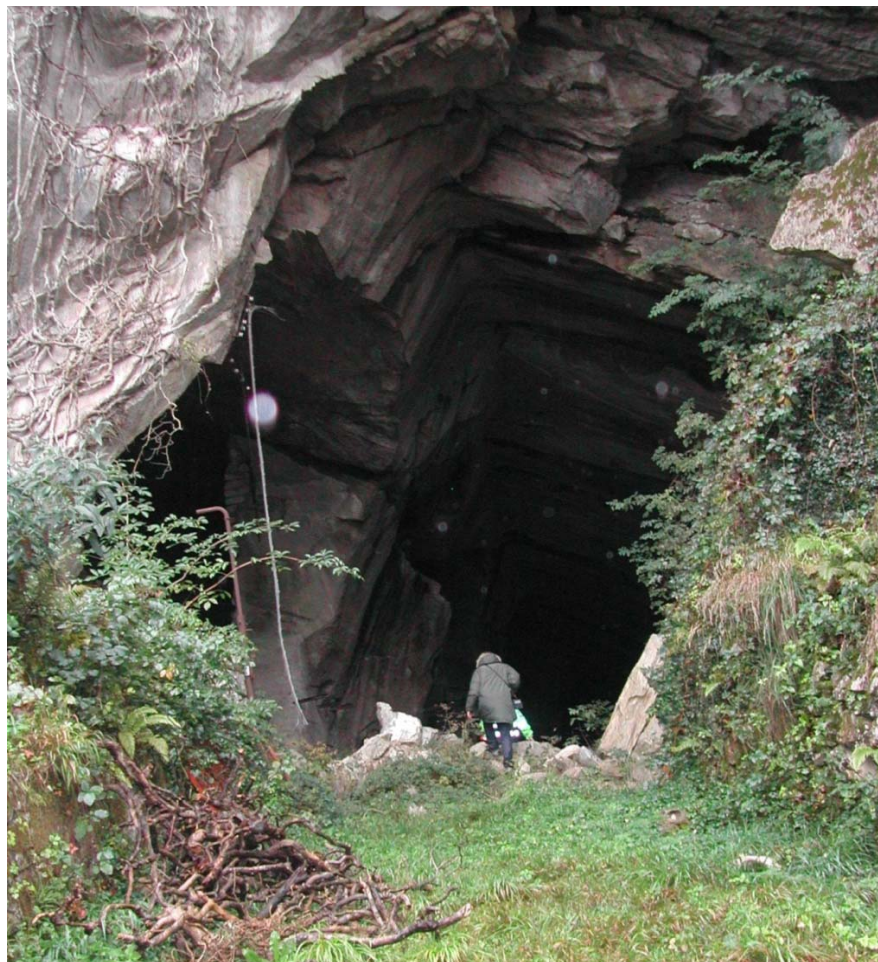
Figure 4. View of middle entrance of Beltrami quarry.
