## Mississippi River Levee Failures: June 2008 Flood

**ABSTRACT:** *During the spring and summer of 2008, record rainfall in the Midwest United States led to severe flooding as water overtopped the levees bordering the Mississippi River and its tributaries. The erosion associated with the overtopping resulted in levee breaches in many places. After the flooding, a field reconnaissance team was sent to collect time-sensitive data and provide a comprehensive overview of the performance of the levees during the flooding.*

Reference: Bernhardt, M., Briaud, J.L., Kim, D., Leclair, M., Storesund, R., Lim, S.G., Bea, R.G., Rogers, J.D., (2011). *Mississippi River Levee Failures: June 2008 Flood*. International Journal of Geoengineering Case Histories, <http://casehistories.geoengineer.org>, Vol.2, Issue 3, p. 127-162. doi: 10.4417/IJGCH-02-02-03.

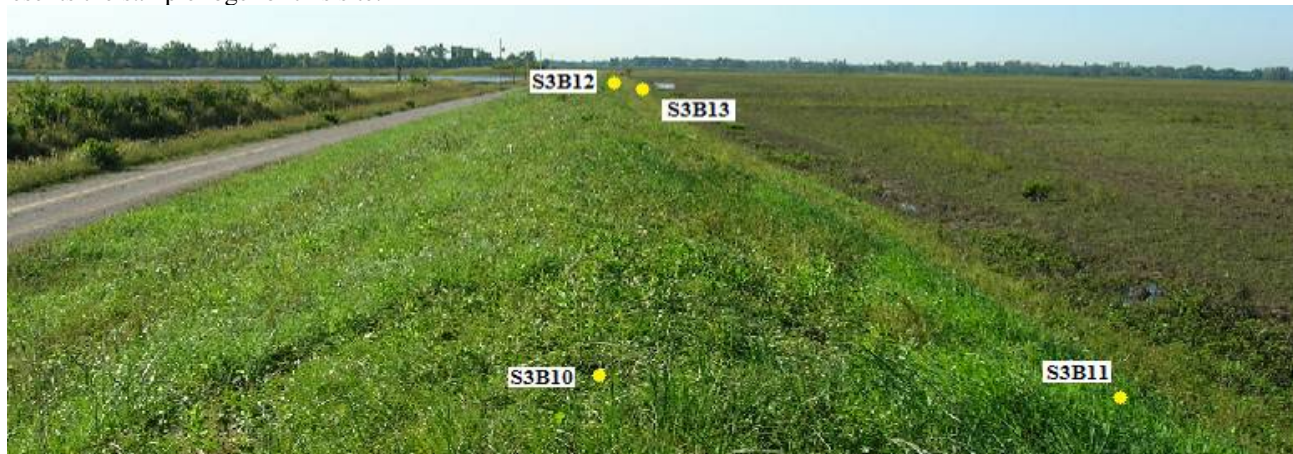
Figure 20. Brevator boring locations.

This site was unique in the fact that there was no breach in 2008. The only sign of erosion was at a box culvert that was cracked allowing water and soil to seep through. A local resident (Mr. James Pieper) informed the team that the levee was overtopped by nearly 1 m of water for three days and never failed. Four samples were collected from various locations along the levee. Because there was no actual breach, only surficial samples were taken. These samples were much harder to obtain and the soil seemed to be much stiffer than at the previous sites as can be seen by the higher Pocket Penetrometer values (Table 6) obtained at this site compared to the Winfield site. Figure 20 shows the boring locations and Table 6 presents the sample logs for this site.
