Expedient Mitigation of Collapsible Loess in Northern Afghanistan

Christopher T. Senseney, Assistant Professor, U.S. Air Force Academy, Colorado, 80840-6232, USA; email: christopher.senseney@usafa.edu

Reference: Senseney, C. (2013). *Expedient Mitigation of Collapsible Loess in Northern Afghanistan*

International Journal of Geoengineering Case histories,

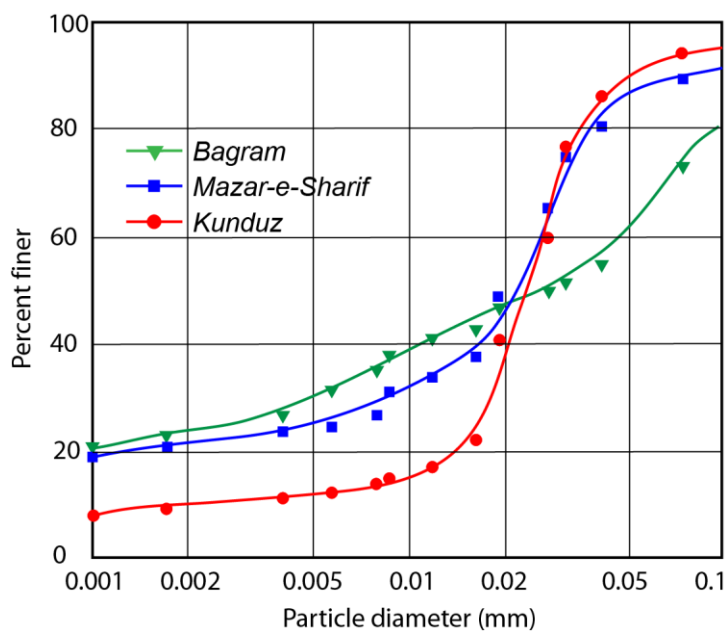
Figure 4. Particle size distributions of Kunduz, Mazar-e-Sharif and Bagram soil.

Soils from Afghanistan military bases in Kunduz, Mazar-e-Sharif and Bagram were evaluated for collapse using Gibbs and Bara's criteria and Handy's criteria. Sand cone tests were conducted and disturbed soil samples were collected at a depth of 0.5 m (20 in). Three sand cone tests and three samples were obtained from Kunduz and two sand cone tests and two samples each were obtained from Mazar-e-Sharif and Bagram. An average of the soil properties are given in Table 1 and an average of the particle size distributions in Fig. 4, where fine content less than 0.075 mm was determined using a hydrometer apparatus (ASTM 2007). The Kunduz and Mazar-e-Sharif soil exhibit a uniform distribution with particles concentrated in the range 0.01 to 0.06 mm, indicating the soils are loessial and will not compact well. On the contrary, the Bagram soil exhibits a more well-graded distribution, indicating the soil is not loessial and has higher potential for compaction. According to Gibbs and Bara's criteria, the Kunduz and Mazar-e-Sharif soil is collapsible, while the Bagram soil would fall just inside the non-collapsible region (see Fig. 3). According to Handy's criteria, the Kunduz soil has high probability of collapse, the Mazar-e-Sharif soil will probably collapse, and the Bagram soil has less than 50% probability. These results match what military forces have observed. As many as 48 sites in and around the Kunduz Airfield show signs of collapsed soil (SIGAR 2010) and an earthen drainage ditch near the Mazar-e-Sharif Airfield experienced slope failure from collapsible soil. No evidence of collapse has been observed at Bagram. Lutenegeger and Saber's collapse test or other collapse tests were not used in this study because the equipment to obtain undisturbed samples and equipment to conduct necessary laboratory tests are not available in Afghanistan.
