Expedient Mitigation of Collapsible Loess in Northern Afghanistan

Christopher T. Senseney, Assistant Professor, U.S. Air Force Academy, Colorado, 80840-6232, USA; email: christopher.senseney@usafa.edu

Reference: Senseney, C. (2013). *Expedient Mitigation of Collapsible Loess in Northern Afghanistan*

International Journal of Geoengineering Case histories,

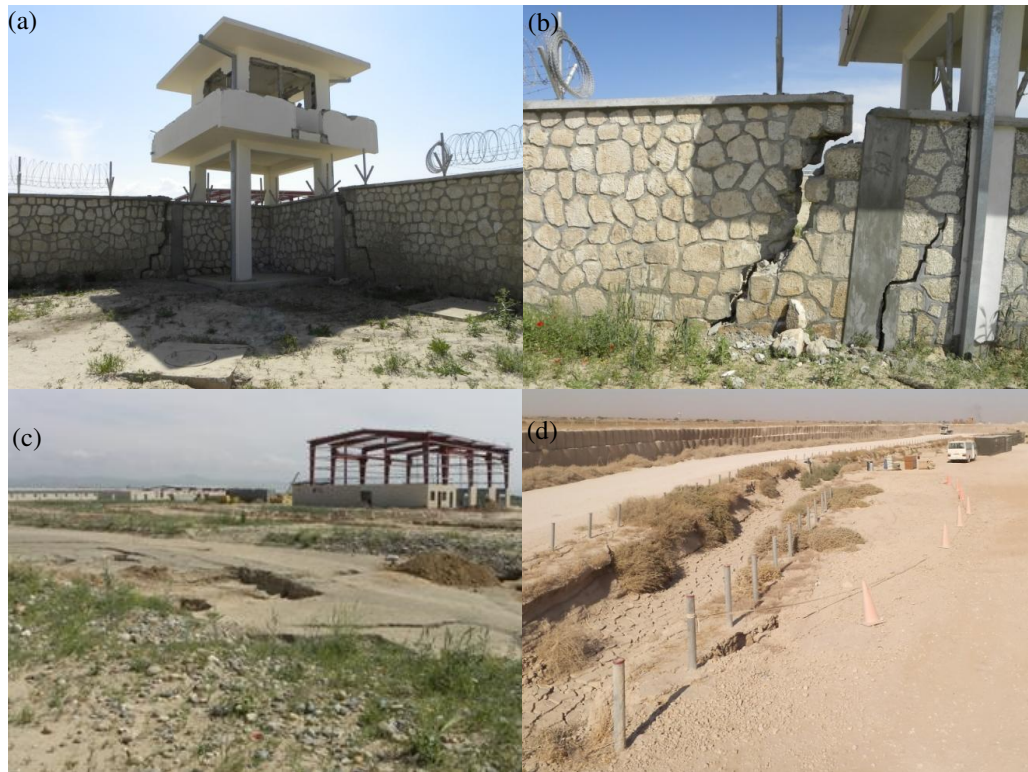
Figure 2. a. Damaged guardhouse and security wall in Kunduz, b. security wall damaged in Kunduz, c. settlement basin through a road in Kunduz, d. slope failure next to earthen drainage ditch in Mazar-e-Sharif as evidenced by coned off area.

The magnitude of collapse and resulting damage to infrastructure and facilities is primarily dependent on the amount of wetting. In low lying areas where water pools or flows after heavy rains, soil collapse often manifests itself in settlement basins or slope failure. Settlement basins typically occur near the perimeter of a facility beneath downspouts or on the edge of roads near drainage ditches. The facilities, in turn, experience differential settlement and structural damage, as evidenced by building settlements up to 10 cm (4 in) around Mazar-e-Sharif and Kunduz (Meier et al. 2009, SIGAR 2010). Settlement basins also cause failure to security walls (Fig. 2a-b) and damage roads (Fig. 2c). Slope failures damage the drainage system and render limited real estate unusable (Fig. 2d). Repairing damage wastes valuable resources that could be better utilized elsewhere.

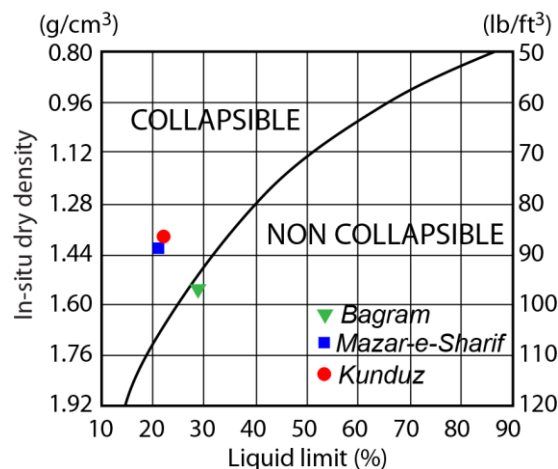
Figure 3. Gibbs and Bara (1962) criteria for determining collapsibility.

Of the methods to identify collapsible soil, two of the most common are the dry density and liquid limit graph (Gibbs and Bara 1962) and the one-dimensional compression test using an oedometer (Lutenegger and Saber 1988). By studying alluvial fan deposits in California with low dry density, Gibbs and Bara (1962) showed that when the saturated moisture content exceeds the liquid limit, the soil will likely collapse. Using this relationship, they developed the dry density versus liquid limit criteria in Fig. 3. The Gibbs and Bara approach is most applicable to clayey sands and sandy clays (NAVFAC 1986), but in the absence of a collapse test, it is a reasonable preliminary assessment for loess soils. Lutenegger and Saber (1988) introduced a collapse test that applies a vertical stress to a laterally confined, undisturbed sample of loess at its natural water content, and then introducing water to the specimen. A decrease in volume at a constant vertical stress is an indication of the collapse potential of the soil.

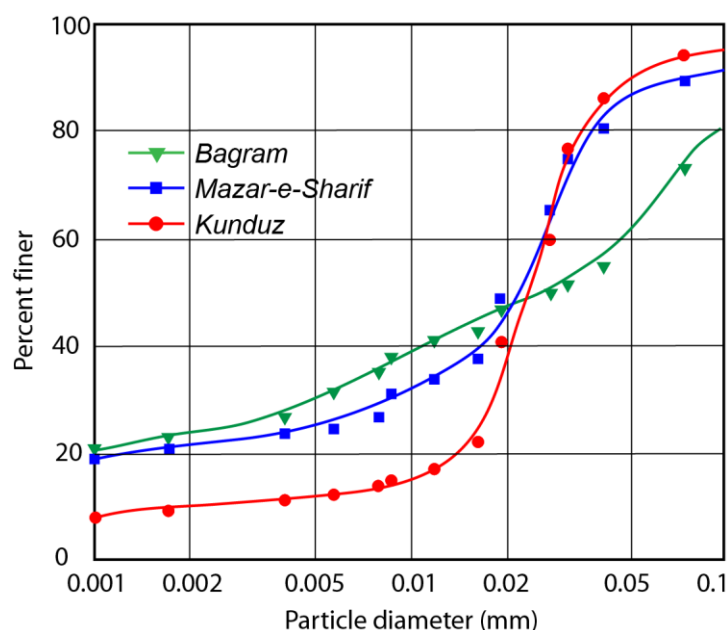
Figure 4. Particle size distributions of Kunduz, Mazar-e-Sharif and Bagram soil.

Soils from Afghanistan military bases in Kunduz, Mazar-e-Sharif and Bagram were evaluated for collapse using Gibbs and Bara's criteria and Handy's criteria. Sand cone tests were conducted and disturbed soil samples were collected at a depth of 0.5 m (20 in). Three sand cone tests and three samples were obtained from Kunduz and two sand cone tests and two samples each were obtained from Mazar-e-Sharif and Bagram. An average of the soil properties are given in Table 1 and an average of the particle size distributions in Fig. 4, where fine content less than 0.075 mm was determined using a hydrometer apparatus (ASTM 2007). The Kunduz and Mazar-e-Sharif soil exhibit a uniform distribution with particles concentrated in the range 0.01 to 0.06 mm, indicating the soils are loessial and will not compact well. On the contrary, the Bagram soil exhibits a more well-graded distribution, indicating the soil is not loessial and has higher potential for compaction. According to Gibbs and Bara's criteria, the Kunduz and Mazar-e-Sharif soil is collapsible, while the Bagram soil would fall just inside the non-collapsible region (see Fig. 3). According to Handy's criteria, the Kunduz soil has high probability of collapse, the Mazar-e-Sharif soil will probably collapse, and the Bagram soil has less than 50% probability. These results match what military forces have observed. As many as 48 sites in and around the Kunduz Airfield show signs of collapsed soil (SIGAR 2010) and an earthen drainage ditch near the Mazar-e-Sharif Airfield experienced slope failure from collapsible soil. No evidence of collapse has been observed at Bagram. Lutenegegger and Saber's collapse test or other collapse tests were not used in this study because the equipment to obtain undisturbed samples and equipment to conduct necessary laboratory tests are not available in Afghanistan.

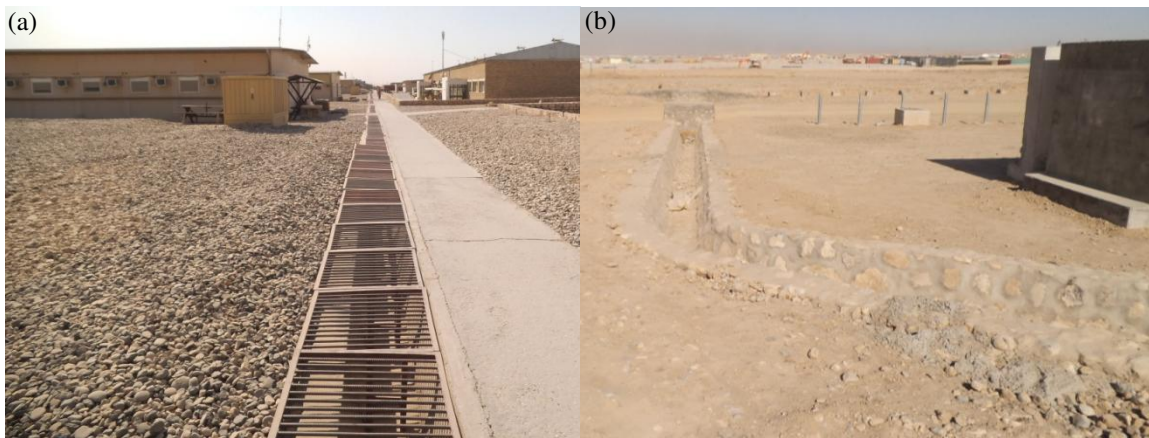
Figure 5.a. Cast in place concrete trench drain and gravel cover over the ground surface, b. grouted stone channel constructed with locally available cobble stones.

A suitable drainage design at expedient military bases is open channel drains and a gravel cover over the ground surface. Cast in place concrete trench drains (as shown in Fig. 5a) should be trapezoidal or rectangular with depths generally ranging from 0.15-1.0 m (0.5-3.3 ft), depending on local hydrological conditions. The drain bottom and side walls must be reinforced to withstand earth pressure and anticipated loads. Grouted stone channels (see Fig. 5b) are also acceptable. Such channels are common in Afghanistan given the abundance of naturally occurring cobble stone deposits in river beds. Downspouts from buildings should feed into the drains. UngROUTED riprap-lined channels or earthen drainage ditches (see Fig. 2d) are not recommended because water infiltration may cause collapse and/or slope failure.
