Estimation of the Hydroconsolidation Susceptibility of the Anthropogenic Fill of the Historical Center of Thessaloniki, Greece

ABSTRACT: *The collapse of soil structure due to wetting is called hydroconsolidation and occurs only once under constant loading, in cases of perturbation of the soil's moisture content. It is encountered usually in non-sedimentary soils such as anthropogenic fills and residual materials. This paper presents an interpretation of hydroconsolidation settlements of a building in the historical center of Thessaloniki after a rise of the water table. The interpretation is based on the results of laboratory evaluation of hydroconsolidation properties, in conjunction with in situ measurements of settlements.*

Reference: Hatzigogos, N.P.T., Makedon, T.K., Tsindaris, G.E., Tsotsos, S.C. and Christaras B.C. (2016). *Estimation of the Hydroconsolidation Susceptibility of the Anthropogenic Fill of the Historical Center of Thessaloniki, Greece*. International Journal of Geoenvironmental Engineering Case histories, Vol.4, Issue 1, p.46-56. doi: 10.4417/IJGCH-04-01-04

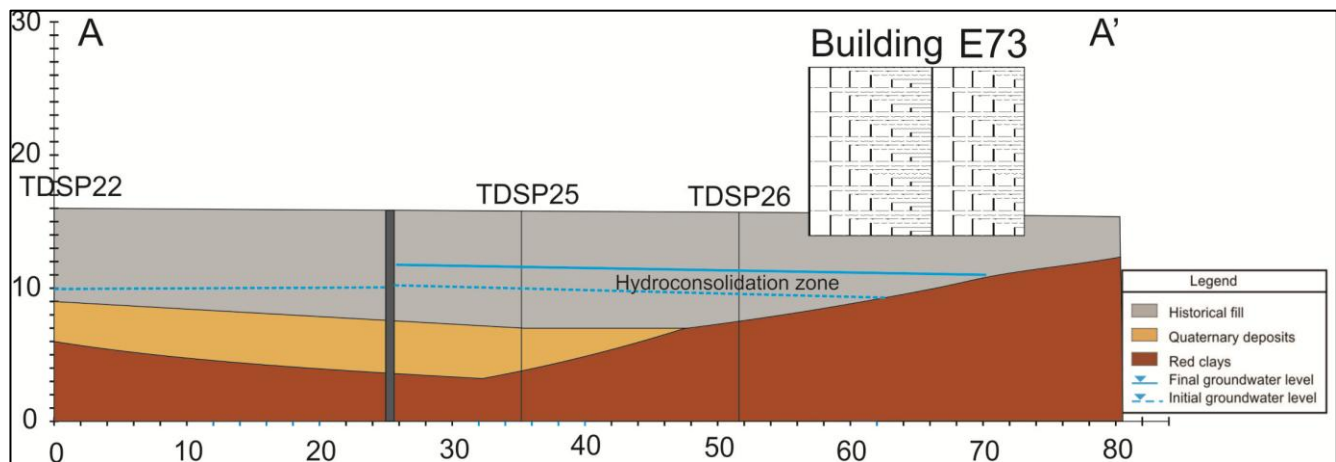
Figure 14. A-A' geological cross-section pointing the hydroconsolidation region.

higher towards the NE in respect to the groundwater level and consequently the hydroconsolidated part of the layer becomes less at this direction. Figure 14 shows a characteristic cross section of NW-SE direction that depicts the hydroconsolidated area below the building.
