Estimation of the Hydroconsolidation Susceptibility of the Anthropogenic Fill of the Historical Center of Thessaloniki, Greece

Reference: Hatzigogos, N.P.T., Makedon, T.K., Tsindaris, G.E., Tsotsos, S.C. and Christaras B.C. (2016). *Estimation of the Hydroconsolidation Susceptibility of the Anthropogenic Fill of the Historical Center of Thessaloniki, Greece*. International Journal of Geoenvironmental Engineering Case histories, Vol.4, Issue 1, p.46-56. doi: 10.4417/IJGCH-04-01-04

The scope of this paper is the estimation of hydroconsolidation susceptibility of Thessaloniki's historical fill formations through laboratory simulation for the interpretation of settlement measurements at a building of the historical centre of the city.

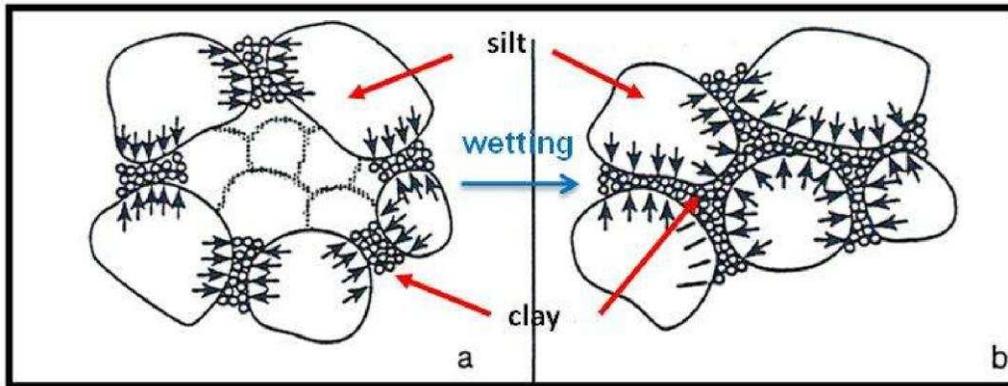
Figure 1. Collapse of a soil structure under load due to wetting (Knight, 1961).

The volumetric change behavior of a saturated soil is generally controlled by effective stress. However this behavior under unsaturated conditions cannot be estimated on the basis of effective stress alone but it is controlled by the changes of the soil moisture that result in changes of soil's matric suction (Khalili et al, 2004). The phenomenon of soil collapse can be manifested gradually and not necessarily as an immediate settlement, depending on the initial moisture content and the moisture variation range. If the soil is loaded under saturated conditions then it will consolidate without collapsing. If however its moisture content under constant loading is initially low (partially saturated) and is subsequently increased, then for low stress levels the soil will swell, whereas for higher stress levels it will sustain volume decrease due to structure collapse. Figure 1 shows the phenomenon of gradual collapse with increased wetting which is called hydroconsolidation; it occurs once and results in a new more stable soil structure (Knight, 1961).

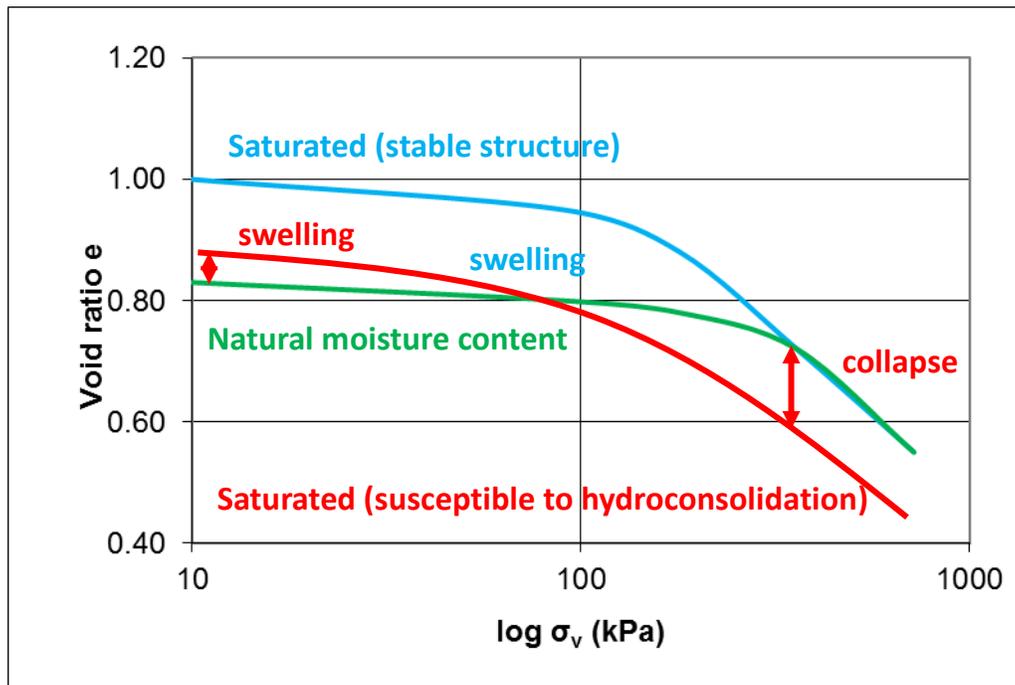
Figure 2. Soil swelling and collapse behavior after wetting under constant load (modified from Jennings & Knight, 1975).

Hydroconsolidation usually occurs in cases of wetting in soils of unstable granular structure due to technical interventions, in residual soils and in non cohesive man-made historical and urban non-engineered fills. The magnitude of settlements due to soil collapse depends on the soil's void ratio as well as the applied load. For low foundation stress levels from 100-300 kPa, research shows observed volume changes up to 10% and settlement as much as 15% of the thickness of the susceptible layers (Tromp, 1985). Hydroconsolidation is estimated via oedometer test with simulation of the loading procedure followed by sample inundation as in Figure 2 (Jennings & Knight, 1975).

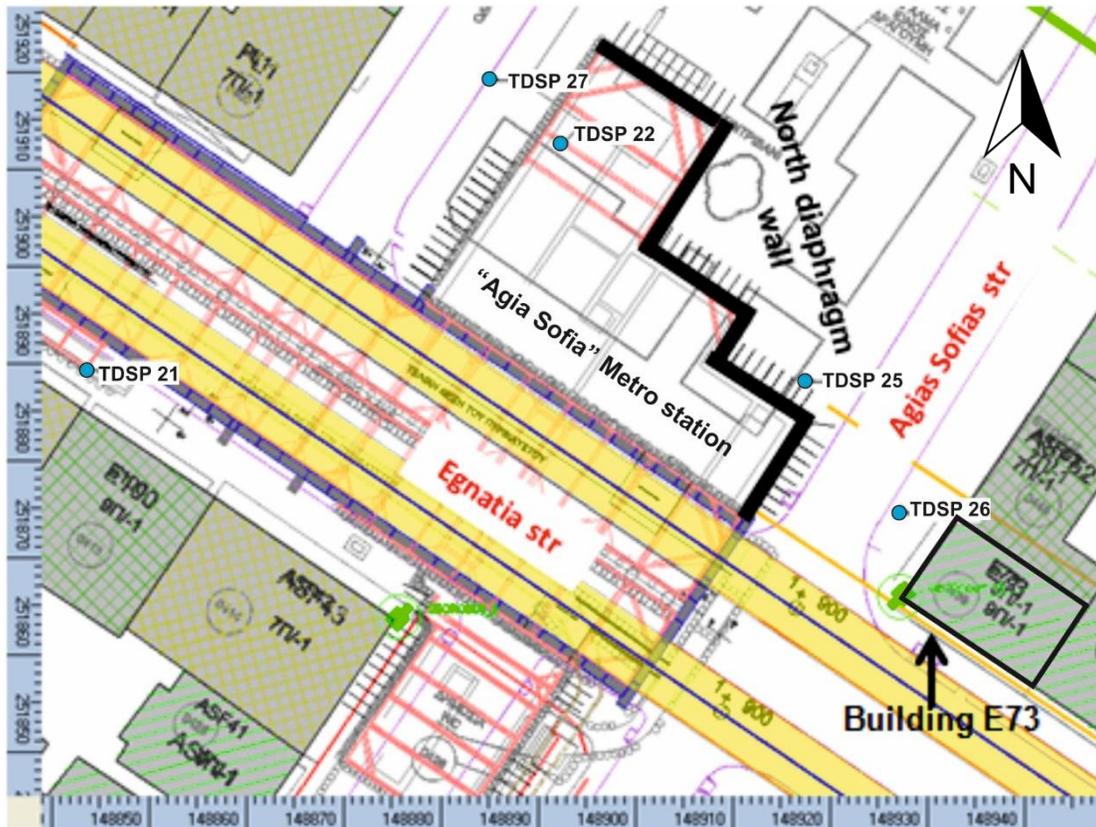
Figure 3. Planar view of the construction of diaphragm walls and piezometers (TDSP 21-27) in "Agia Sofia" Metro Station, along with building E73.

The area of investigation is adjacent to the construction site of the "Agia Sofia" station of Thessaloniki's Metro. During the construction of the station's north diaphragm walls displacements were observed on an adjacent block of flats at the corner of Agia Sofia and Egnatia streets (building E73). The displacements resulted in the deflection of the building towards SW. Systematic measurements of the displacements on the foundation ground were carried out to investigate the phenomenon as well as measurements of the groundwater level in piezometers of the construction area as shown in Figure 3.

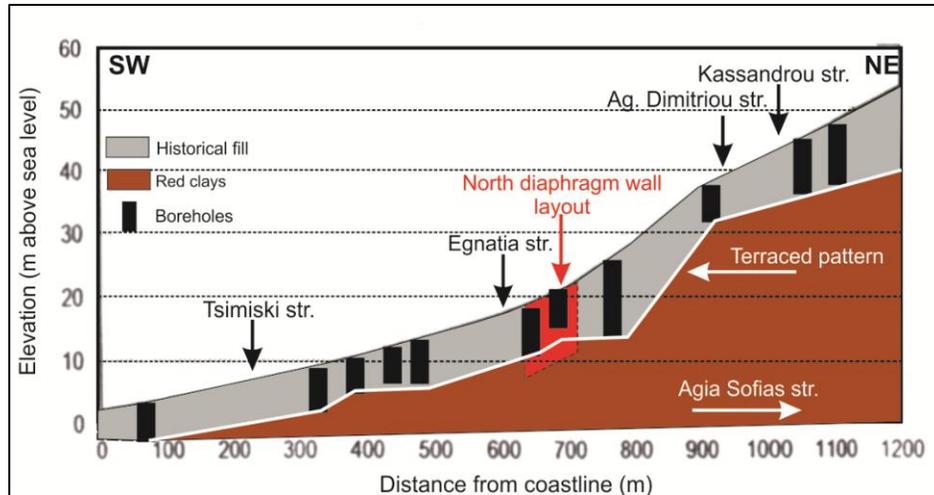
Figure 4. Cross section along Agias Sofias street indicating the terraced pattern of the soil strata underneath the historical fill (modified from Chatzigogos et al, 2006).

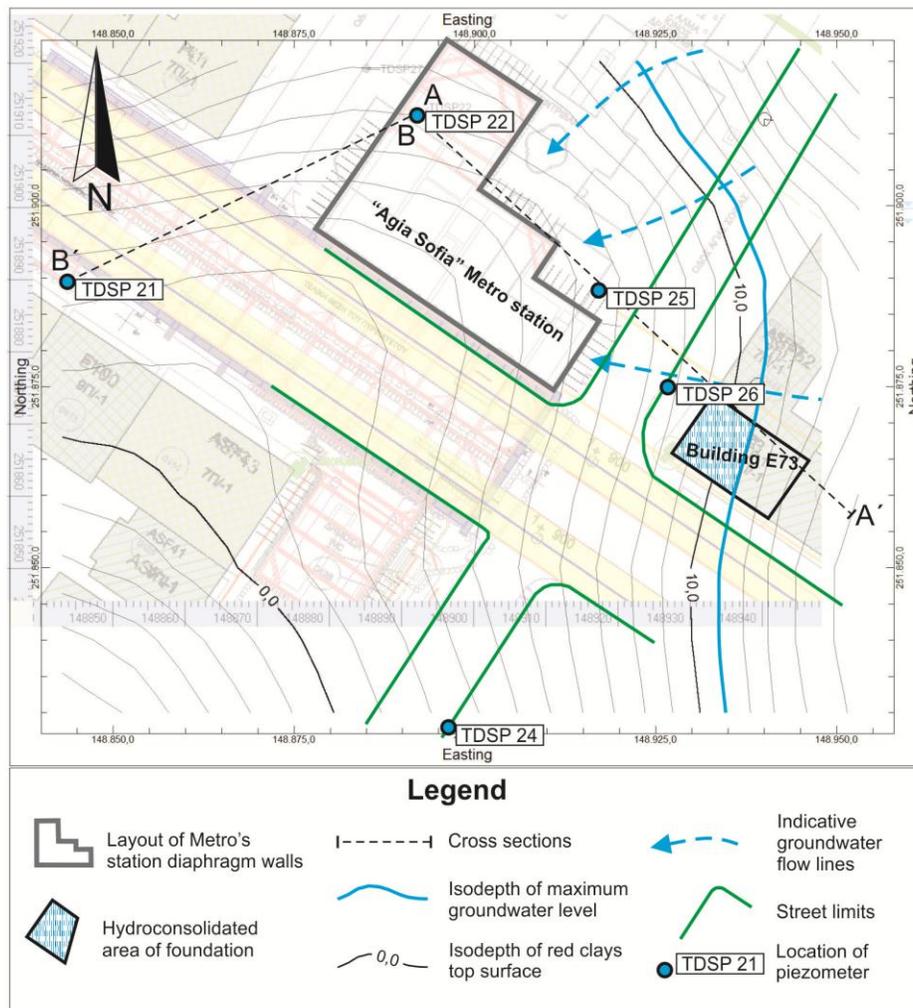
Figure 5. Map of the investigation area with the isodepths of the red clays.

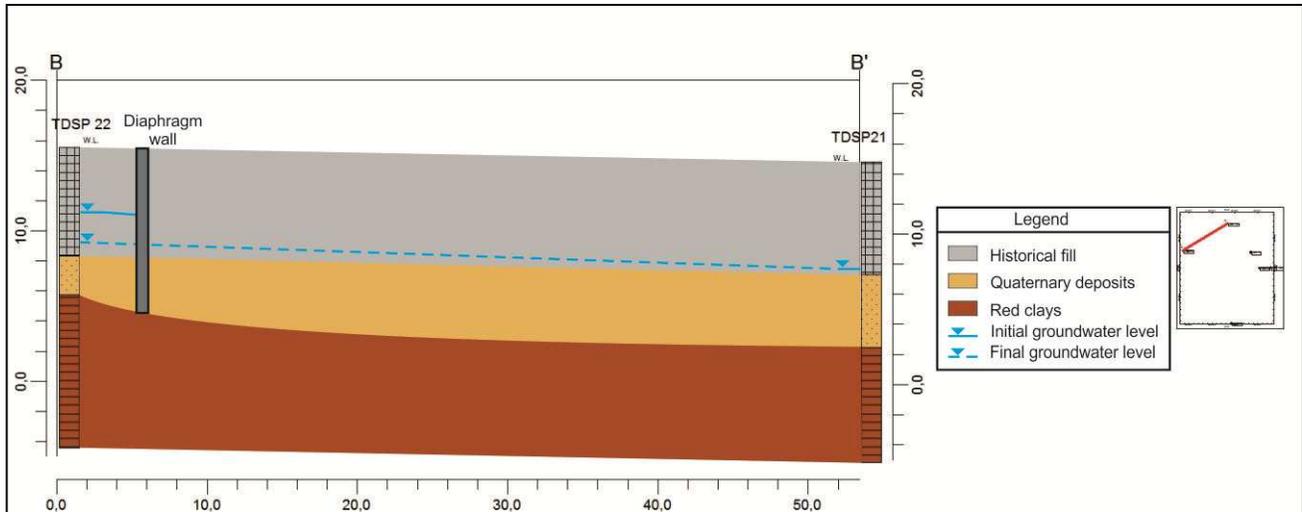
Figure 6. Geological cross section in NE-SW direction along boreholes TDSP22-TDSP21.

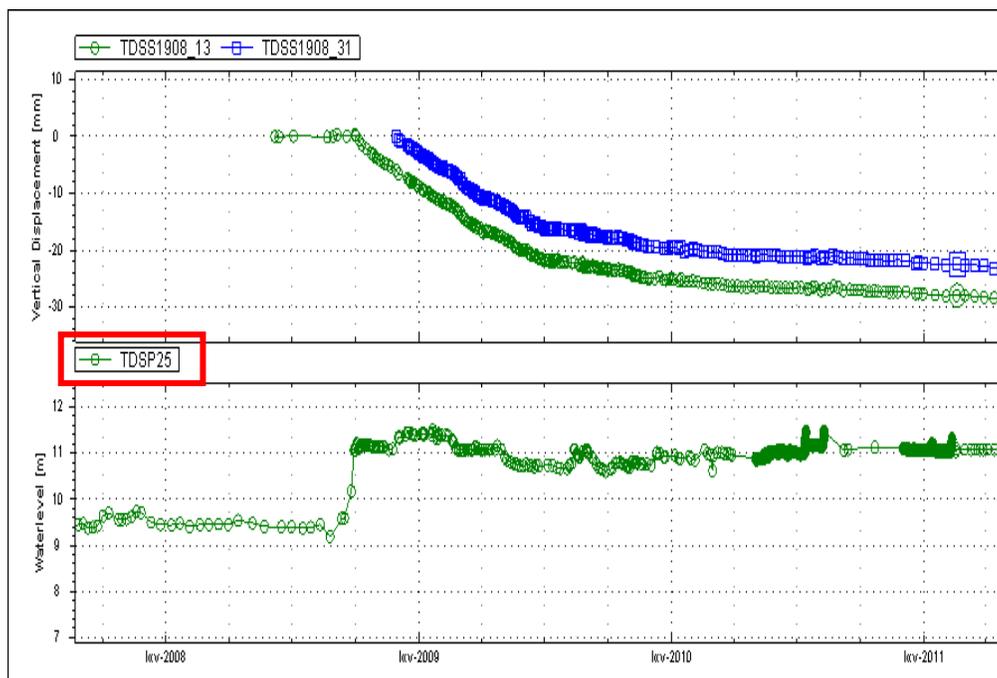
Figure 7. Settlement in building E73 following the rise of the water table (borehole TDSP25).

The works in the station begun with the construction of the northern side diaphragm walls. This created a cutoff barrier to the underground flow of the perched water table resulting to a significant local rise in piezometers TDSP22, TDSP25, TDSP26 and TDSP27 shown in Figure 7, as water flow is bypassing around the diaphragm walls. After the bypass to the SW the water level drops back to the normal level and that is why no rise is detected in piezometers TDSP21 and TDSP24 that are located S-SW of the diaphragm walls. The total rise reached 1.5 m and displacements - settlements were simultaneously observed on the aforementioned building (E73) at the corner of Egnatia and Agia Sofia streets. These displacements resulted in a deflection (inclination) of the building towards Egnatia str. (the free face of the building). The displacement reached 30 mm in a time period of 3 years starting from September 2008 (Figure 8). An additional issue that required interpretation was that the displacements did not affect equally the entire area of the building foundation but only its W-SW section and they were observed during a rise and not a drop of the groundwater level.

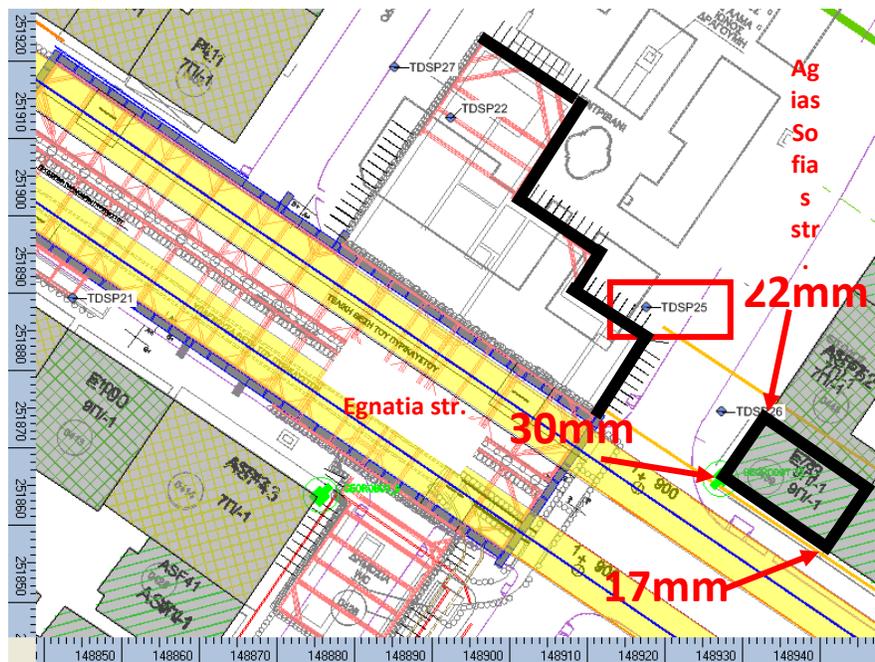
Figure 8. In situ measurements of vertical displacements .

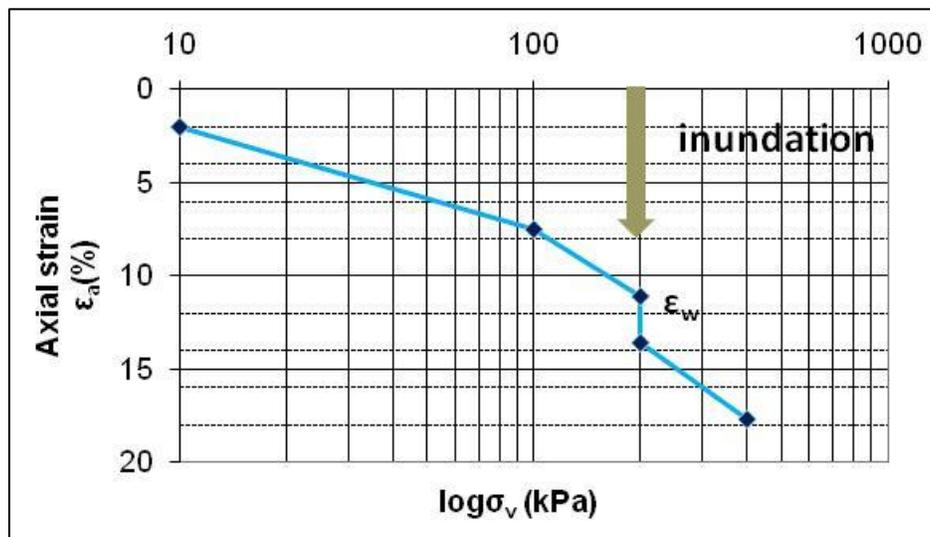
Figure 9. Axial strain due to wetting under constant load of 200 kPa.

The test program was carried out for samples from the historical layer and Table 1 presents the results for ϵ_w values due to wetting of the samples under constant load. Figure 9 shows the change of void ratio due to hydroconsolidation of sample 4 for constant load (200 kPa) during wetting. The results of Table 1 produced the characteristic hydroconsolidation curve of the studied layer as seen in Figure 10, which describes the volume change behavior of the layer after wetting under constant load. There is swelling of the layer for stress <95 kPa and volume decrease for stress >95 kPa. As an example, the volume change calculated due to wetting under constant stress of 400 kPa is $\epsilon_w=4.1\%$.

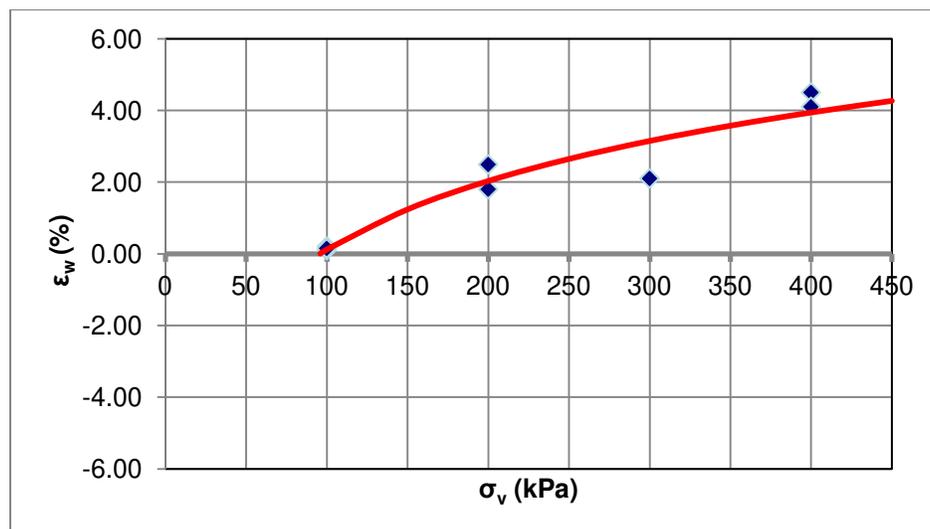
Figure 10. Axial strain due to wetting of Thessaloniki's historical fill at different stresses

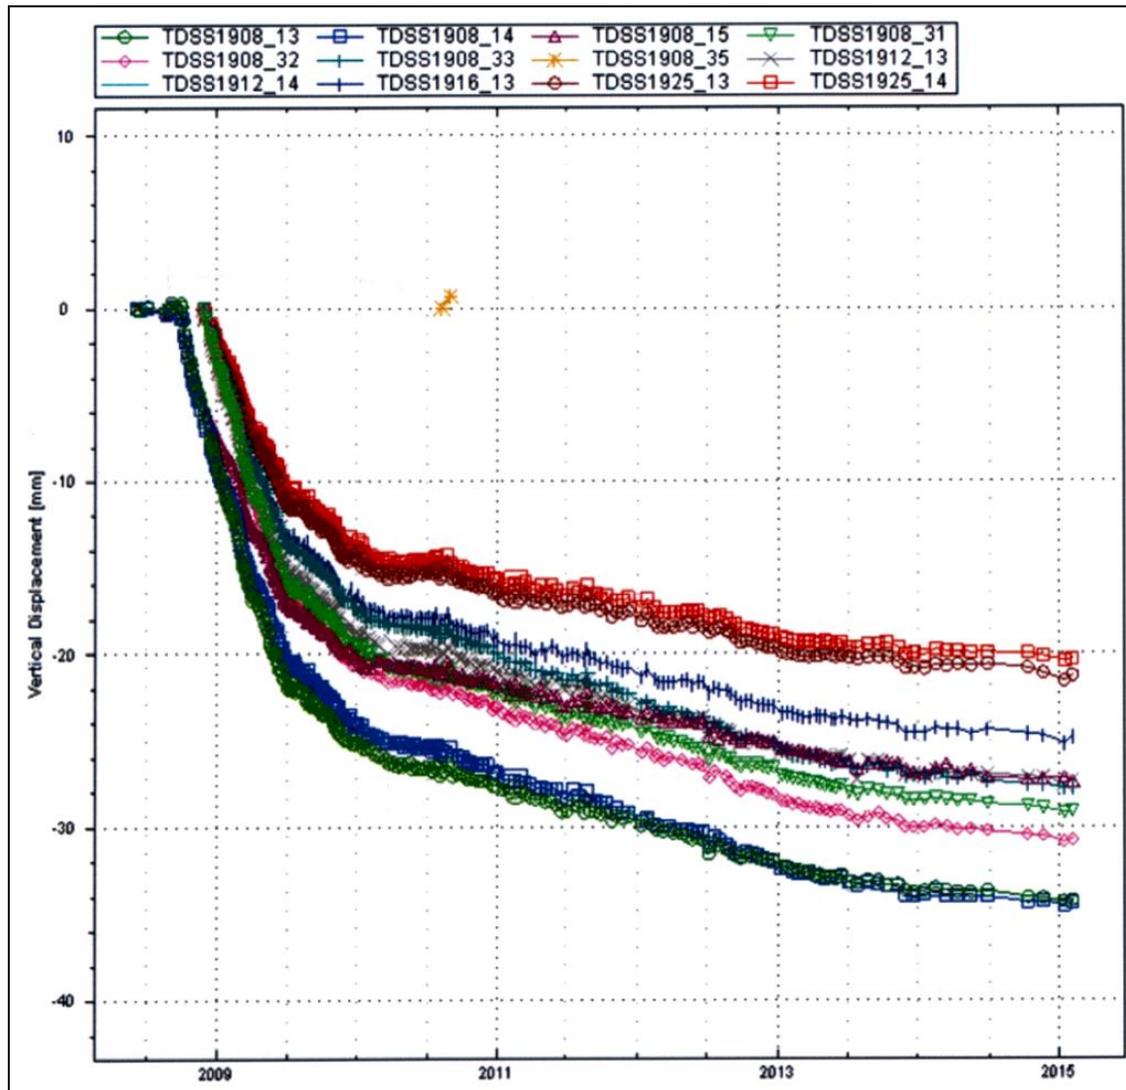
Figure 11. In situ measurements of vertical displacements in the perimeter of building E73.

The in situ measured displacements shown in Figure 11 correspond to a maximum deformation of approximately 2.25% due to hydroconsolidation for a groundwater level rise of 1.5 m. The maximum displacement measured at the SW corner of the building for a time period of more than 5 years is 34 mm and still increases. Despite the fact that all measuring points show different magnitude of displacement they all produce displacements of relatively high rate for the initial 9 months and then the rate decreases dramatically. The same mechanism is displayed in the displacement-time curves after inundation in the laboratory tests in Figure 12. An initial deformation at high rate takes place representing the collapse of the structure after wetting and then the soil is consolidated at a much slower rate.

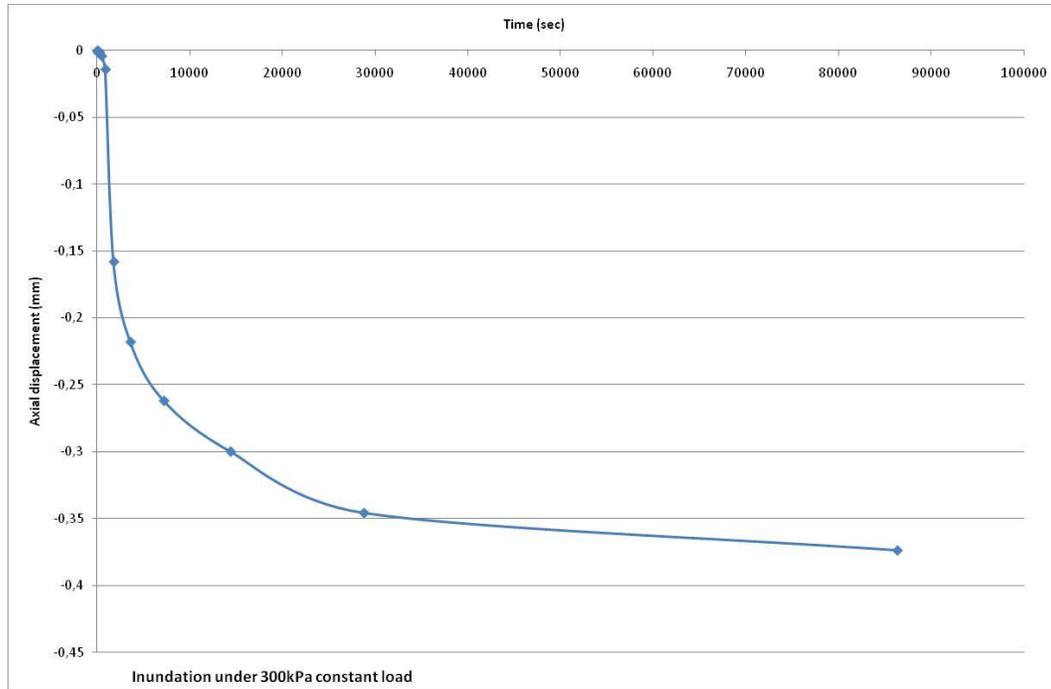
Figure 12. Laboratory displacement-time curves after inundation.

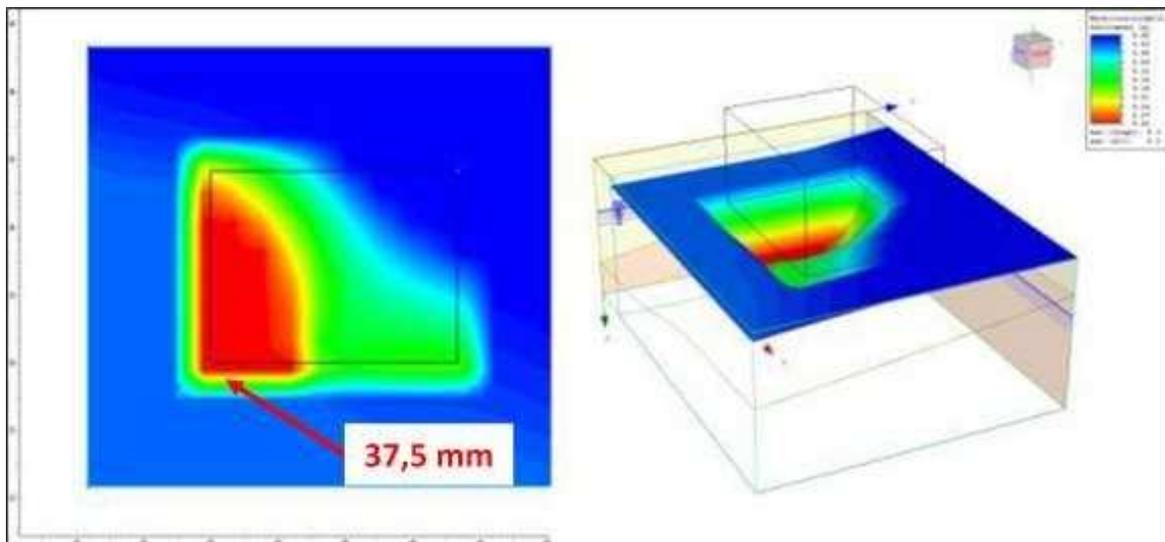
Figure 13. 2D and 3D analysis of hydroconsolidation settlement in building E73.

In comparison to the in situ measurements, the anticipated settlements were calculated introducing the layer parameters from the geological model, the groundwater level rise and the hydroconsolidation characteristics of the layer estimated from the laboratory tests in Settle 3D and the results are shown in Figure 13. As seen from the results there is an uneven distribution of settlements with increased values for the Agia Sofia str. side of the building with a maximum value of 3,75 cm on the SW corner (Figure 13). The Egnatia str. side shows decreasing values of displacements towards E. The calculations correspond to the in situ measurements which also show a gradual decrease of the displacements on the building from SW to NE.

The differential distribution of settlements is due to the fact that the thickness of the susceptible historical layer (which experienced a maximum groundwater level rise of 1.5 m) is uneven because of its SW dip. Therefore the layer is located

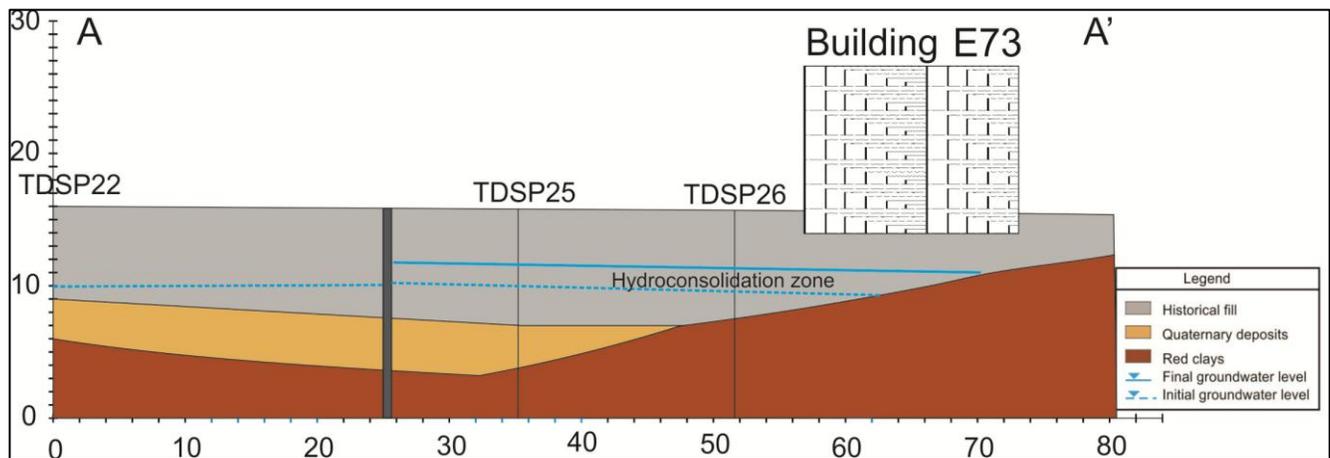
Figure 14. A-A' geological cross-section pointing the hydroconsolidation region.

higher towards the NE in respect to the groundwater level and consequently the hydroconsolidated part of the layer becomes less at this direction. Figure 14 shows a characteristic cross section of NW-SE direction that depicts the hydroconsolidated area below the building.
