## St. Isaac Cathedral (St. Petersburg, Russia): A Case History

**ABSTRACT:** *St Isaac's Cathedral in St. Petersburg was completed in 1858 after 40 years of construction; it is today the fourth largest domed Cathedral in Europe. The underlying soil is a relatively soft saturated sediment and carries this 3155 MN structure that is 100 meters high with an imprint of 92 m by 100 m. It is founded on a 7.5 m thick mat of granite and limestone blocks resting on relatively short timber piles of different lengths. The Cathedral has progressively experienced significant deformation including differential settlement causing cracks in the pillars and tilting of the porticoes. The paper summarizes the available geotechnical engineering and engineering geology aspects of the soil on which the Cathedral is built as well as classical issues such as foundation ultimate capacity and settlement analysis through simple calculations and numerical simulations. It also includes some less classical issues such as the influence of microbial activity on the behavior of the Cathedral through the changes the microbes and their activity create in the engineering properties of the soil and in the groundwater

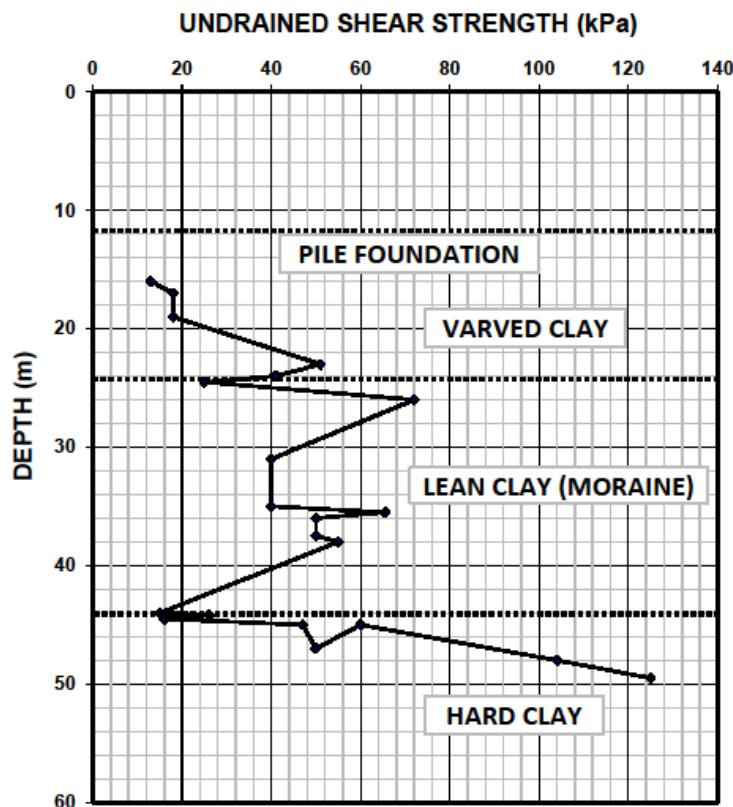
Figure 10.  $S_u$  profile versus depth.

The shear strength properties, cohesion and angle of internal friction, available from the archives of 1954 are limited to direct shear test results (Table 3). In 2009, unconsolidated undrained triaxial tests were performed. The undrained shear strength ( $s_u$ ) vs. depth profile obtained from these tests is shown in Fig. 10. Figs. 11 and 12 show the deviator stress vs. normal strain for some of the tests; the samples failed mostly in general deformation mode (barrelling) rather than along a single plane of failure. As indicated by the stress strain curves, the varved lacustrine clay underlying the pile foundation is very soft with  $s_u$  values between 18 and 20 kPa. The glacial clayey soil below the varved clay is a bit stronger with values in the range of 25 to 72 kPa. The Vendian clay below that glacial soil has  $s_u$  values which vary with depth from 18 kPa at the top of the layer to 125 kPa at depth. This significant variation could be due to the micro-fissures present in the upper zone of that clay layer which weaken the global strength.
