Geotechnical and Structural Challenges over an Active Landslide

ABSTRACT: The construction of the steel arched Tsakona Bridge, designed to overpass an active landslide, required several temporary projects. Auxiliary steel towers were used for the erection and welding of the arch segments. Most of them had to be founded in the body of the sliding mass. An automated instrumentation and monitoring system was installed on site providing early warning to the engineers in charge in case large displacements were measured. The real-time recording data provided valuable information about the landslide movements. These monitoring results defined the geotechnical and structural design criteria for the deep foundation of the temporary towers. Several 2D and 3D geotechnical and structural models were created to evaluate the sliding effect on the foundation components, finalize their dimensioning and calculate the required reinforcement. The procedure followed for the design of the temporary deep foundation is described based on the criteria devised using the monitoring system, emphasizing on the continuous feedback between the geotechnical and structural design teams. Several key structural de

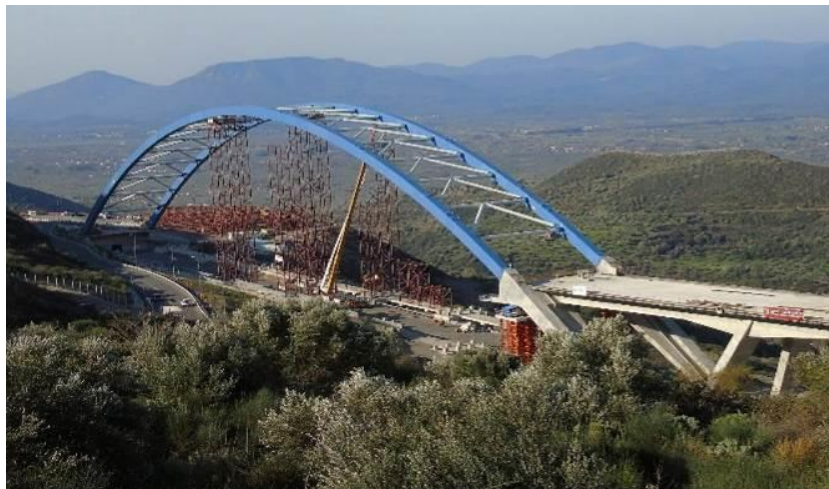
Figure 14. Removal of the temporary towers.

Other crucial issues were related with gradual removal of the arch supporting towers (Figure 14), as well as the total release of the bridge and the removal of the last supporting structure, the MT towers.
