The Observation Method for Bridge Scour: Case Histories

Reference: Briaud, J.L., Jung, I., Govindasamy, A., Kim, D. and Lee, J. (2018). *The Observation Method for Bridge Scour: Case Histories*. International Journal of Geoengineering Case Histories, Vol.4, Issue 3, p.185-202. doi: 10.4417/IJGCH-04-03-03

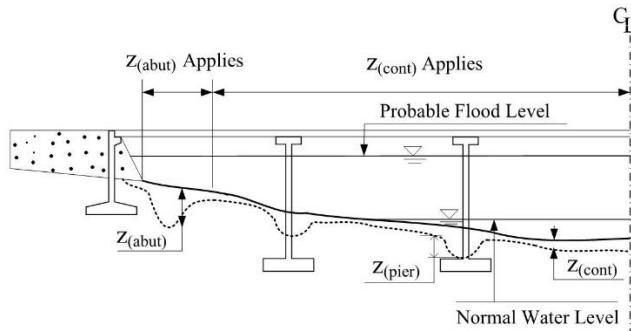
Bridge scour (Fig. 1) is the formation of holes in the soil due to water flow around bridge supports. These scour holes can form around the pier in the river (pier scour) or around the abutment (abutment scour) or can be due to the narrowing of the river flow (contraction scour). Bridge scour is the number one cause of bridge collapse in the USA as shown by the hydraulic condition bar in Fig. 2. Yet the current FHWA guidelines are considered by many to be very conservative on the average (Fig. 3). These apparently conflicting statements come from the fact that the foundation of most bridges built before 1987 was not designed for scour. Thus the pre-1987 bridges have most of the scour problems while the post-1987 bridges are very conservatively designed against scour. On 5 April 1987, the New York State Thruway Bridge over Schoharie Creek collapsed due to scour and 10 people died. This disaster prompted a national reaction, which through research and design guidelines has made bridges in the USA much more scour safe (Fig. 4). Fig. 3 shows significant conservatism on the average and significant scatter overall. Because of the scatter, the FHWA guidelines are sound since they minimize the number of times where the scour depth is likely to be under-estimated.

Figure 1. Bridge scour.

The maximum observed scour depth Z_{mo} is obtained from the bridge inspection records by studying the river bottom profile (Fig. 1). To predict pier scour, Z_{mo} is the maximum observed value of $Z_{(pier)}$ in Fig. 1. To predict abutment scour Z_{mo} is the maximum observed value of $Z_{(abut)}$ in Fig. 1. To predict contraction scour, Z_{mo} is the maximum observed value of $Z_{(contraction)}$ in Fig. 1.

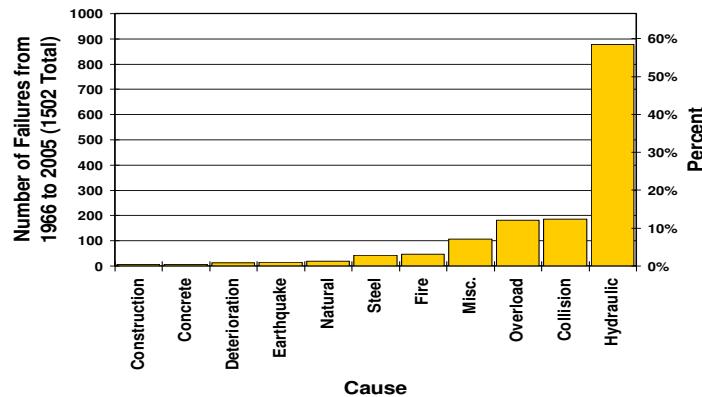
Figure 2. Causes of bridge failures in the USA (Briaud, 2006).

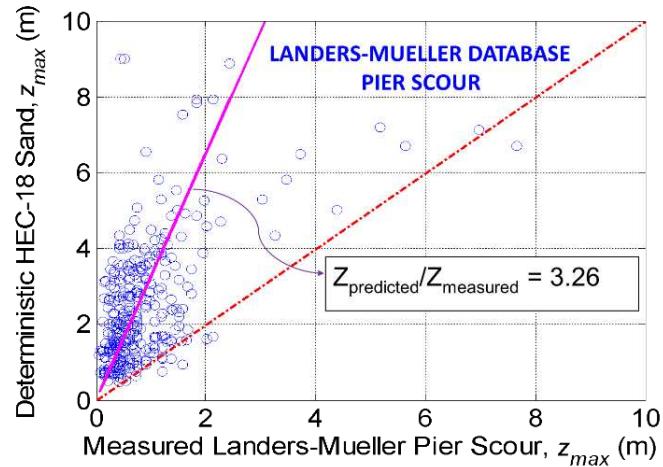
Figure 3. Predicted vs. measured pier scour depth using Landers-Mueller database (Landers, Mueller, 1996, Briaud et al., 2014).

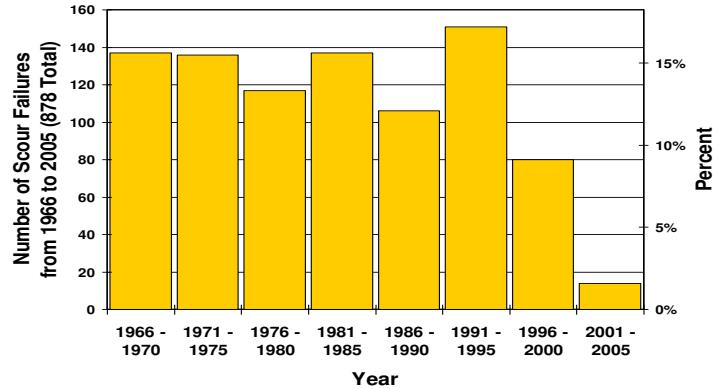
Figure 4. Impact of scour research and associated design guidelines on bridge scour failures in the USA (Briaud, 2006).

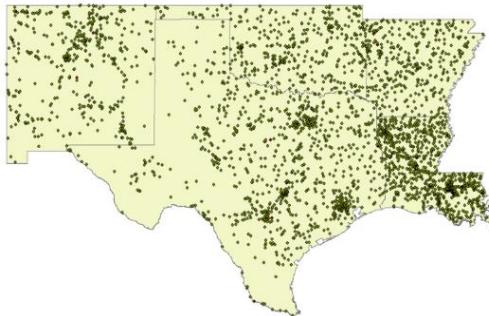
Figure 5. Location of the flow gages used for mapping Texas and neighboring States (Briaud et al., 2009).

This is done by first collecting the records of all USGS flow gages in a State (Fig. 5). Then for each one of the gages, a detailed flood analysis is conducted to identify the maximum observed recurrence interval RI_{mo} during each year at the gage location on that river.

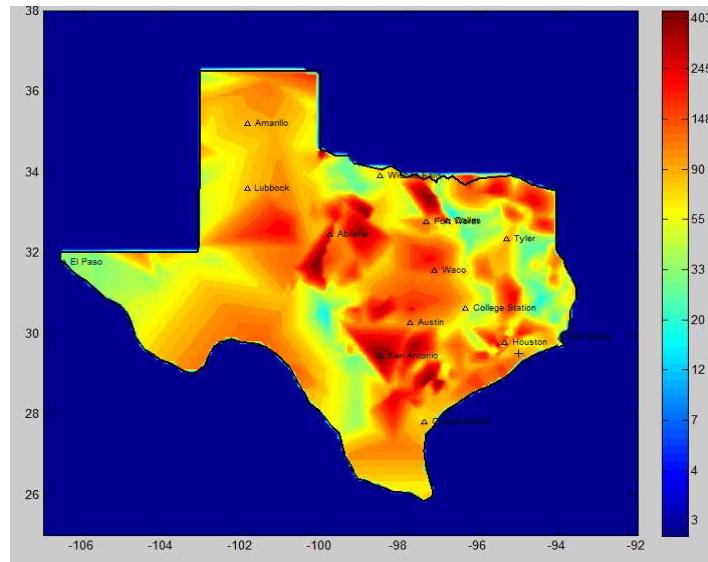
Figure 6. Maximum recurrence interval RI_{mo} map for Texas for 1920 to 2005.

Then RI_{mo} contour maps are prepared for the state for any one year and organized in a software called TAMU-OMS. If RI_{mo} is required for a period of several years, the life of the bridge for example, the yearly RI data is combined over the required period and TAMU-OMS outputs a map covering the required period (e.g., Fig. 6). Linear interpolation is used to obtain RI_{mo} at river locations where a gage is not available. The velocity ratio (V_{fut}/V_{mo}) is obtained from the recurrence interval ratio (RI_{fut}/RI_{mo}) by using a combination of correlation using all the flow gage data and open channel hydraulics (Briaud et al. 2009). These relationships depend on the recurrence interval and are embedded in TAMU-OMS, but a reasonable approximation is given below:

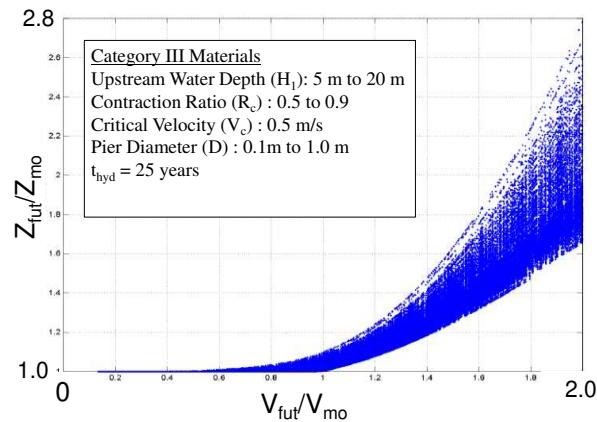
Figure 7. Large number of calculations to select conservative envelope for Z_{fut} chart.

In the end and to be conservative, the upper bound of all dots shown on the example of Fig. 7, was selected as the recommended curve for that Z_{fut} chart. These charts are embedded in the software TAMU-OMS and require the following input: scour type, soil type, time duration of the hydrograph, and the size of the obstacle. At the end of step 3, the future scour depth Z_{fut} that the bridge would experience should it be subjected to the chosen future flood (V_{fut}) is estimated by obtaining the ratio Z_{fut}/Z_{mo} from the Z_{fut} chart and multiplying that ratio by the known value of Z_{mo} from step 1. This is automated with TAMU-OMS.

- Then given the soil erosion category (3), the scour type (pier), the length of the future hydrograph considered ($t_{\text{hyd}} = 5$ years) and the value of $V_{\text{fut}}/V_{\text{mo}}$ (1.145), the value of $Z_{\text{fut}}/Z_{\text{mo}}$ was found from the Z_{fut} chart embedded in TAMU-OMS (Fig. 7 is an example) to be 1.17.

- Then given the soil erosion category (3), the scour type (pier), the length of the future hydrograph considered ($T_{\text{hyd}} = 5$ years) and the value of $V_{\text{fut}}/V_{\text{mo}}$ (0.95), the value of $Z_{\text{fut}}/Z_{\text{mo}}$ was found from the Z_{fut} chart embedded in TAMU-OMS (Fig. 7 is an example) to be 1.07.

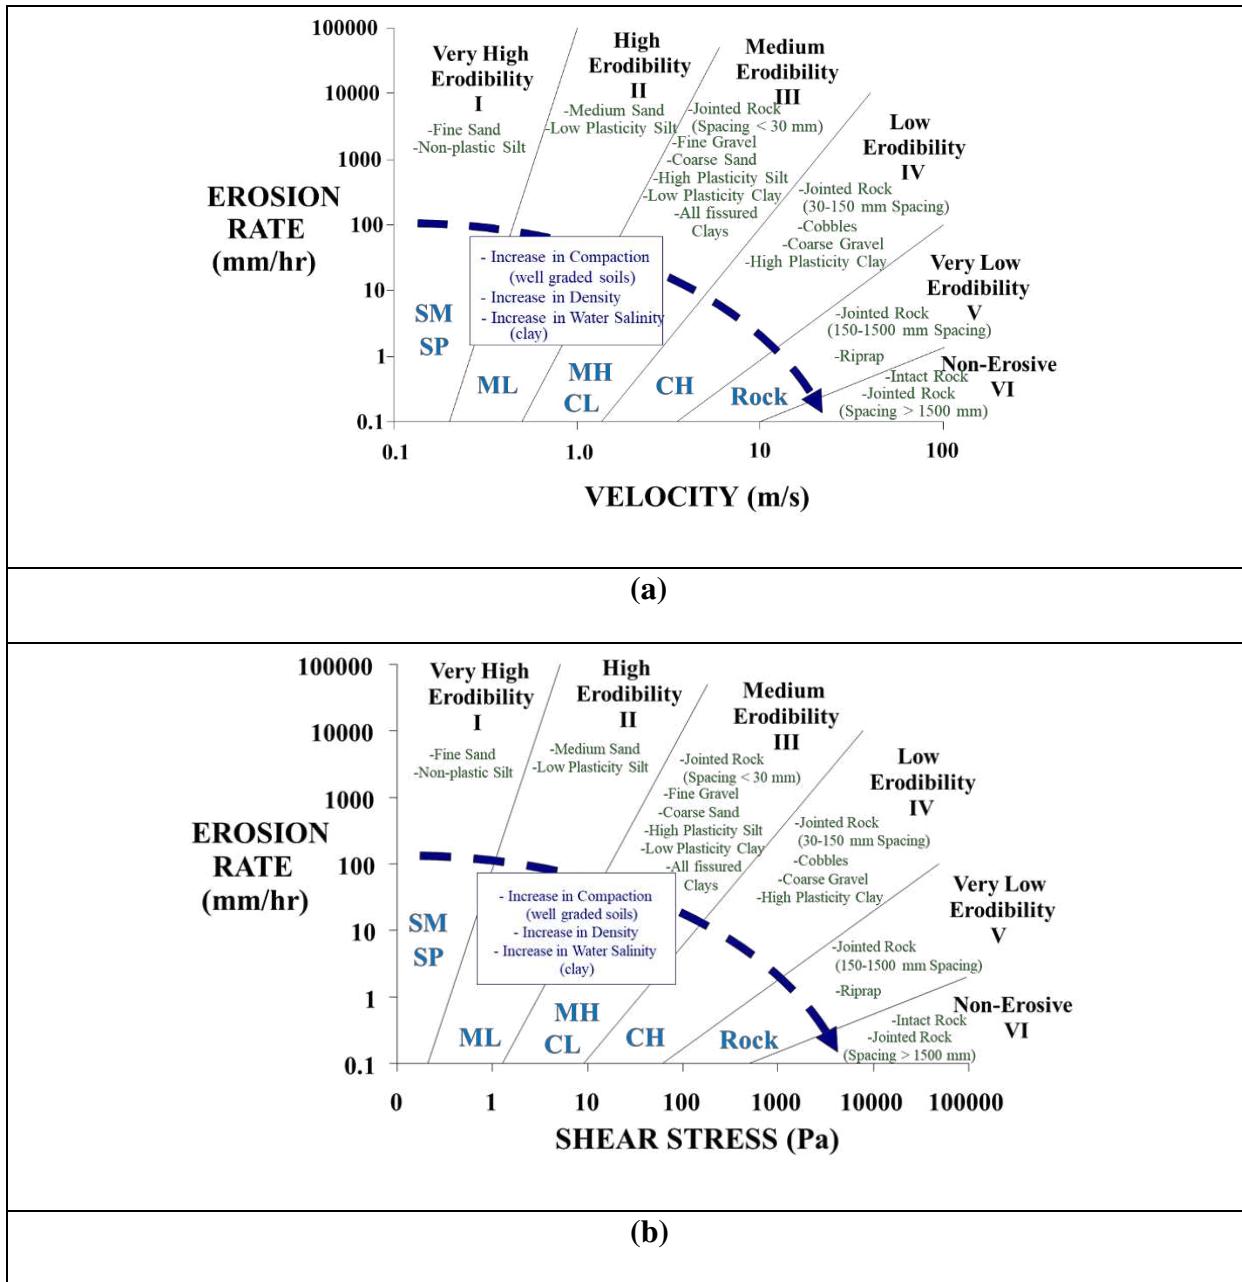
Figure 8. Erosion categories charts (Briaud, 2013): (a) erosion rate vs. velocity; (b) erosion rate vs. shear stress.

A database of 11 full-scale bridge case histories was collected to evaluate the precision of the TAMU-OMS method. Four of those bridges were located in Texas and seven in Massachusetts. The bridge identification number from the DOT inventory, the bridge location, the year built, the soil type and the soil erosion category from Fig. 8 are listed in Table 1.

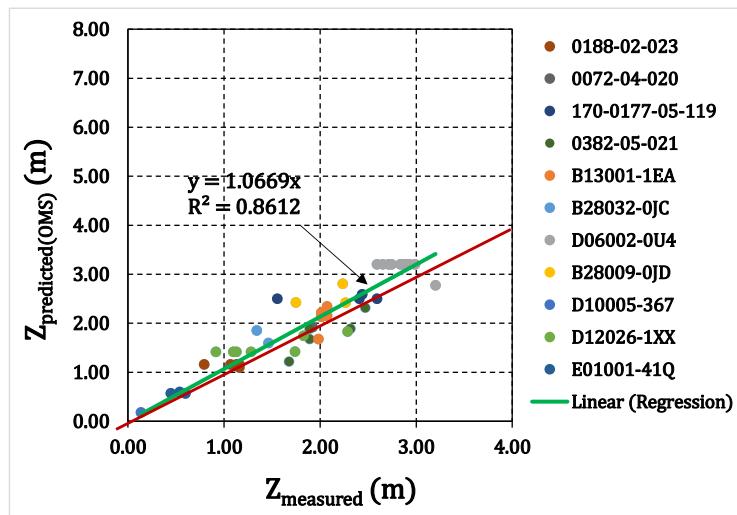
The comparisons between the measured scour depth and the TAMU-OMS predicted scour depth for the 11 bridges are tabulated in Table 2 and presented in Fig. 9. It indicates a very reasonable match.

Figure 9. Comparison between measured and OMS predicted Z_{fut} for 11 bridges in Texas and Massachusetts.

Inspection of Figs. 9 and 10 shows that the scatter in TAMU-OMS is significantly reduced compared to the scatter in the current HEC-18 method. Indeed the R^2 value for the predicted vs. measured regression is increased from 0.3061 for HEC-18 to 0.8612 for TAMU-OMS. Also the degree of conservatism is practically eliminated since the mean ratio between the predicted scour depth over the measured scour depth (slope of the regression line) decreases from 1.7687 for HEC-18 to 1.0669 from TAMU-OMS.

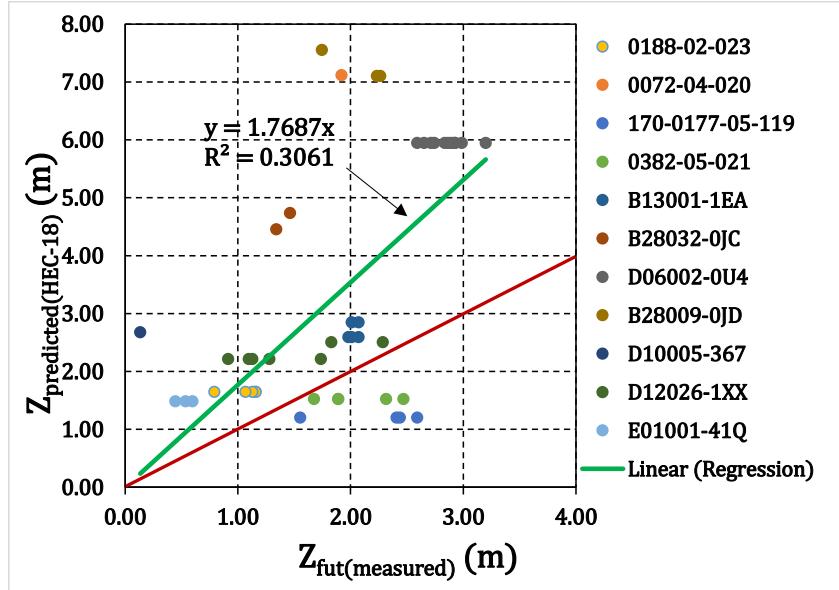
Figure 10. Comparison between measured and HEC-18 predicted scour depth for 11 bridges in Texas and Massachusetts.

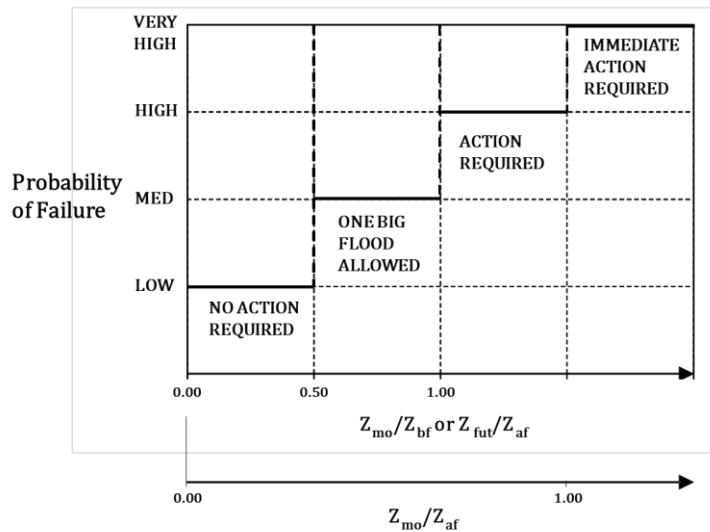
TAMU-OMS can also be used to evaluate the probability of failure due to scour for a bridge over water. The risk defined as the product of the probability of failure times the value of the consequence can then be evaluated separately by using allowable risk targets of 0.001 fatalities per year and \$1000 per year as proposed by Briaud (2013). The probability of failure presented in Figure 11 and Table 4 is based on a comparison between the future scour depth predicted by TAMU-OMS, Z_{fut} , and the allowable scour depth Z_{all} . In this case the scour depth Z_{fut} is calculated based on the design flood, say the 100 year flood and the allowable scour depth Z_{all} is established on the basis of safe local practice. For example in Texas and for a one time flood, the allowable pier scour depth is taken as one half the original embedded pile length. Actually, two allowable scour depth are identified, Z_{af} and Z_{bf} . The scour depth Z_{af} is the allowable scour depth after the flood and is the same as Z_{all} , but Z_{bf} is the scour depth which would lead to a scour depth equal to Z_{all} should the bridge be subjected to the design flood. The relationship between Z_{bf} and Z_{af} is obtained from the charts in TAMU-OMS with the following input. The RI_{mo} is the one for the bridge until the present, RI_{fut} is the design RI value, and all other parameters (soil, scour type, and so on) are the ones for the specific bridge site. Fig. 11 and Table 4 give a proposed probability of failure rating for bridges. It also indicates what action might be needed for each probability level.

Figure 11. Probability of failure evaluation chart for scour at bridges based on TAMU-OMS.

- The comparison between Z_{all} and Z_{fut} shows that this bridge is in the “high probability of failure” category based on Fig. 11 and Table 4. Indeed $Z_{fut} > Z_{all}$.

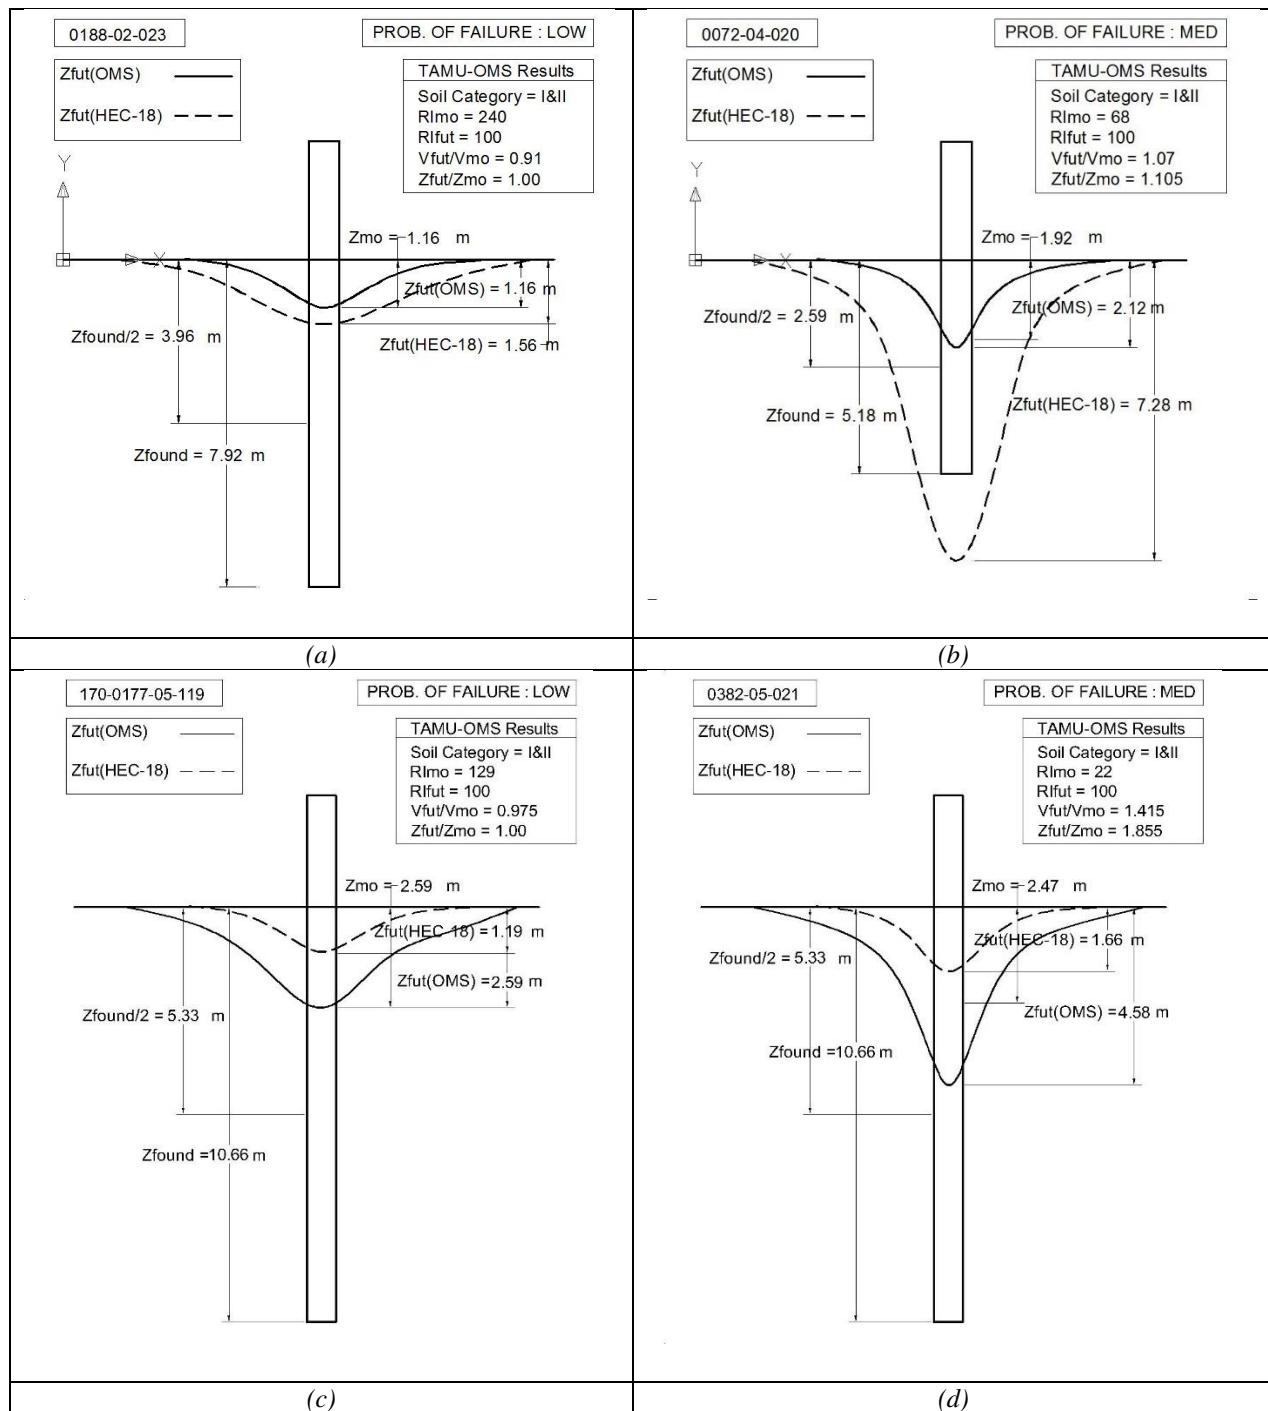
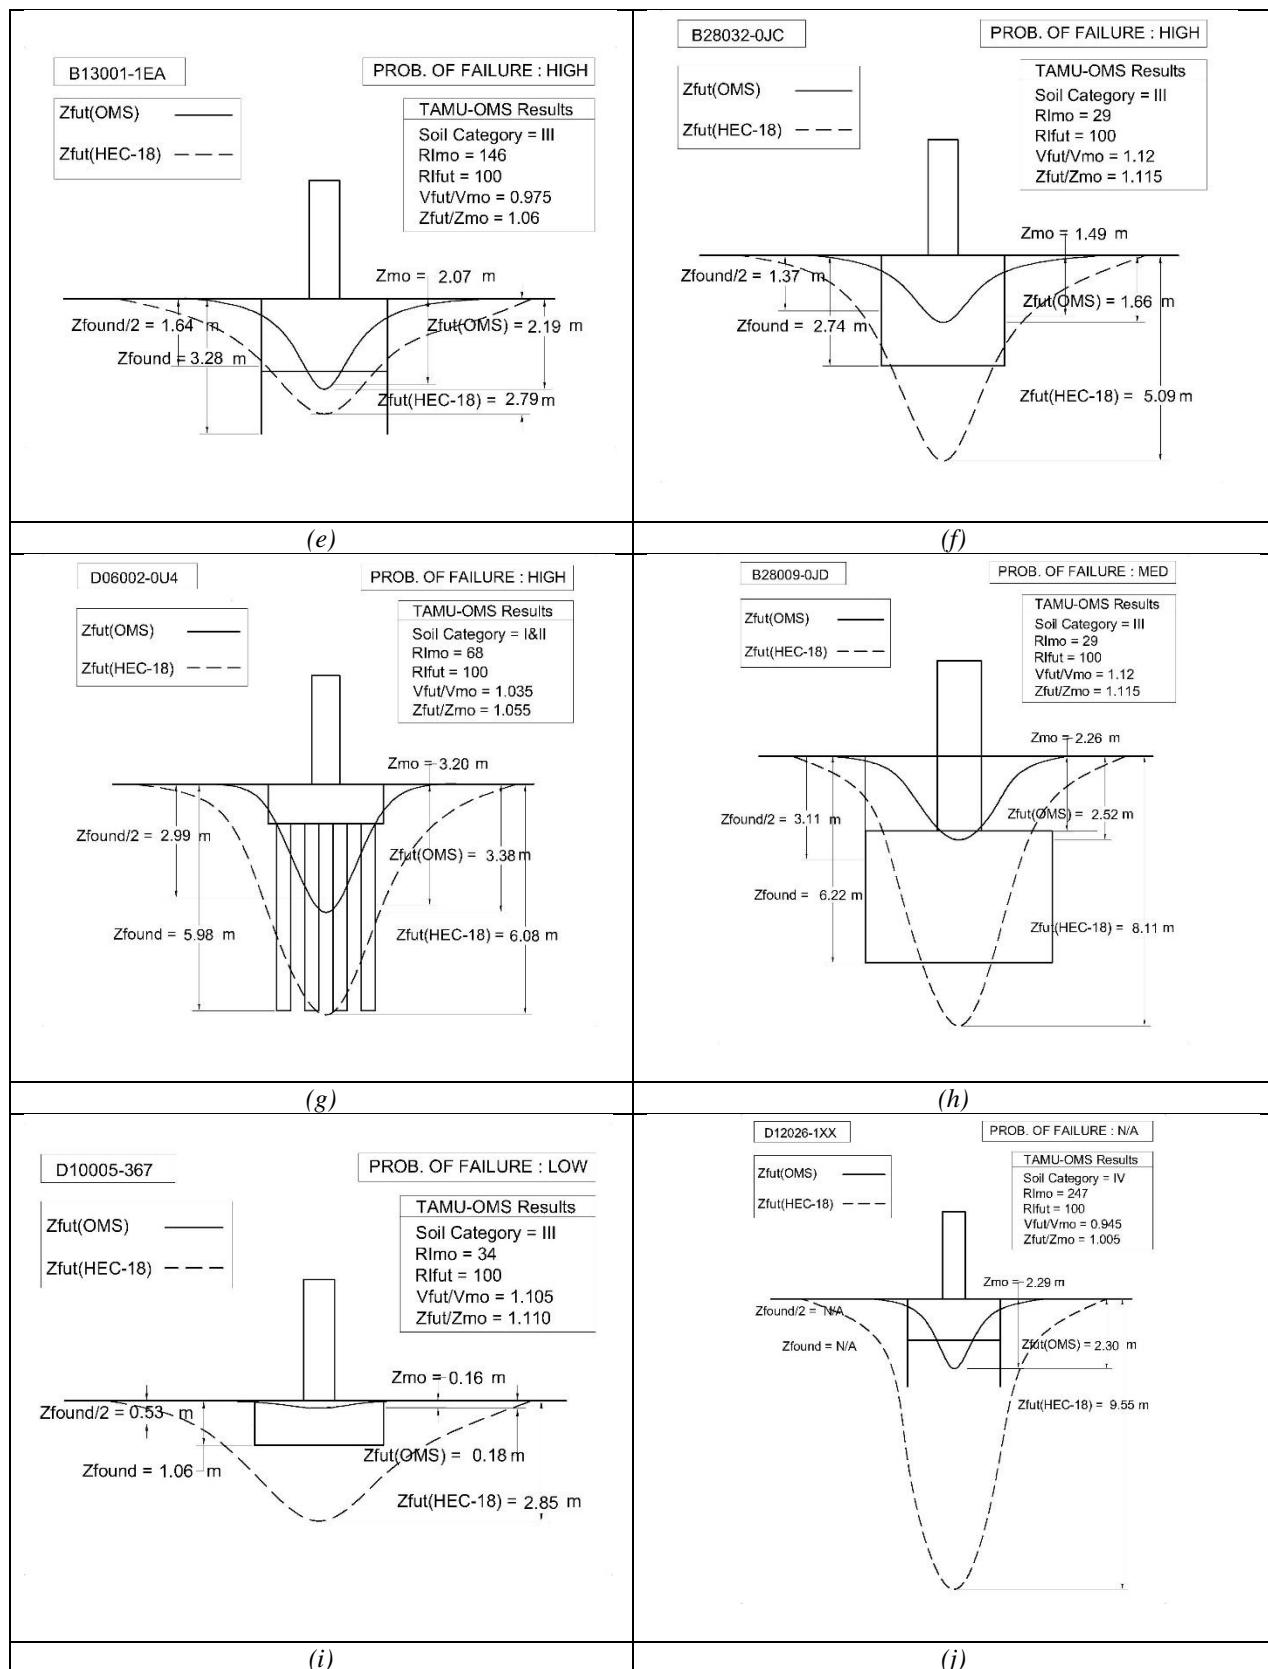
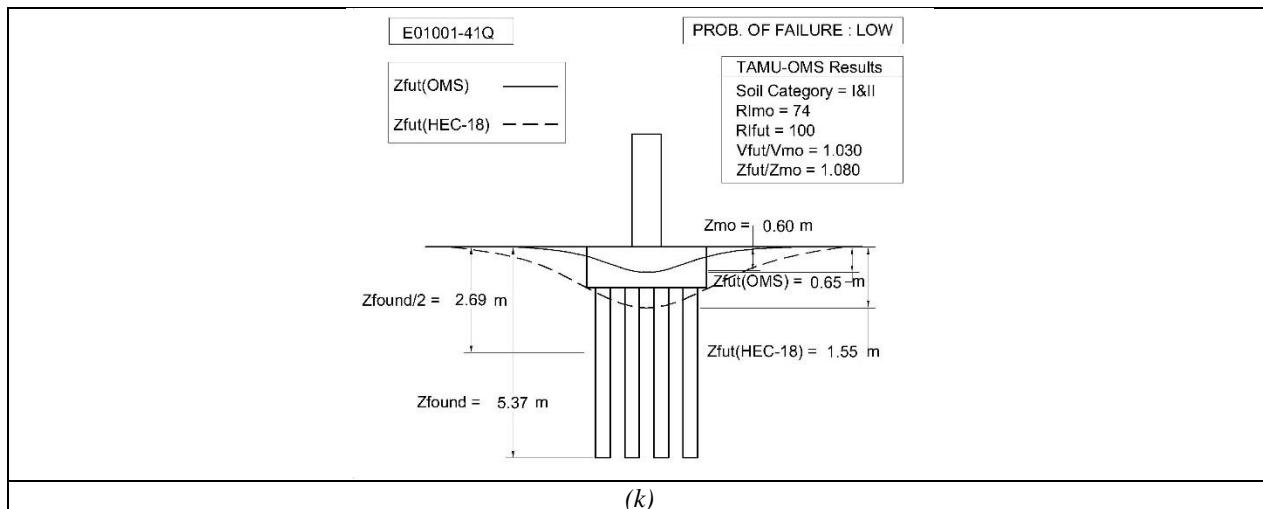
Figure 12. Scour situation for 11 bridges in Texas and Massachusetts. (a) bridge 0188-02-023, (b) bridge 0072-04-020, (c) bridge 170-0177-05-119, (d) bridge 0382-05-021, (e) bridge B13001-1EA, (f) bridge B28032-0JC, (g) bridge D06002-0U4, (h) bridge B28009-0JD, (i) bridge D10005-367, (j) bridge D12026-1XX, (k) bridge E01001-41Q.
