Geobarrier System for Protection Against Rainfall-induced Slope Failure

Reference: Rahardjo, H., Satvanaga, A., Gofar, N., Leong, E.C., Kew, J.H., Wang, C.L. and Wong, J.L.H. (2019). Geobarrier System for Protection Against Rainfall-induced Slope Failure. *International Journal of Geoengineering Case Histories*, Vol.5, Issue 1, p. 26 - 42. doi: 10.4417/IJGCH-05-01-03

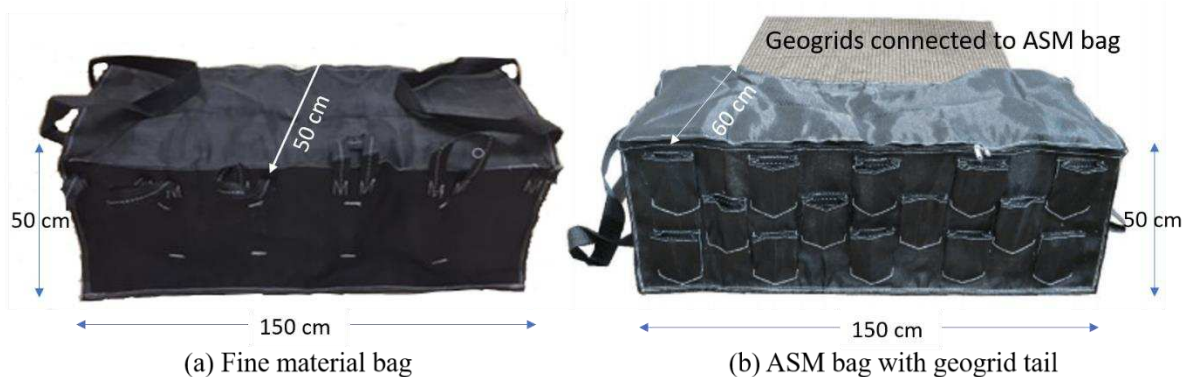
Figure 2. Geotextile bags for fine material and ASM.

Figure 2 shows the geobags used for fine-grained material and ASM. The dimension of ASM geobag is 0.6 m width \times 0.5 m height \times 1.5 m length while the dimension of the geobag for the fine-grained material is 0.5 m width \times 0.5 m height \times 1.5 m length. The ASM bag is supported by specially designed pockets for planting different types of plants. The ASM bag is also connected to geogrids used as a reinforcing element. The bi-axial geogrids should be made from high-quality polyester yarn fibres with high tensile strength with a design life of 120 years and a tensile strength of 12 kN/m @ 2% strain and 30 kN/m @ 5% strain.
