# Geobarrier System for Protection Against Rainfall-induced Slope Failure

**ABSTRACT**: Slope failures are a common occurrence in tropical regions with a high intensity of rainfall. Tropical areas such as Singapore are normally covered with residual soils whose behaviour does not follow the principles of classical saturated soil mechanics because these soils are often unsaturated in nature. The negative pore-water pressure in unsaturated soil is highly influenced by the changes in the flux boundary conditions, resulting from the variation in climatic conditions. On the other hand, the negative pore-water pressure contributes additional shear strength to the unsaturated soil. As water infiltrates into the slope, pore-water pressure in the slope increases (matric suction decreases), and the additional shear strength due to matric suction will decrease, causing the slope to be more susceptible to failure. Singapore is a land scarce country with a critical need to optimize land utilization. Steepening slopes or cutting back slopes and supporting them using a retaining structure is one way to create new spaces. In this study, a new type of retaining structure, Geobarrier System (GBS) i

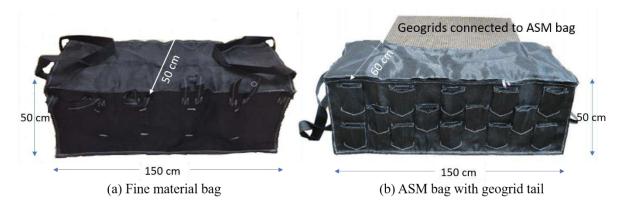
Figure 2 shows the geobags used for fine-grained material and ASM. The dimension of ASM geobag is  $0.6 \, \mathrm{m}$  width  $\times 0.5 \, \mathrm{m}$  height  $\times 1.5 \, \mathrm{m}$  length while the dimension of the geobag for the fine-grained material is  $0.5 \, \mathrm{m}$  width  $\times 0.5 \, \mathrm{m}$  height  $\times 1.5 \, \mathrm{m}$  length. The ASM bag is supported by specially designed pockets for planting different types of plants. The ASM bag is also connected to geogrids used as a reinforcing element. The bi-axial geogrids should be made from high-quality polyester yarn fibres with high tensile strength with a design life of 120 years and a tensile strength of 12 kN/m @ 2% strain and 30 kN/m @ 5% strain.

Figure 2. Geotextile bags for fine material and ASM.

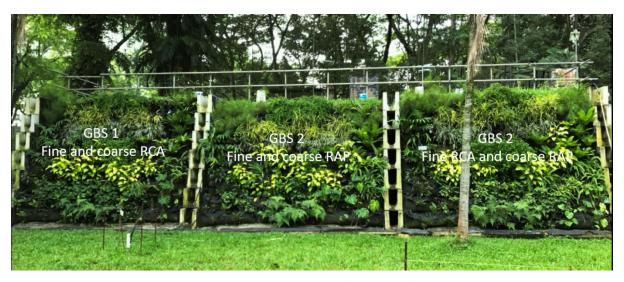
Three GBSs were constructed at Orchard Boulevard in Singapore with a slope height of 4 m and a slope angle of 70° (Figure 4). The original slope was inclined at 35°, thus the construction of the GBSs involved excavation of the slope to the designed slope angle. Preliminary site investigation indicated that the groundwater table was located at about 2 m and 6 m below the ground surface at the toe and crest, respectively. In other words, the residual soil below and behind the slope was in an unsaturated condition. The results from index properties for residual soil at Orchard Boulevard indicated that the residual soil

Figure 4. GBS at Orchard Boulevard.
