# Geobarrier System for Protection Against Rainfall-induced Slope Failure

**ABSTRACT:** Slope failures are a common occurrence in tropical regions with a high intensity of rainfall. Tropical areas such as Singapore are normally covered with residual soils whose behaviour does not follow the principles of classical saturated soil mechanics because these soils are often unsaturated in nature. The negative pore-water pressure in unsaturated soil is highly influenced by the changes in the flux boundary conditions, resulting from the variation in climatic conditions. On the other hand, the negative pore-water pressure contributes additional shear strength to the unsaturated soil. As water infiltrates into the slope, pore-water pressure in the slope increases (matric suction decreases), and the additional shear strength due to matric suction will decrease, causing the slope to be more susceptible to failure. Singapore is a land scarce country with a critical need to optimize land utilization. Steepening slopes or cutting back slopes and supporting them using a retaining structure is one way to create new spaces. In this study, a new type of retaining structure, Geobarrier System (GBS) i

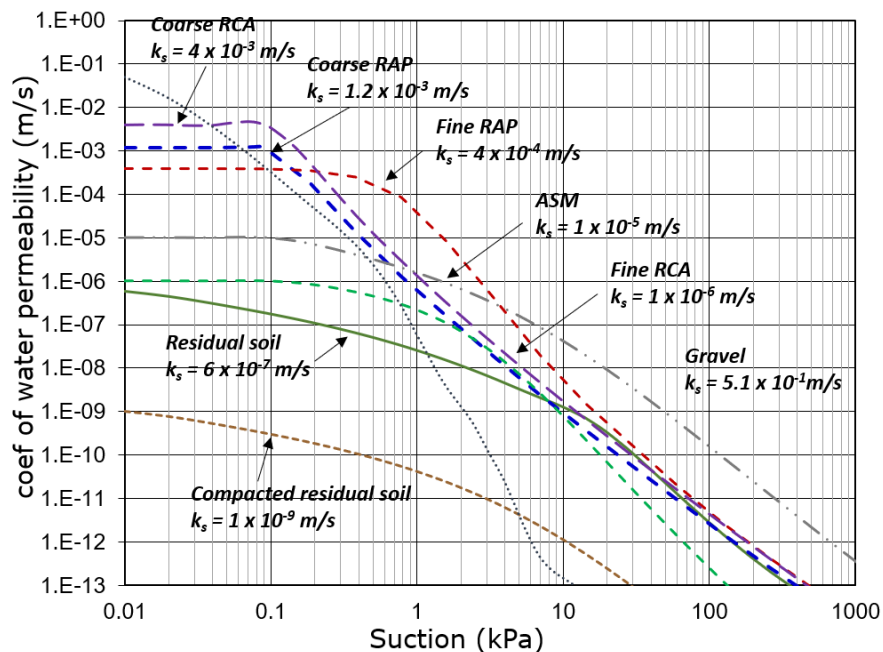
The drying and wetting SWCCs of the residual and compacted residual soils as well as the ASM and gravel are shown in Figure 13 while the drying and wetting SWCCs of the fine and coarse RCA as well as the fine and coarse RAP are shown in Figure 7. Wetting SWCCs were used in the numerical analysis to replicate the wetting process due to the extreme rainfall. In addition, Bashier et al. (2016) indicated that the use of wetting SWCC and permeability function is associated with worst scenario since the numerical analysis results predicted a higher infiltration rate. Hence, the factor of safety is the lowest if the numerical analysis incorporates wetting SWCC and permeability function. The wetting permeability function was determined from the SWCC wetting curves of all materials using a statistical method (Child and Collis-George, 1950) are shown in Figure 14.

Figure 14. Permeability functions of all materials used in GBS.
