# Geobarrier System for Protection Against Rainfall-induced Slope Failure

GeobARRIER System for Protection Against Rainfall-induced Slope Failure. International Journal of Geoengineering Case Histories, Vol.5, Issue 1, p. 26 - 42. doi: 10.4417/IJGCH-05-01-03

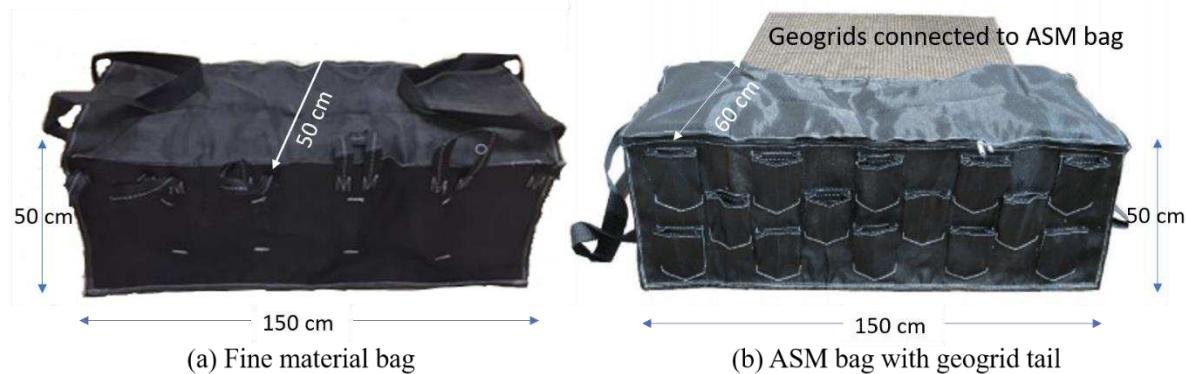
Figure 2. Geotextile bags for fine material and ASM.

Figure 2 shows the geobags used for fine-grained material and ASM. The dimension of ASM geobag is 0.6 m width × 0.5 m height × 1.5 m length while the dimension of the geobag for the fine-grained material is 0.5 m width × 0.5 m height × 1.5 m length. The ASM bag is supported by specially designed pockets for planting different types of plants. The ASM bag is also connected to geogrids used as a reinforcing element. The bi-axial geogrids should be made from high-quality polyester yarn fibres with high tensile strength with a design life of 120 years and a tensile strength of 12 kN/m @ 2% strain and 30 kN/m @ 5% strain.

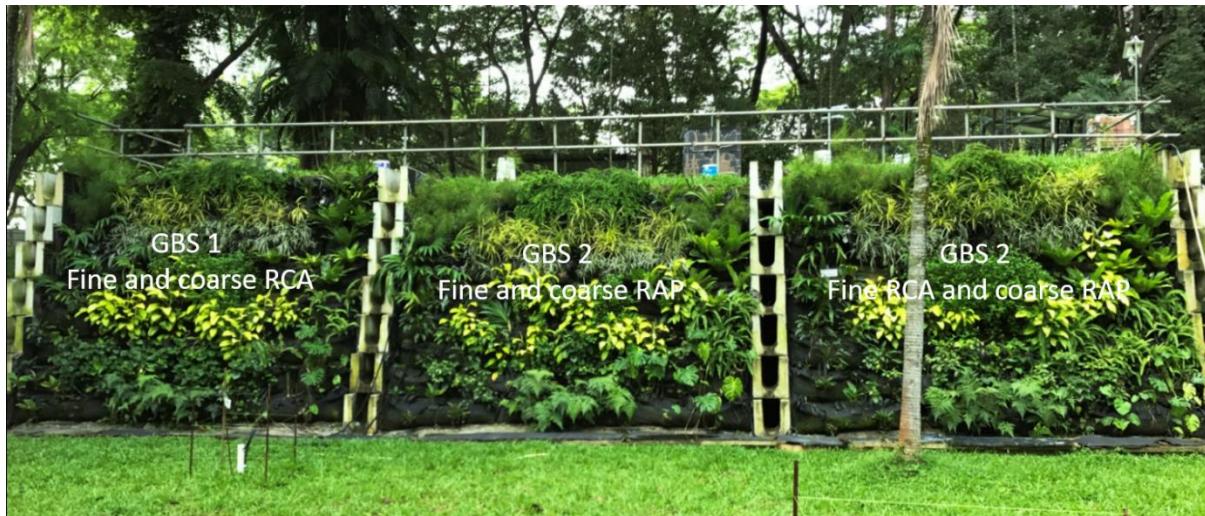
Figure 4. GBS at Orchard Boulevard.

Three GBSs were constructed at Orchard Boulevard in Singapore with a slope height of 4 m and a slope angle of 70° (Figure 4). The original slope was inclined at 35°, thus the construction of the GBSs involved excavation of the slope to the designed slope angle. Preliminary site investigation indicated that the groundwater table was located at about 2 m and 6 m below the ground surface at the toe and crest, respectively. In other words, the residual soil below and behind the slope was in an unsaturated condition. The results from index properties for residual soil at Orchard Boulevard indicated that the residual soil
