# **Electrical Resistivity at Internal Erosion Locations in Levees**

ABSTRACT: Internal erosion through or beneath levees frequently occurs during flood events, resulting in sand boils. Determining the extent of damage from the seepage channels that caused the sand boils remains difficult, and many sand boils are simply monitored in subsequent floods. There is a need for a nondestructive methodology to map the voids caused by seepage channels so that needed repairs can be identified prior to the next flood. The objective of this study is to identify the electrical response of internal erosion pathways with electrical resistivity tomography (ERT). A case study using ERT on the Hager Slough Levee, which has experienced sand boils since the 1990s, is presented. Three ERT surveys were conducted along the levee in an area of apparent damage (i.e., crown settlement and sand boils) and where nearby boring logs were available. Laboratory resistivity tests provide support for the field ERT interpretations. The results indicate that ERT may be used to identify zones of damage within and beneath a levee. If used in practice, ERT has the potential to improve remediation of levees by identifyi

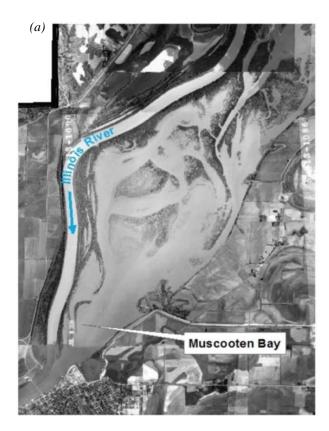
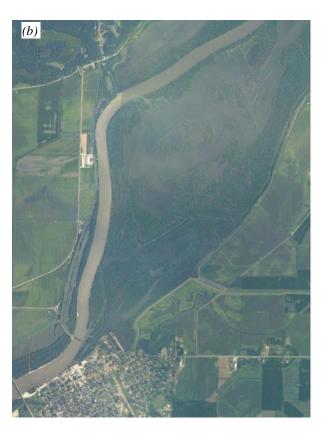
Figure 2. Sangamon River history: (a) Muscooten Bay pre-diversion (~1939); (b) Muscooten Bay post-diversion (~2011) (Bishop et al. 2015).

The historic channel of the Sangamon River was originally 101 km long with a slope of 0.09 m/km. The river was channelized, and levees were built by local farmers to create drainage for the agricultural lands surrounding the river between 1905 and 1909. In 1949, the U.S. Army Corps of Engineers (USACE) diverted the lower 9.7 km of the river south through Muscooten Bay (Figure 2). In the 1980s, the river was straightened by the USACE to help with the silting of the Beardstown marina. Currently, the river channel is only 57.9 km long with an average channel slope of 0.19 m/km (Bishop et al. 2015). As a result of the straightening of the channel and diversion, the sediment load carried by the Sangamon River has been deposited in Muscooten Bay and its adjacent areas (Lee 1982). This caused silt and sandbars to form along the riverfront of Beardstown, causing issues with boating access in the marina (Jangea 2003) and the formation of log jams along the Sangamon River (Blanchette 2016). The USACE studied the problem by modeling the watershed and sediment transport, leading to a recommended sediment management plan (Bishop et al. 2015).

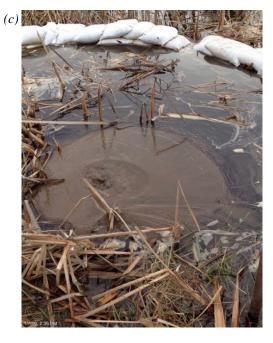
Figure 4. Observed damage during December 2015 flood event: (a) crown of levee, (b) 0.33 m diameter active sand boil, (c) active sand boil (Rutherford et al. 2016).

The levee district officials and the USACE engineers have observed a large number of sand boils at the Hager Slough Levee toe during flood events over the last thirty years (Bishop et al. 2015). In December of 2015, unusual winter storms related to a strong El Niño weather pattern in the Midwest sent large volumes of water into rivers and drainage areas, causing historic flooding in Illinois. As part of the flood protection systems investigation in Illinois, a team from the Geotechnical Extreme Events Reconnaissance (GEER) Association was mobilized to investigate the impacts of record and near-record flood crests and the performance of levee systems (Rutherford et al. 2016). The Hager Slough Levee was inspected and damage in multiple locations was documented on January 8, 2016. There were upwards of 15 active (carrying material) sand boils and many inactive (clear flowing water) sand boils from previous flood events which were documented during the reconnaissance. New (active at the time) sand boils generally formed adjacent to the existing boils. There were upwards of 41 sand bag rings placed by the levee district in coordination with the USACE in the 0.4 km levee stretch covered during the site visit. Many of the sand bag rings contained numerous sand boils and seeps. The sand bag rings were typically 2.43 – 3.00 m in diameter and 0.610 – 1.22 m in height (Figure 4).

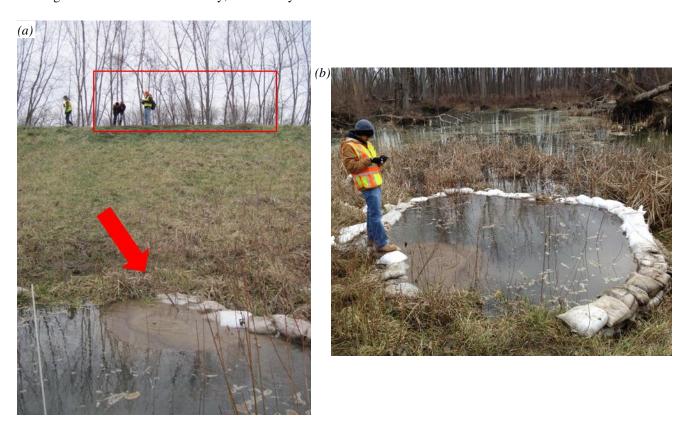
Figure 5. December 2015 flood reconaissance: (a) settlement of crown with active sand boil at toe of levee, (b) active sand boil with sand bag ring (Rutherford et al. 2016).

Settlement of the levee crown occurred in several locations during the 2015 flooding which required repair (repair images not available). Subsidence of the levee crown in these locations was observed to be adjacent to sand bag rings (Figure 5), suggesting that the subsidence was due to material loss. The objective of the geophysical investigation described in this study was to evaluate if ERT can be used as an imaging technique to detect zones of material loss within the levee. Such a system would enable improvement of remediation methodologies following flood events where sand boils occur. ERT may also be used to evaluate if a levee is damaged internally despite the lack of external physical evidence (e.g., sand boils). Following this introduction are a brief background on ERT and the research methodology. The ability of ERT to identify material removal has been investigated by performing a series of ERT surveys and supported with soil borings and a laboratory electrical resistivity measurement of the material in the sand boils. A discussion of the field and laboratory results is presented, including limitations of this case history, followed by conclusions and recommendations.
