Electrical Resistivity at Internal Erosion Locations in Levees

Reference: Tucker-Kulesza, S., Rutherford, C. and Bernhardt-Barry, M. (2019). Electrical Resistivity at Internal Erosion Locations in Levees. *International Journal of Geoenvironmental Engineering Case Histories*, Vol.5, Issue 2, p. 55 - 69. doi: 10.4417/IJGCH-05-02-01

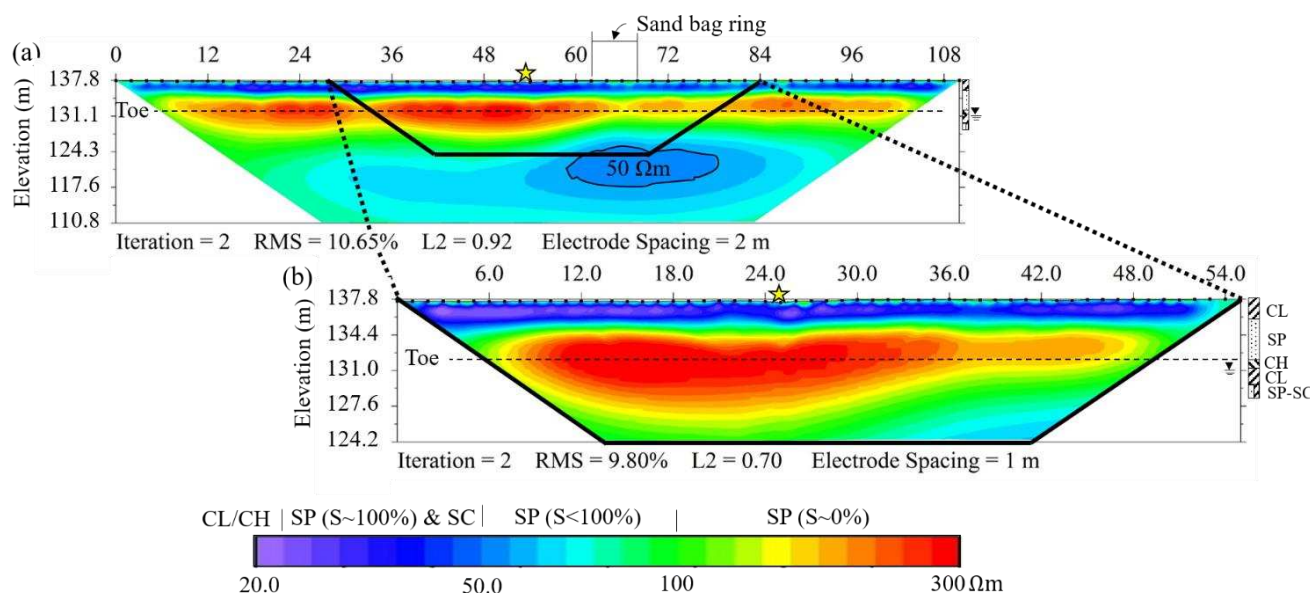
Three ERT surveys were conducted at the Hager Slough Levee: two survey lines on the crown of the levee and one survey line at the landside toe. Figure 9 shows Line 1 (top, a) and Line 2 (bottom, b), which were conducted along the levee crown as shown in Figure 7. The depression in the crown is again marked with a star on each inverted image and the survey alignment with a ring of sand bags at the toe of the levee is also shown. The horizontal distance along the crown is depicted on the top

of each survey and the elevation above sea level is on the side of each survey, both in m. Line 1 was 110 m long with a maximum survey depth of 27 m (El. 110.8 m). The approximate location of the native soil based on the height of the levee is shown with a dashed line in Figure 9. Borehole data were available approximately 73 m west of the first electrode in Line 1. Because of the depth of investigation and scale of Figure 9(a), the borehole data are also shown to the right of Figure 9(b) so that the stratigraphic units could be aligned with the image and compared with geophysical interpretations.

The soil stratigraphy based on the borehole consisted of: 1.4 m of sandy lean clay (CL), 4.2 m of poorly graded fine sand (SP), 0.3 m of fat clay (CH), 1.5 m of sandy lean clay (CL), and 1.3 m of poorly graded sand with clay (SP-SC) until the boring was terminated. The water level was noted at El. 132.2 m, near the interface of the fat and lean clays as shown in Figure 9. The river level was measured at approximately the same elevation. The color-coded electrical resistivity scale and approximate Unified Soil Classification System (USCS) classifications, based on the borehole data and general soil type classifications of ERT data, are shown beneath the inversions (ASTM D2487 2011; Everett 2013; Sharma 1997). The observed electrical resistivity from the ERT profile in Figure 9(a) is a low resistivity layer of 25-40 Ωm in the top 2 m over a layer of higher resistivity ($\sim 150 - 300 \Omega\text{m}$). The higher resistivity layer thickness varies from approximately El 135.8 m to El 129.8 m along the profile in Figure 9(a). The layer of higher resistivity aligns well with the SP layer identified in the borehole from approximately 60 m to 110 m along the profile. From 0 m to 60 m, the high resistivity layer penetrates to El 129.8 m, where the deepest point is at the 48 m marker on Figure 9(a). Note that this point was located two electrode spacings from the depression in the crown. The bulk electrical resistivity beneath the high resistivity zone was between 60 and 80 Ωm in the rest of the inversion, except beneath the 60 to 74 m markers where a zone of lower resistivity (47-50 Ωm) was noted. No resistivity measurements are shown outside the trapezoidal ERT inversions because ERT measurements are only marginally sensitive in these regions.

Figure 9. Crown surveys: (a) Line 1 with 2 m electrode spacing; (b) Line 2 with 1 m electrode spacing.

Line 2 (Figure 9(b)) was conducted at half the electrode spacing of Line 1. The outermost 14 electrodes on both sides of the central point in Line 1 were removed and installed between the remaining 28 electrodes. The alignment of Figure 9(b) within Figure 9(a) is shown with a black trapezoid on Figure 9(a). The larger electrode spacing in Figure 9(a) increased the penetration depth of the survey; however, near surface resolution was lost as a trade-off. Therefore, the lower resistivity band is more apparent in Figure 9(b) than in Figure 9(a), varying from 20 – 25 Ωm . A band of higher resistivity (200 – 300 Ωm) is again noted beneath the low resistivity layer along the surface. In Figure 9(b), the depth of this higher resistivity layer varies from El. 134.4 m to El. 129.4 m. There is a bowl shape of the higher resistivity layer in Figure 9(b), with the maximum curvature approximately 3 electrode spacings from the depression in the crown of the levee. The small pocket of lower resistivity (60 Ωm in Figure 9(b)) is observed in the lower right side of the inversion, though the depth of penetration of this signal did not allow the entire region to be captured. Although the borehole data were approximately 99 m from this survey,

the data are shown along with the measured groundwater table in Figure 9(b). The soil stratigraphy aligns well with the geophysical measurements in the upper 5 m of the levee from 36 to 48 m along the profile.

There are relatively thin layers between the higher and lower resistivity zone discussed in both surveys. These should not be interpreted as additional soil layers, but rather as smoothing effects. ERT surveys collect bulk measurements with depth, and a trade-off of the mathematically stable Occam style smooth inversion smears at sharp boundaries, preventing the defining of sharp layer interfaces with depth. This smearing effect is especially noted in Figure 9(a) where the resistivity in the upper 2 m appears to be higher and less uniform than in Figure 9(b), where higher resolution data were collected near the surface. The smearing effect is still noted between the two layers in Figure 9(b), though it is minimized.

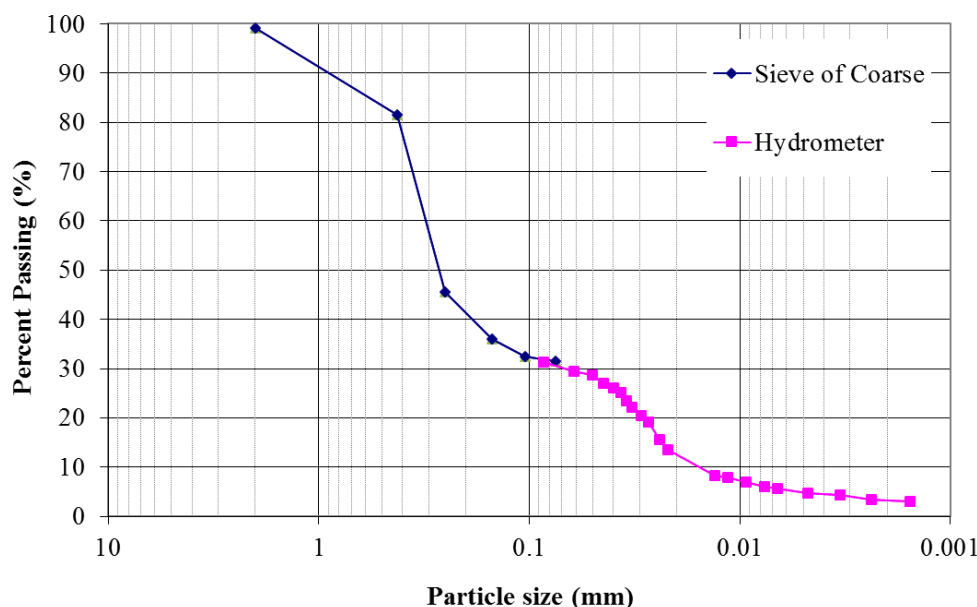
Sample B1 classified as a silty sand (SM) based on the USCS classification (ASTM D2487 2011); however, there was no SM identified in the soil borings by the USACE. Determination of the percent fines by washing (ASTM D1140 2017), particle size analysis of the coarse fraction by sieve (ASTM D6913 2017), and particle size analysis of the fine-grained fraction by hydrometer (ASTM D7928 2017) were conducted to determine whether this soil was a mixture of the sand fill and clay levee material shown in the boring log or a foundation soil located deeper than what was captured in the USACE boring. Figure 11 shows the particle size distribution curve for sample B1. The soil contained approximately 68% sand particles and 32% fine-grained particles passing the No. 200 sieve, of which approximately 3.5% were clay sized particles (i.e., < 0.002 mm). This soil was comprised of approximately 28% silt sized particles. The large fraction of silt size particles and the fact that a silty soil was not identified on the boring log suggested that the soil came from locations deeper than what was captured by the available boring. The low percentage clay fraction obtained also indicated that this soil was a different soil altogether and was not a mixture of the sand and clay soils resulting in a SM classification. The liquid limit and plastic limit of sample B1 were determined to both be 19 (following ASTM D4218 2017), resulting in a non-plastic designation for the fines.

Figure 11. Particle size distribution for sample B1 retrieved from Sand Boil 1.
