Forensic Analysis of Levee Failures: The Breitenhagen Case

ABSTRACT: *Forensic analysis of past failures is valuable to improve our understanding of levee behavior. In this article a new systematic approach of forensic analysis for levee failures is proposed and applied to the Breitenhagen levee breach that occurred along the river Saale in Germany in 2013. The purpose of this study is to identify the cause of the breach based on the proposed approach, even though limited data is available. Based on the information prior, during and after the breach of the levee, a slope stability model is developed for the entire event. First, results from this model are obtained based on the expected values of the uncertain parameters and the best estimates of the situation. Uncertainty of the model is included in the calculation subsequently by defining possible failure scenarios. The most likely failure scenarios are derived from the data and included into the model so that it is possible to eliminate or validate all possible causes by means of a sensitivity calculation. It is concluded that the levee breach is likely caused by locally weak soil conditions, unexpected high water pressures due

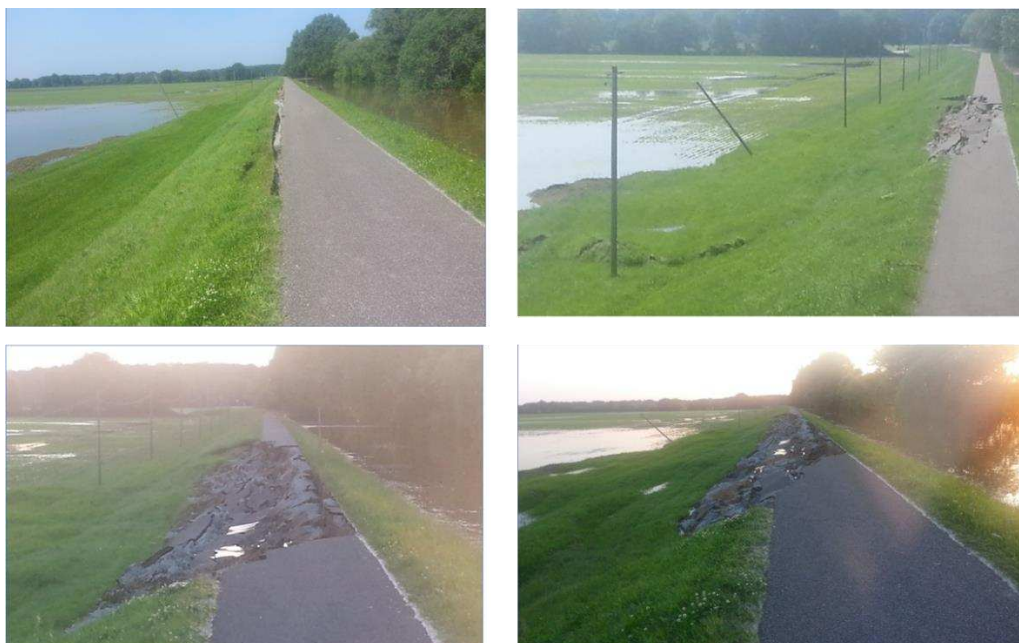
Figure 6. Photo series over time (upper left: 08.06.2013-10:37, initial break at the edge of the slope, upper right: 08.06.2013-14:10, horizontal shifts, bulge of the toe, lower left: 08.06.2013-20:51 continuing failure, lower right, 08.06.2013-20:55, continuing failure with the visual predictors (Grubert, 2013). Riverside of the levee is on the right for all photos.

Photo data were collected during the breaching process as well, showing recognizable indications of the levee failure. The indicators were used to identify the deformations and the geometry of the slip circle (Figure 6). Also, ponding due to possible seepage of water at the landside is shown. Possible high water pressures in the aquifer may cause seepage and saturation of the soil at the landside of the levee.

On the left side of the picture an electricity pole is recognized which seems to tilt over time, until it is almost completely horizontal (Figure 6). Also the slip circle is expanding until the road is completely damaged indicating an increasing deformation over time. The initial failure is considered to have weakened the levee to such a level that the levee lost all its retaining capacity.

Introducing undrained soil behavior for the clay, scenario D, results in FoS between 1.66 and 1.28. The slip circle of the actual failure (Figure 6) and the calculated slip circle (for example with the use of Bishop with undrained soil behavior and Spencer with drained soil behavior) differ in geometry. The slip circle of the Spencer method seems to show more realistic geometry of slip circle than the Uplift Van method and Bishop’s method in case of low effective soil pressures at the interface between sand and clay (Figure 14).
