# Forensic Analysis of Levee Failures: The Breitenhagen Case

**ABSTRACT:** Forensic analysis of past failures is valuable to improve our understanding of levee behavior. In this article a new systematic approach of forensic analysis for levee failures is proposed and applied to the Breitenhagen levee breach that occurred along the river Saale in Germany in 2013. The purpose of this study is to identify the cause of the breach based on the proposed approach, even though limited data is available. Based on the information prior, during and after the breach of the levee, a slope stability model is developed for the entire event. First, results from this model are obtained based on the expected values of the uncertain parameters and the best estimates of the situation. Uncertainty of the model is included in the calculation subsequently by defining possible failure scenarios. The most likely failure scenarios are derived from the data and included into the model so that it is possible to eliminate or validate all possible causes by means of a sensitivity calculation. It is concluded that the levee breach is likely caused by locally weak soil conditions, unexpected high water pressures

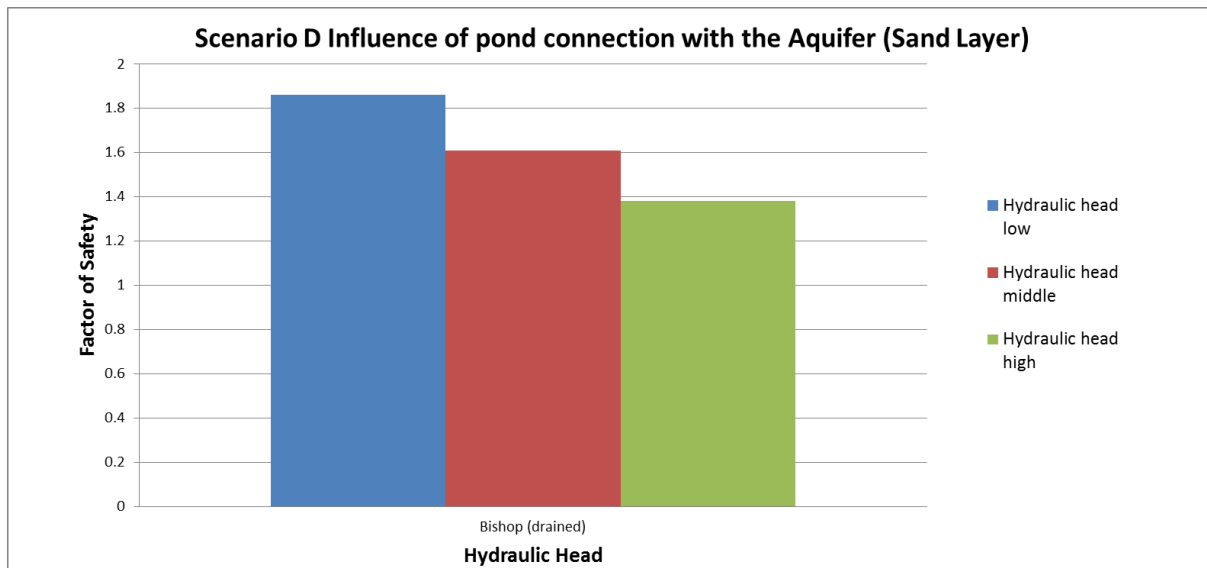
Figure 13. Influence of the rise of the hydraulic head in the aquifer with three different levels in hydraulic head in scenarios D.

The stratigraphy shows an aquifer below the levee which might be in direct contact with the water level at the riverside by means of a pond in front of the levee (Figure 10). Similar to the phreatic line, the different water pressures in the aquifer influence the shear strength as well. For the analysis of the contribution of the aquifer to the cause of failure, the model uses three scenarios for the water pressure. The results are shown in Figure 13.

Due to the rise of the hydraulic head in the aquifer, the range of the FoS overall is between 1.86 and 1.38. The shape of the slip circle shows realistic similarities with the actual slip circle. However the slip circle still intersects the levee crest instead of starting from the landside of the levee.
