## Forensic Analysis of Levee Failures: The Breitenhagen Case

ABSTRACT: Forensic analysis of past failures is valuable to improve our understanding of levee behavior. In this article a new systematic approach of forensic analysis for levee failures is proposed and applied to the Breitenhagen levee breach that occurred along the river Saale in Germany in 2013. The purpose of this study is to identify the cause of the breach based on the proposed approach, even though limited data is available. Based on the information prior, during and after the breach of the levee, a slope stability model is developed for the entire event. First, results from this model are obtained based on the expected values of the uncertain parameters and the best estimates of the situation. Uncertainty of the model is included in the calculation subsequently by defining possible failure scenarios. The most likely failure scenarios are derived from the data and included into the model so that it is possible to eliminate or validate all possible causes by means of a sensitivity calculation. It is concluded that the levee breach is likely caused by locally weak soil conditions, unexpected high water pressures du

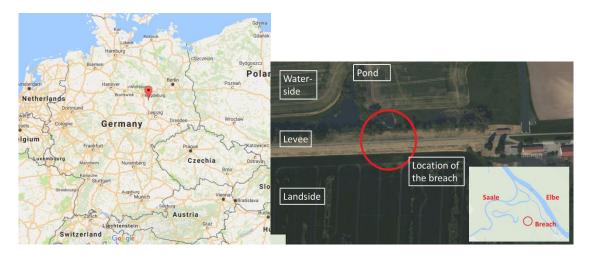
Figure 2. Overview of the location of the breach (GeoBasis-DE/BKG, 2009).

The data collected prior to the breach provide an indication of the condition of the levee prior to the breach. The overview photo shows a pond in front of the levee possibly caused by an earlier breach (Figure 2). This indicates the possibility of a direct connection between the outside water level and the aquifer below the levee. The photos show a row of trees at the riverside toe of the levee which might influence the conductivity of the levee due to the intrusion of the roots inside the levee, or might indicate the presence of a more conductive layer inside the levee (Figure 2). The slope of the levee is very steep (about 1:2.1 vertical to horizontal) with a gradient that exceeds the friction angle of most soil types. The slope at the landside is prone to instability (Figure 5).

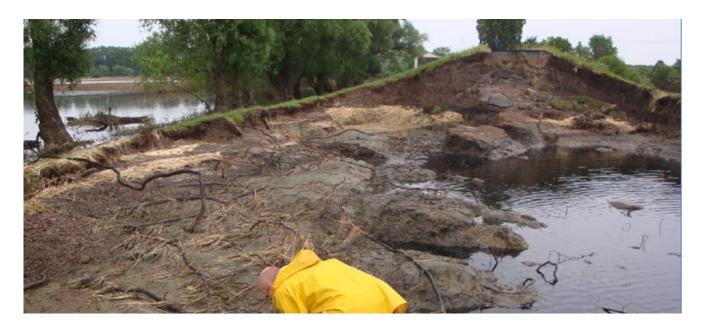
The photos taken after the breach show the presence of roots in the cross-section even after the breach as shown in Figure 7. The roots are numerous and the length of the roots indicate that they have grown deep into the levee. The presence of the tree roots might indicate a highly conductive layer which could have a direct effect on the local pore pressures inside the levee. The soil surface that is exposed by the breach, seems to consist of a cohesive material.

Figure 7. Photo of the cross-section of the breached levee (Grubert, 2013).
