Geotechnical Effects and a 6-Year Outlook of the 2012 Hurricane Sandy in the Eastern United States

ABSTRACT: Hurricane Sandy was the deadliest and most destructive event of the 2012 Atlantic hurricane season. It originated as a storm off the coast of West Africa that turned into a tropical wave in the southwestern Caribbean Sea, and then into a hurricane that moved slowly north along the United States East Coast. Numerous regional coastal communities and urban centers in New Jersey (NJ) and the New York City (NYC) metropolitan area experienced widespread flooding, extreme winds, and heavy damage that disrupted daily life and business in Lower Manhattan, the world's financial capital. Consequences with great geotechnical engineering interest include: (i) modification of the regional coastal geomorphology due to storm surge, with the birth of new inlets, erosion, scour of soil at the shorelines; (ii) damage in coastal communities that revealed the vulnerability of residential building foundations not designed according to modern flood protection standards; and (iii) interruption of service of buried structures and below ground infrastructure due to flood damage to non-structural com

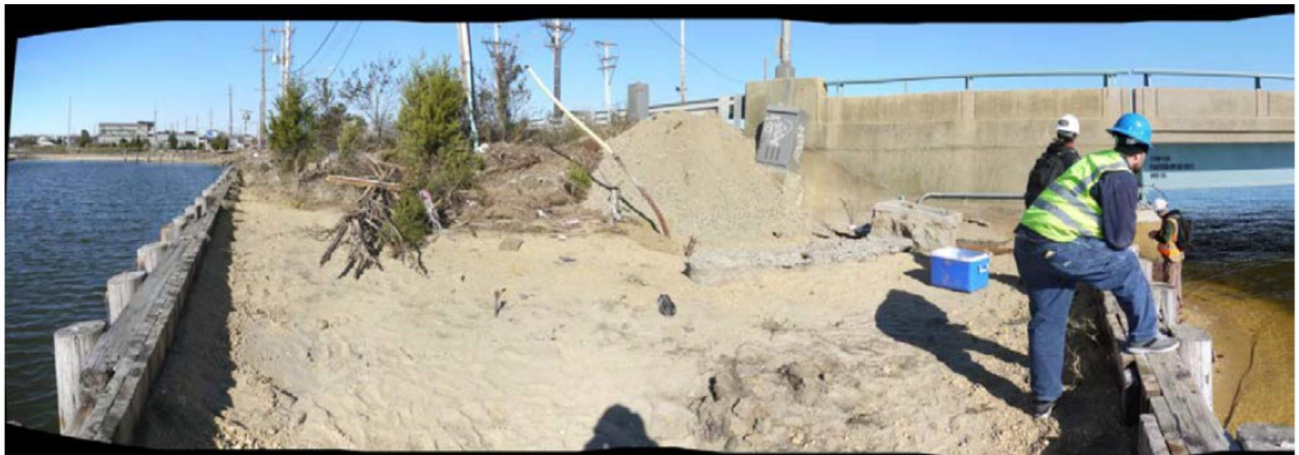
Figure 9. Erosion at Mathis Bridge southwest abutment (eastbound Rt37) ($39.949350^{\circ}\text{N}$, $74.113902^{\circ}\text{W}$; GEER 2014).

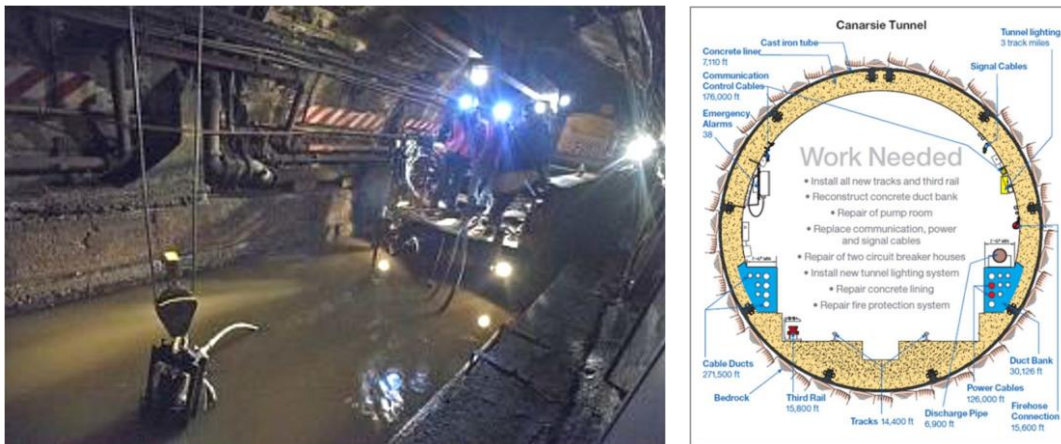
Figure 15. Canarsie tube of [L] line: damage from Sandy (left) and work needed to repair it (right) (MTA, 2017).

While most tunnels experienced minimal structural damage, utilities and ventilation systems were severely damaged and required lengthy repairs. Indicatively, the [R] Montague St. subway and the World Trade Center PATH tunnels were out of service for 2-3 months. The R line was taken out of service again in 2013 for lingering flood damage repairs. The Canarsie Tube of the [L] subway line was inundated with 265,000 m³ (7M gallons) of saltwater that caused corrosion of cabling, circuit breakers, and disabling of power/track equipment. The duct bank alongside the track, which provides walkway for emergency egress, sustained heavy damage and exhibited a partial collapse. With an initial 15-month shutdown plan, a complete overhaul is still necessary today, in 2020 (Fig. 15), as the L line is critical with a large portion of its daily 400,000 riders travelling to 14th Street stations, some of which are not easily reached by other lines. The Queens [A] Rockaway subway line was out of service for nearly seven months due to two major washouts at the earth embankment crossing Jamaica Bay, which exposed the old Long Island Rail Road (LIRR) infrastructure (Fig. 16).

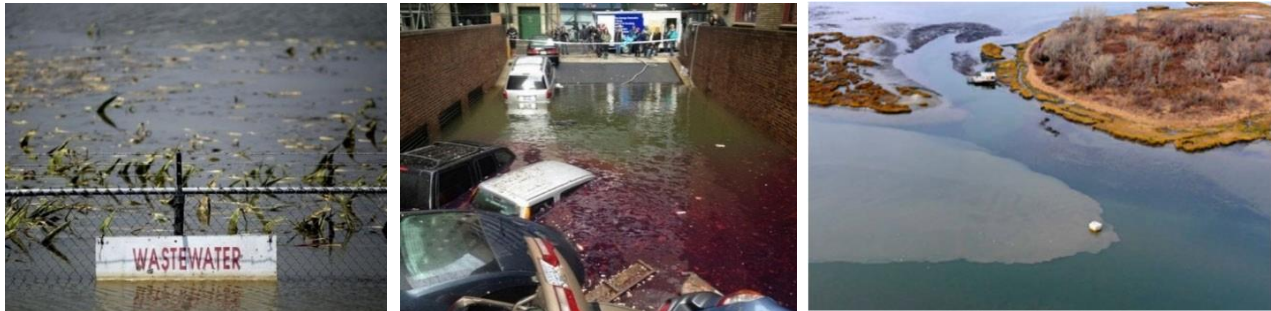
Figure 26. Untreated waste spilled in NY Harbor (left, photo Getty/Tama) and buried cars (middle, photo Bloomberg/Korby). Overflow from Bay Park Sewage Treatment Plant, East Rockaway (right, photo by D. Kuntz; Kenward et al., 2013).

to shut down or divert sewage into waterways due to power outages and flooding (e.g., Fig. 26 shows untreated waste spilled in the LI South Shore Estuary from the Bay Park Sewage Plant in East Rockaway). GEER visited the WWTP that processes waste water from Yonkers. Founded on filled land along the east bank of the Hudson River, it experienced one of the largest overflows with 4.5M m³ (1.2B gallons). The river frontage has a rip-rap revetment at the south and a steel seawall (Fig. 27) about 1.5 m (5 ft) higher than the north rip-rap. Normally, the plant handles daily 360 m³ (95M gallons) of waste water; during in Hurricane Irene in 2011, it processed 1,150 m³ (300M gallons). After Sandy, loss of gravity flow caused more than 2.8 m (9 ft) of tail water and therefore flooding of below-grade areas (Fig. 27), something that damaged equipment including boilers, the alarm system, pipes, and motors.

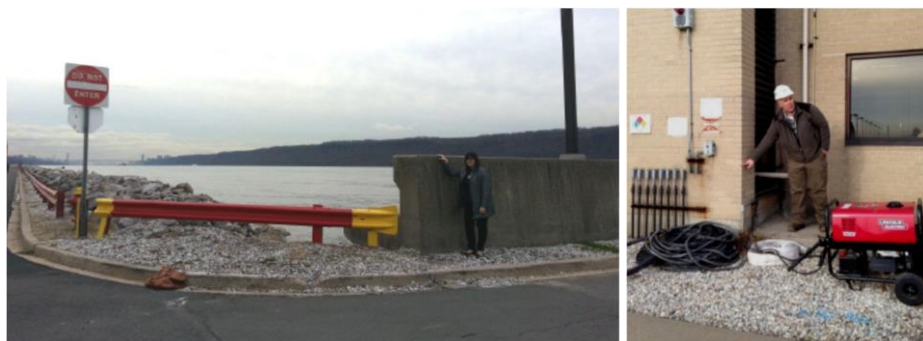
Figure 27. Yonkers Joint WWTP: junction of rip-rap revetment and seawall, looking south (left); vent grates in aeration blower building where water entered, with flood water elevation shown by plant superintendent (right); GEER (2014).

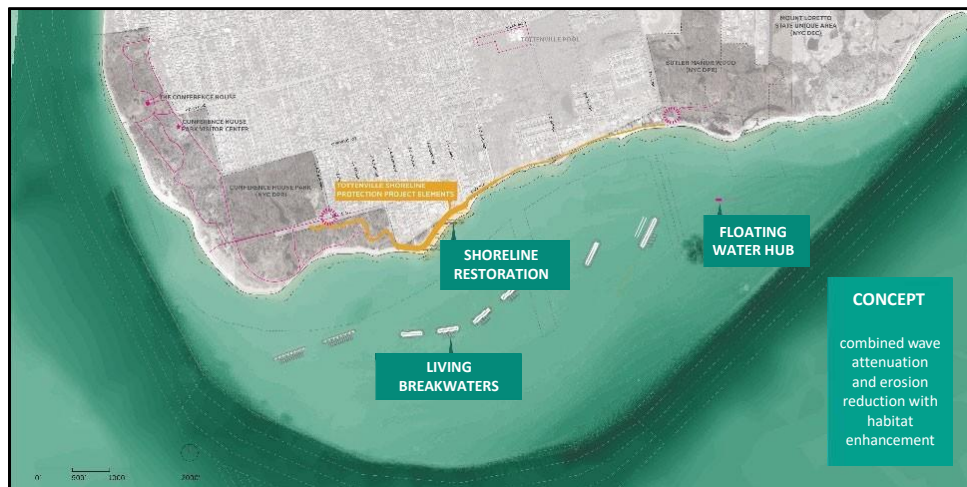
Figure 34. Living Breakwaters system: combined wave attenuation and erosion reduction with habitat enhancement.

added to the shoreline will protect vulnerable beaches, while breakwaters work to accrete beach elsewhere (Fig. 34). Similarly, in NJ, Rebuild by Design includes several projects, such as: (i) CDBG (\$380M) projects to be completed by 2022; (ii) Hudson River (\$230M) communities and critical infrastructure flood-resistance structures (e.g., N. Hudson Sewerage Authority); and (iii) protection of Meadowlands (\$150M) Little Ferry, Moonachie, Carlstadt, Teterboro, and S. Hackensack.
