Geotechnical Effects and a 6-Year Outlook of the 2012 Hurricane Sandy in the Eastern United States

ABSTRACT: Hurricane Sandy was the deadliest and most destructive event of the 2012 Atlantic hurricane season. It originated as a storm off the coast of West Africa that turned into a tropical wave in the southwestern Caribbean Sea, and then into a hurricane that moved slowly north along the United States East Coast. Numerous regional coastal communities and urban centers in New Jersey (NJ) and the New York City (NYC) metropolitan area experienced widespread flooding, extreme winds, and heavy damage that disrupted daily life and business in Lower Manhattan, the world's financial capital. Consequences with great geotechnical engineering interest include: (i) modification of the regional coastal geomorphology due to storm surge, with the birth of new inlets, erosion, scour of soil at the shorelines; (ii) damage in coastal communities that revealed the vulnerability of residential building foundations not designed according to modern flood protection standards; and (iii) interruption of service of buried structures and below ground infrastructure due to flood damage to non-structural com

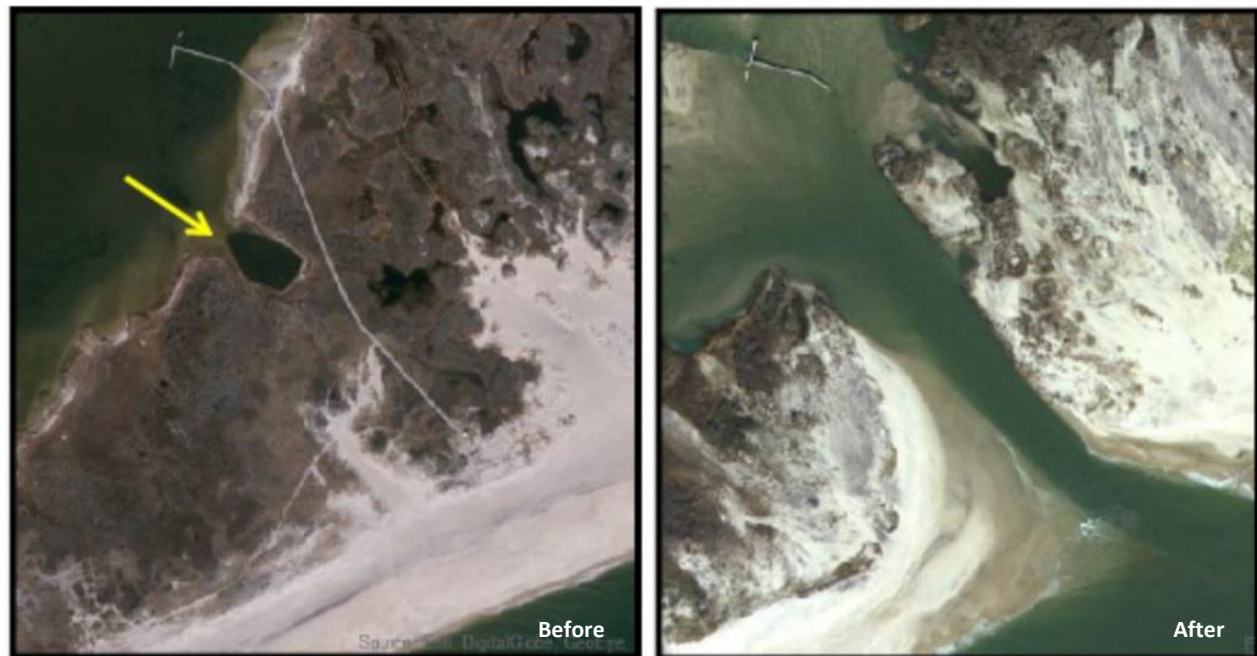
Figure 7. Fire Island, LI: New inlet with narrowing point by embayment in yellow arrow (Ref: tmappsevents.esri.com/).

The storm surge significantly modified the coastal NY/NJ geomorphology, with the birth of new inlets and severe erosion and scour of soil on the shorelines (Fig. 7). While devastating in their path, these effects were largely consistent with predictions.

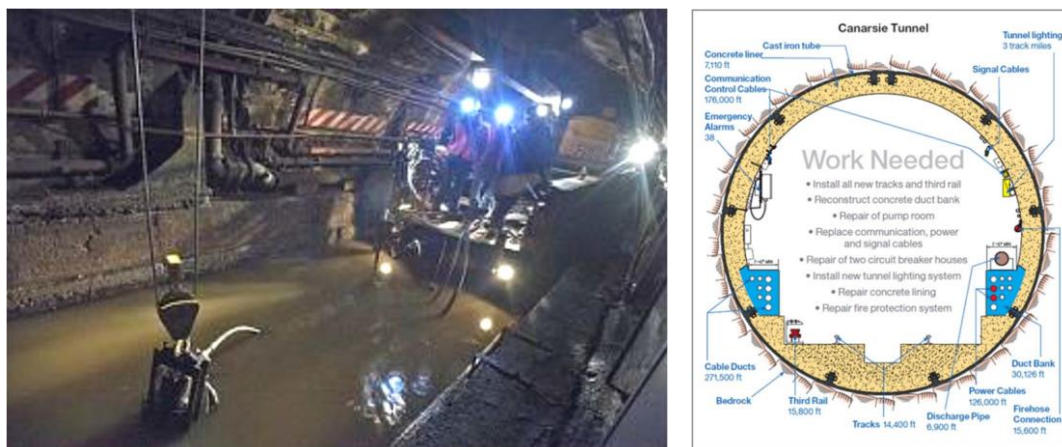
Figure 15. Canarsie tube of [L] line: damage from Sandy (left) and work needed to repair it (right) (MTA, 2017).

While most tunnels experienced minimal structural damage, utilities and ventilation systems were severely damaged and required lengthy repairs. Indicatively, the [R] Montague St. subway and the World Trade Center PATH tunnels were out of service for 2-3 months. The R line was taken out of service again in 2013 for lingering flood damage repairs. The Canarsie Tube of the [L] subway line was inundated with 265,000 m³ (7M gallons) of saltwater that caused corrosion of cabling, circuit breakers, and disabling of power/track equipment. The duct bank alongside the track, which provides walkway for emergency egress, sustained heavy damage and exhibited a partial collapse. With an initial 15-month shutdown plan, a complete overhaul is still necessary today, in 2020 (Fig. 15), as the L line is critical with a large portion of its daily 400,000 riders travelling to 14th Street stations, some of which are not easily reached by other lines. The Queens [A] Rockaway subway line was out of service for nearly seven months due to two major washouts at the earth embankment crossing Jamaica Bay, which exposed the old Long Island Rail Road (LIRR) infrastructure (Fig. 16).

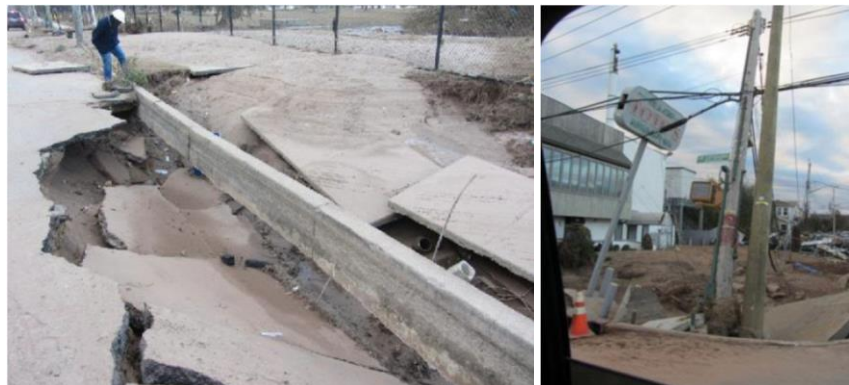
Figure 24. Scour undermining of street and utilities at Seaview Blvd, SI (40.579283°N, 74.077849°W, 11/4/12, GEER, 2014).

Severe soil erosion was observed along Father Capodanno Blvd in Midland Beach, Staten Island (SI), where sinkholes undermined the street, curb line, sidewalks, utility poles, and house foundations (Figs. 23, 24). Throughout the area, wood decks, trees, cars, and other debris had been deposited inland. Concrete wall foundations generally sustained little or no structural damage, though they sometimes experienced erosion and scour along their perimeter.
