Geotechnical Effects and a 6-Year Outlook of the 2012 Hurricane Sandy in the Eastern United States

ABSTRACT: Hurricane Sandy was the deadliest and most destructive event of the 2012 Atlantic hurricane season. It originated as a storm off the coast of West Africa that turned into a tropical wave in the southwestern Caribbean Sea, and then into a hurricane that moved slowly north along the United States East Coast. Numerous regional coastal communities and urban centers in New Jersey (NJ) and the New York City (NYC) metropolitan area experienced widespread flooding, extreme winds, and heavy damage that disrupted daily life and business in Lower Manhattan, the world's financial capital. Consequences with great geotechnical engineering interest include: (i) modification of the regional coastal geomorphology due to storm surge, with the birth of new inlets, erosion, scour of soil at the shorelines; (ii) damage in coastal communities that revealed the vulnerability of residential building foundations not designed according to modern flood protection standards; and (iii) interruption of service of buried structures and below ground infrastructure due to flood damage to non-structural com

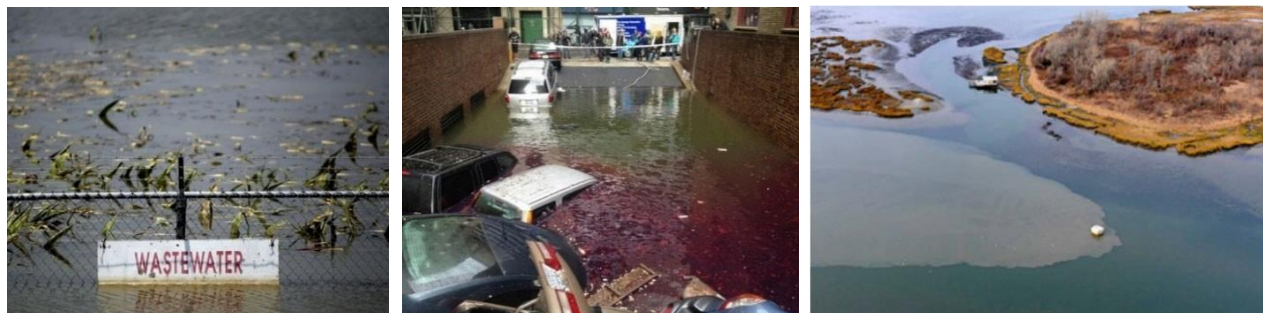
Figure 26. Untreated waste spilled in NY Harbor (left, photo Getty/Tama) and buried cars (middle, photo Bloomberg/Korby). Overflow from Bay Park Sewage Treatment Plant, East Rockaway (right, photo by D. Kuntz; Kenward et al., 2013).

to shut down or divert sewage into waterways due to power outages and flooding (e.g., Fig. 26 shows untreated waste spilled in the LI South Shore Estuary from the Bay Park Sewage Plant in East Rockaway). GEER visited the WWTP that processes waste water from Yonkers. Founded on filled land along the east bank of the Hudson River, it experienced one of the largest overflows with 4.5M m³ (1.2B gallons). The river frontage has a rip-rap revetment at the south and a steel seawall (Fig. 27) about 1.5 m (5 ft) higher than the north rip-rap. Normally, the plant handles daily 360 m³ (95M gallons) of waste water; during in Hurricane Irene in 2011, it processed 1,150 m³ (300M gallons). After Sandy, loss of gravity flow caused more than 2.8 m (9 ft) of tail water and therefore flooding of below-grade areas (Fig. 27), something that damaged equipment including boilers, the alarm system, pipes, and motors.

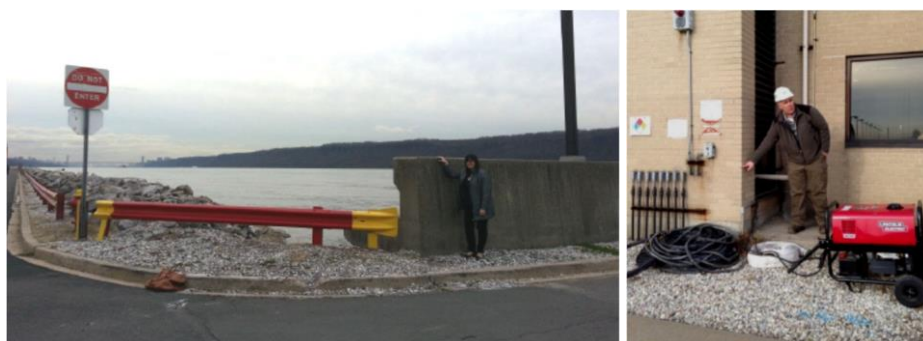
Figure 27. Yonkers Joint WWTP: junction of rip-rap revetment and seawall, looking south (left); vent grates in aeration blower building where water entered, with flood water elevation shown by plant superintendent (right); GEER (2014).

Preparedness allowed for on-site decisions that accelerated recovery to 3-4 days for primary treatment and 21 days for normal operations to resume. Planning before the storm prevented longer disruptions (e.g., sandbagging prevented flooding of the feeder, the control center, and the emergency generator), while on-site staff were properly trained to manually operate system components that failed.
