## Geotechnical Effects and a 6-Year Outlook of the 2012 Hurricane Sandy in the Eastern United States

**ABSTRACT:** Hurricane Sandy was the deadliest and most destructive event of the 2012 Atlantic hurricane season. It originated as a storm off the coast of West Africa that turned into a tropical wave in the southwestern Caribbean Sea, and then into a hurricane that moved slowly north along the United States East Coast. Numerous regional coastal communities and urban centers in New Jersey (NJ) and the New York City (NYC) metropolitan area experienced widespread flooding, extreme winds, and heavy damage that disrupted daily life and business in Lower Manhattan, the world's financial capital. Consequences with great geotechnical engineering interest include: (i) modification of the regional coastal geomorphology due to storm surge, with the birth of new inlets, erosion, scour of soil at the shorelines; (ii) damage in coastal communities that revealed the vulnerability of residential building foundations not designed according to modern flood protection standards; and (iii) interruption of service of buried structures and below ground infrastructure due to flood damage to non-structu

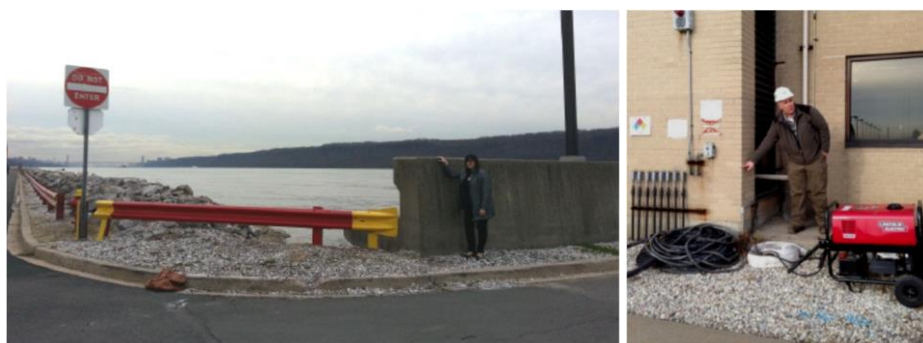
Figure 27. Yonkers Joint WWTP: junction of rip-rap revetment and seawall, looking south (left); vent grates in aeration blower building where water entered, with flood water elevation shown by plant superintendent (right); GEER (2014).
