# Geotechnical Effects and a 6-Year Outlook of the 2012 Hurricane Sandy in the Eastern United States

ABSTRACT: Hurricane Sandy was the deadliest and most destructive event of the 2012 Atlantic hurricane season. It originated as a storm off the coast of West Africa that turned into a tropical wave in the southwestern Caribbean Sea, and then into a hurricane that moved slowly north along the United States East Coast. Numerous regional coastal communities and urban centers in New Jersey (NJ) and the New York City (NYC) metropolitan area experienced widespread flooding, extreme winds, and heavy damage that disrupted daily life and business in Lower Manhattan, the world's financial capital. Consequences with great geotechnical engineering interest include: (i) modification of the regional coastal geomorphology due to storm surge, with the birth of new inlets, erosion, scour of soil at the shorelines; (ii) damage in coastal communities that revealed the vulnerability of residential building foundations not designed according to modern flood protection standards; and (iii) interruption of service of buried structures and below ground infrastructure due to flood damage to nonstructural co

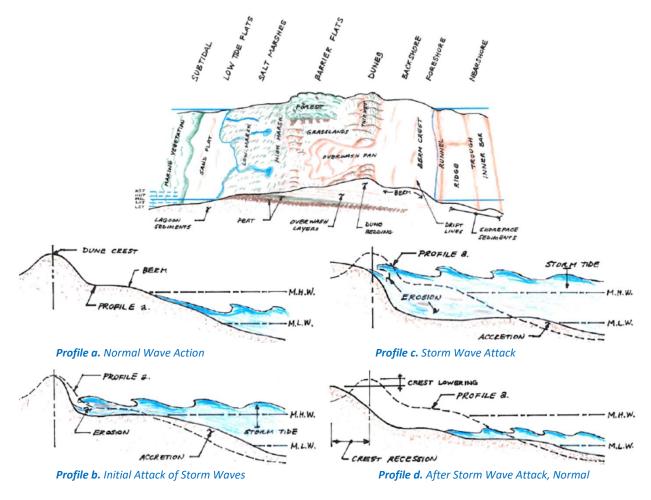
Figure 4. Barrier environments (top) and beach profile changes (bottom) in response to a coastal storm (Refs: A. Dyer from Leatherman, S.P., 1979; Godfrey, 1976; and U.S. Army Corps of Engineers, 1974).

The affected shoreline is primarily made up of eroding headlands and a series of barrier islands that run roughly parallel to the mainland. The barrier islands are natural buffers that protect the mainland and the back-bay from storms and waves coming from the ocean, and are composed of loose sediment held in place only by gravity and roots. While there are

competing theories on the details, the consensus is that barrier islands began to form after the last glaciation, migrating up the coastal plain as sea level rose to its current levels (Haslet, 2009). As sea level kept rising, the shorelines moved inland and wave action helped the barriers migrate landward (Fig. 4). Strong ocean waves pick up beach sand and move it offshore, steepening the beach during a storm. Then dune lines are eroded and, if they're overtopped, waves can push sand and dunes landward over the marshes. The wash overs build the bay-side of the island, maintaining a barrier between the ocean and the mainland (Fig. 5).

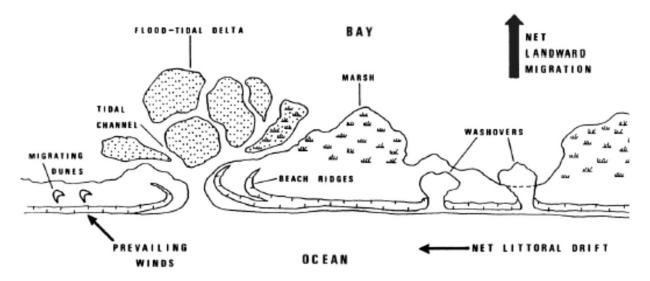
Figure 5. Geologic processes that build up a barrier island, allowing landward migration with sea level rise (Johnson, 1982).

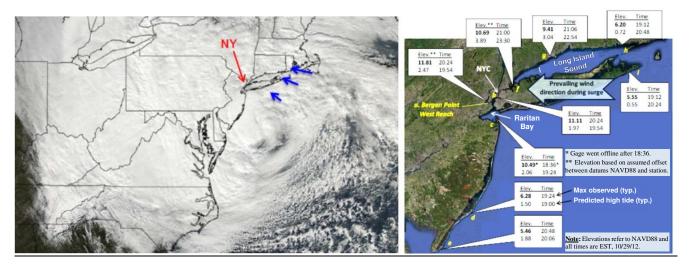
Figure 6. Hurricane Sandy's circulation on 10/29/12 at 2:20 pm EDT; blue arrows show wind direction close to landfall in southern NJ (left; <a href="mailto:nasa.gov/hurricanes/h2012">nasa.gov/hurricanes/h2012</a> Sandy). Observed and predicted tide from NOAA stations (right).

Figure 6 depicts the wind direction, fetch, coastline shape, and normal tidal cycle. The counterclockwise wind currents caused an eastern high velocity wind direction over LI and NYC. This pattern was verified by the GEER team's observation that many of the thousands of fallen trees in LI fell to the west. The following factors contributed to an increase of the surge:

- The westward direction of the winds created a long fetch distance from the east towards Raritan Bay and LI Sound.
- The "constricted" shape of both the Raritan Bay and LI Sound narrowing to the west caused the surge height to increase as it moved into those areas due to a "funneling" effect.
- The slow storm movement resulted in the maximum surge being superimposed above the astronomical high tide.

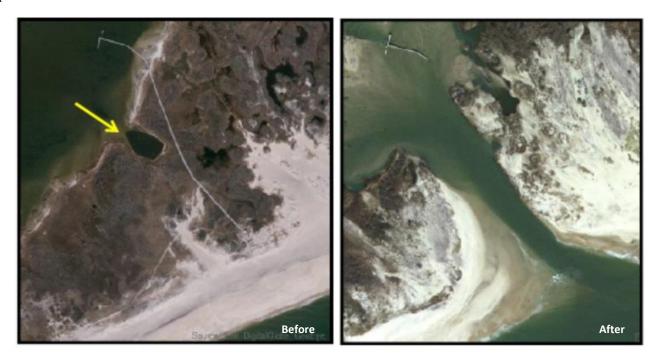
Figure 7. Fire Island, LI: New inlet with narrowing point by embayment in yellow arrow (Ref: tmappsevents.esri.com/).

The storm surge significantly modified the coastal NY/NJ geomorphology, with the birth of new inlets and severe erosion and scour of soil on the shorelines (Fig. 7). While devastating in their path, these effects were largely consistent with predictions.

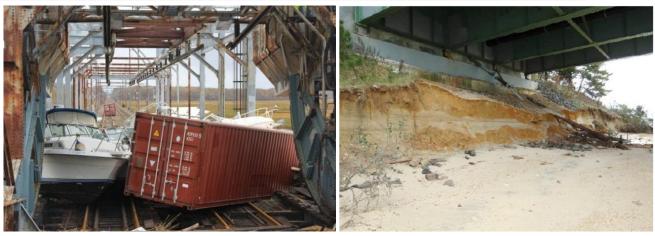
Figure 8. Morgan Drawbridge (left; NJ Transit) and Rt. 72 abutment erosion, looking south-east (right; NJDoT).

GEER observations of seven NJ bridges (NJ 35 - Cheesequake/Manasquan River Drawbridges; Railroad Drawbridge - Manasquan River; NJ 70 - Metedeconk River; NJ 37 - Mathis/Stanley Tunney; NJ 528 - Mantoloking; NJ 72 - Henderson Memorial) and data by the NJ Department of Transportation, Transit Authority, and Ocean County Engineering suggest that bridges remained mostly serviceable immediately or soon after the storm. Two primary themes of damage were identified: (i) flooding effects to drawbridges (e.g., Morgan Drawbridge, Fig. 8) and their electrical systems, and (ii) soil erosion at approaches and abutments (often supported on structures formed by fill within a perimeter soldier pile wall) in several bridges, averaging at 1.5 m (5 ft) of soil removal (e.g., Fig. 8: Rt. 72 Bridge, Fig. 9: Mathis Bridge). The exception was the Mantoloking Bridge that was unserviceable for a long period due to undermining of its abutments and approaches. Figs. 10 and 11 show large floating debris, including houses, that destroyed the T-wall, forcing the coping and sidewalk to cantilever out by about 3 m (10 ft).

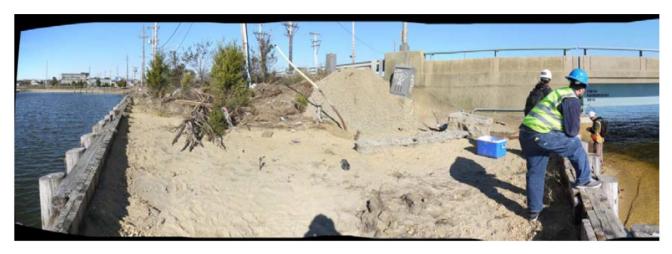
Figure 9. Erosion at Mathis Bridge southwest abutment (eastbound Rt37) (39.949350°N, 74.113902°W; GEER 2014).

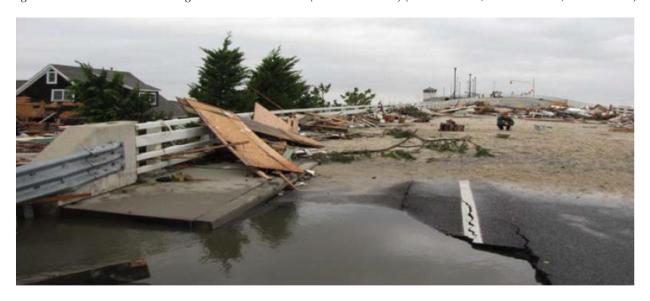
Figure 10. Foundation undermining at east abutment of Mantoloking Bridge (40.040058°N, 74.051886°W; GEER, 2014).

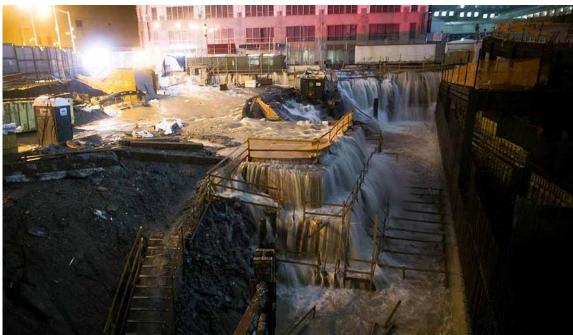
Figure 14. Open excavation flooding at the World Trade Center site (Photo: Associated Press).

Damage in the dense urban NYC area of lower Manhattan was primarily related to flood inundation. High water marks and evidence of flood damage to approximately 1.2-2.1 m (4-7 ft) above street level were observed throughout low-lying neighborhoods (e.g., South Street Seaport) and water front areas (Fig. 12). Below-grade subway stations, tunnels, parking garages, and excavations experienced widespread flooding. While access to many of these locations was restricted to the GEER team due to ongoing recovery work, evidence of flood inundation was visible from the surface, e.g. at the Battery Park underpass and Bellevue Hospital. Based on reports in the days and months following the storm, the flooded tunnels included the Brooklyn Battery, Holland, and Queens-Midtown highway tunnels, the PATH rapid transit tunnels, NJ Transit / Amtrak / LI Railroad Hudson and East River rail, and seven subway tunnels. Several subway stations and open excavations were flooded, including South Ferry, which flooded to the ceiling, as well as an excavation at the World Trade Center site (Figs. 13-14).

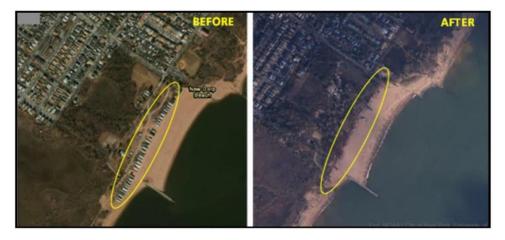
Figure 18. Aerial photographs from New Dorp Beach, SI, before and after Sandy. Row of houses completely removed and debris moved inland. (Images from tmappsevents.esri.com/website/swipe\_sandy/).

Storm surge, flooding, and erosion impacted residential housing and municipal infrastructure foundations in coastal areas investigated by the GEER team (Fig. 3). Destruction of wood-frame houses in Staten Island (SI) was common, as observed based on the "before" and "after" aerial photos of a row of houses (Fig. 18), which were completely removed by the storm. This area is underlain by glacial outwash sands, often overlain by man-made fill. Most of the structural/foundation failures occurred in dwellings built prior to 1938, typically developed as summer residences in areas with direct exposure to open ocean, constructed less robustly than modern, permanent-residence, homes (Eschenasy, 2013). Moving inland, dunes, and vegetated strips had a positive effect in reducing the damage.

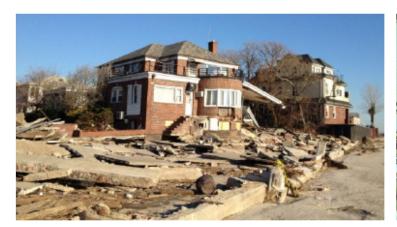
Figure 20. Undermining of beachfront retaining wall and loss of retained soil, Sea Gate, Brooklyn (left, 11/9/12); Destroyed CMU wall foundation, Breezy Point, Queens (right, 11/12/12). Photos by NYCDoB (GEER, 2014).

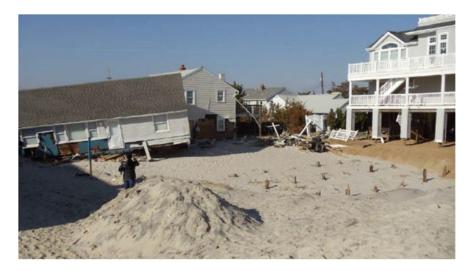
Figure 21. Timber piles remain in place after a home was sheared off in Pehola Park (39.610016N, 74.206657W, GEER, 2014).

A spectacular failure was observed by the GEER team at a two-story home at Pehola Park, Long Beach Island, which was sheared off its piles due to storm surge forces as well as wave action. Only the upper story of the home was visible, found near its original location. The site's approximate ground elevation was 2.35 m (7.7 ft) and the high-water mark was about 0.7 m (2.3 ft) above ground. The surrounding homes were intact, with the only difference being that this home was at a lower elevation than the others (Fig. 21). This pattern of lower story disappearance and/or flattening was observed in other areas as well.

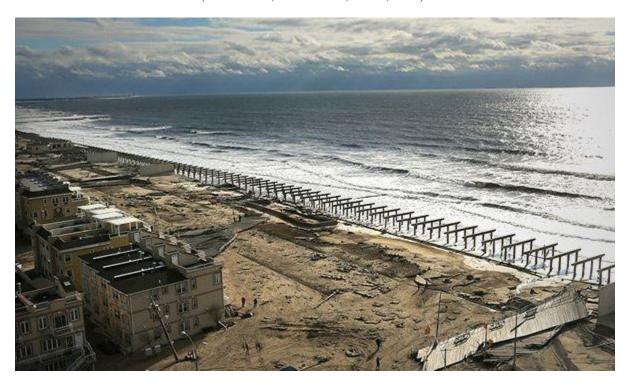
Figure 22. Damage to Boardwalk at Rockaway Beach, Queens (40.583445°N, 73.81553°W). Photo by cnbc.

concrete pile-supported wooden boardwalks, and some homes are separated from the beach by concrete or sheet pile retaining walls. In Rockaways, Queens, the boardwalk had been lifted off its piers and damaged or destroyed over its entire length, with debris carried up to 60 m (~200 ft) inland (Fig. 22).

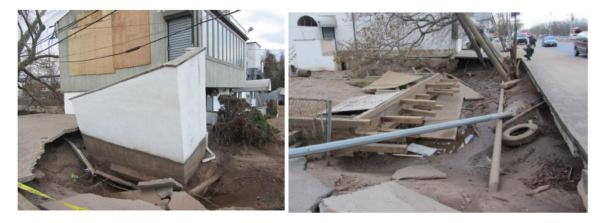
Figure 23. Scour undermining at Seaver Ave & Father Capodanno Blvd, SI (40.575944° N, 74.083015° W, 11/4/12). Damage to stair foundation and drain (left) and sidewalk, utilities, and light pole foundation (right). Photos by GEER (2014).

Severe soil erosion was observed along Father Capodanno Blvd in Midland Beach, Staten Island (SI), where sinkholes undermined the street, curb line, sidewalks, utility poles, and house foundations (Figs. 23, 24). Throughout the area, wood decks, trees, cars, and other debris had been deposited inland. Concrete wall foundations generally sustained little or no structural damage, though they sometimes experienced erosion and scour along their perimeter.

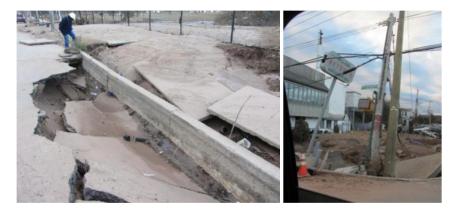
Figure 24. Scour undermining of street and utilities at Seaview Blvd, SI (40.579283°N, 74.077849°W, 11/4/12, GEER, 2014).

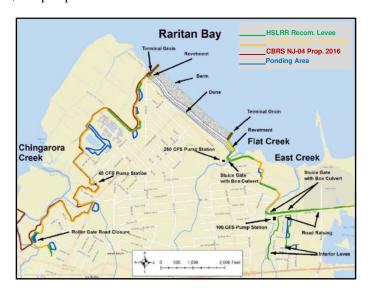
Figure 29. Union Beach plan overview from U.S. Army Corps of Engineering Limited Reevaluation Report (USACE, 2017).

The NJ State issued a report five years after Sandy with: (i) a record of damage and response; (ii) an agency-by-agency response/recovery playbook applicable to other states exposed to hurricanes; and (iii) rebuild measures co-funded by FEMA, the Departments of Interior and Housing and Urban Development (HUD), and Federal Highway Administration (FHWA), such as: Sea Bright wall, Mantoloking and Brick sheet piling, Belmar Lake Como discharge, Brigantine pump stations, Little Ferry tide gate, and Wildwood/Stone Harbor storm water/flood control. The Union Beach project in Raritan Bay (Fig. 29) would rebuild beaches and dunes and restore 100,000 m<sup>2</sup> (25 acres) of degraded wetlands to better absorb flood waters, with levees, flood walls, tide gates, and pump stations.

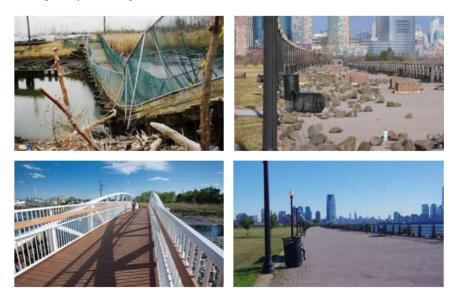
Figure 31. Liberty State Park (40.703100°N, 74.053700°W) before (top) and after rebuild (bottom). Photos by NJ State (2018).

Billions were invested to strengthen the electric and gas distribution networks toward a more resilient energy utilities grid. Advanced technologies were implemented to spot outages faster and deploy repair crews more efficiently. These projects increase the reliability of utility services, but also boost the NJ economy by creating new jobs. Investments in continuing the functionality of small businesses supported the tourism, which reached 98M in 2016 (breaking the 87M record of 2013). Intense efforts were made to reopen all parks within three months of Hurricane Sandy's passing, despite the enormous damage done across the entire state park system (Fig. 31).

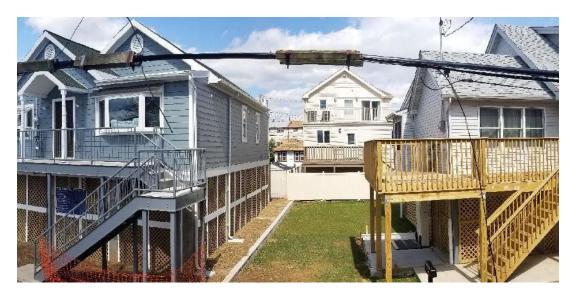
Figure 32. Build It Back elevated homes in New Dorp Beach, Staten Island (NYC Housing Recovery, 2018).

The Build It Back (BIB) program assisted 8,600 homeowners, landlords, and tenants of one- to four-unit homes affected in NYC boroughs by rebuilding homes damaged or destroyed by Sandy in the fall of 2018. The goal was to invest and create resilient neighborhoods through sustainable design, e.g. by requiring new homes to be elevated above projected sea level rise and flood heights. The program was funded by HUD's Community Development Block Grant (CDBG) to rebuild and elevate homes to current stringent flood regulations (Fig. 32) for 12,500 families. Additional support was provided to homeowners with moderate repair needs or without flood insurance, while a few low-income, households received rental assistance (HUD, 2018). Geotechnical considerations included foundations for the elevated homes designed to resist undermining by future flood events. The new foundation systems included jacked or drilled piles as well as the choice to leave open space below the structures to allow for flow.

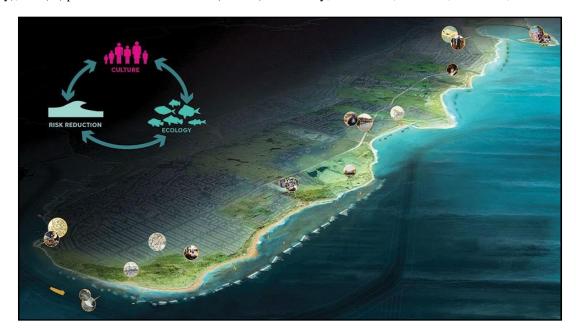
Figure 33. Living Breakwaters concept (SCAPE Landscape Architecture).

added to the shoreline will protect vulnerable beaches, while breakwaters work to accrete beach elsewhere (Fig. 34). Similarly, in NJ, Rebuild by Design includes several projects, such as: (i) CDBG (\$380M) projects to be completed by 2022; (ii) Hudson River (\$230M) communities and critical infrastructure flood-resistance structures (e.g., N. Hudson Sewerage Authority); and (iii) protection of Meadowlands (\$150M) Little Ferry, Moonachie, Carlstadt, Teterboro, and S. Hackensack.

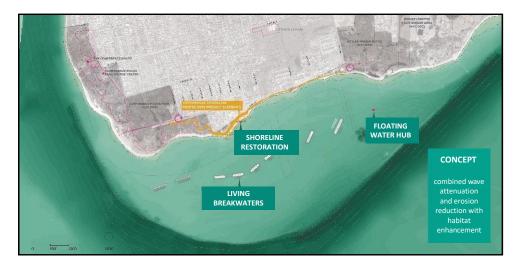
Figure 34. Living Breakwaters system: combined wave attenuation and erosion reduction with habitat enhancement.
