Geotechnical Effects and a 6-Year Outlook of the 2012 Hurricane Sandy in the Eastern United States

KEYWORDS: Hurricane Sandy, GEER, geotechnical reconnaissance, New York - New Jersey, infrastructure, erosion, foundations, sustainability, resilience

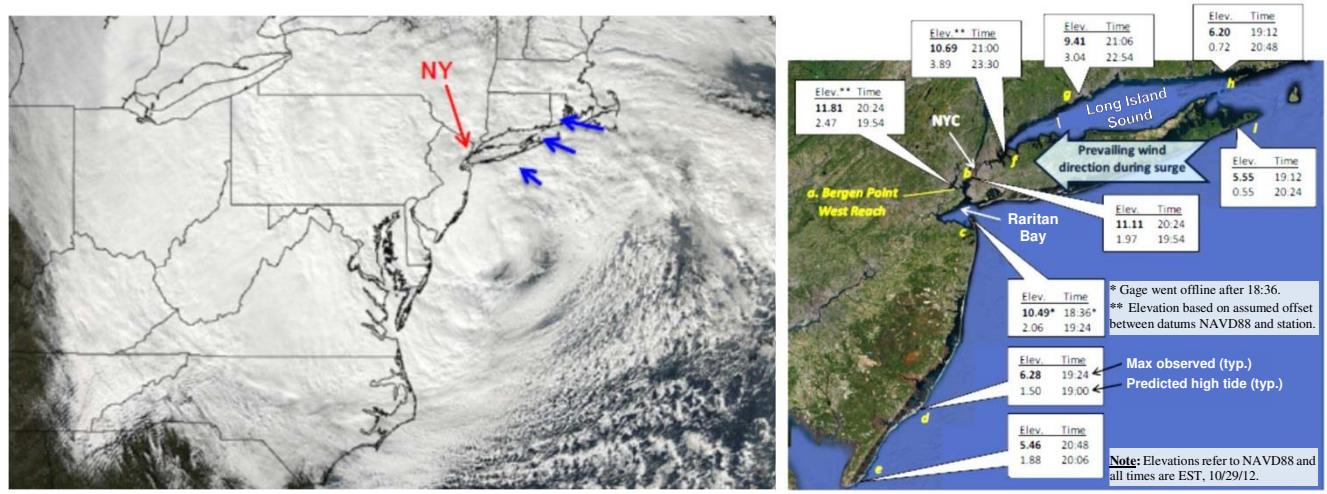
Figure 6. Hurricane Sandy's circulation on 10/29/12 at 2:20 pm EDT; blue arrows show wind direction close to landfall in southern NJ (left; nasa.gov/hurricanes/h2012_Sandy). Observed and predicted tide from NOAA stations (right).

Figure 6 depicts the wind direction, fetch, coastline shape, and normal tidal cycle. The counterclockwise wind currents caused an eastern high velocity wind direction over LI and NYC. This pattern was verified by the GEER team's observation that many of the thousands of fallen trees in LI fell to the west. The following factors contributed to an increase of the surge:

- The westward direction of the winds created a long fetch distance from the east towards Raritan Bay and LI Sound.
- The “constricted” shape of both the Raritan Bay and LI Sound narrowing to the west caused the surge height to increase as it moved into those areas due to a “funneling” effect.
- The slow storm movement resulted in the maximum surge being superimposed above the astronomical high tide.

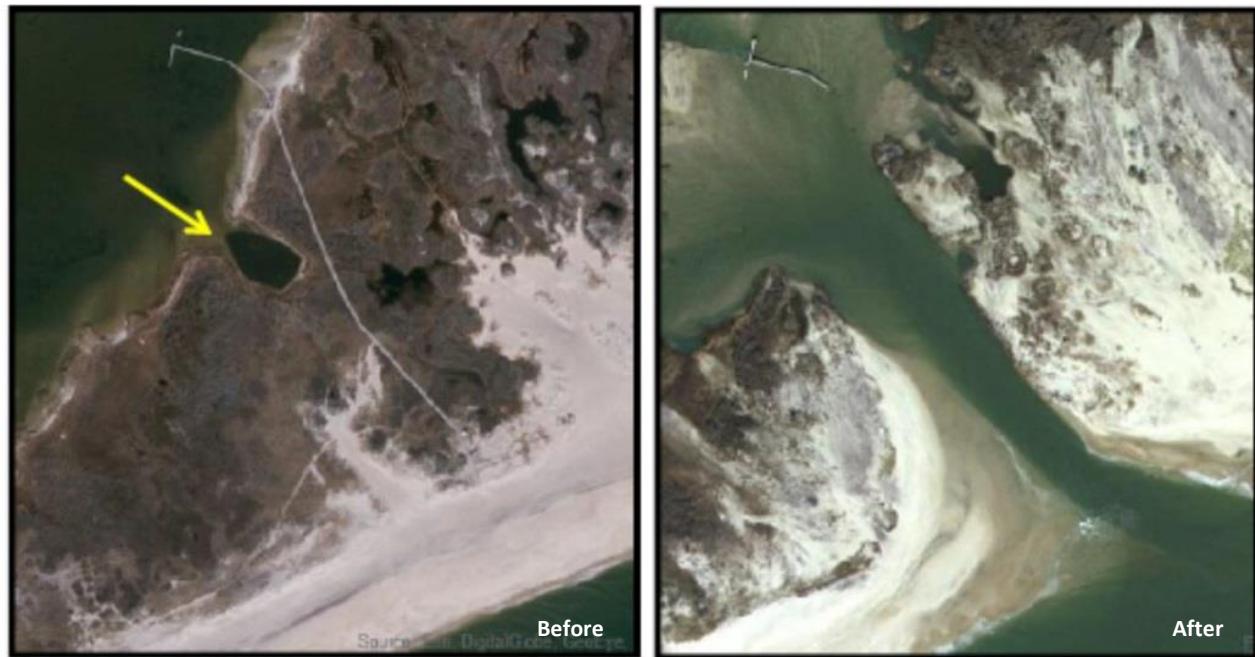
Figure 7. Fire Island, LI: New inlet with narrowing point by embayment in yellow arrow (Ref: tmappsevents.esri.com/).

The storm surge significantly modified the coastal NY/NJ geomorphology, with the birth of new inlets and severe erosion and scour of soil on the shorelines (Fig. 7). While devastating in their path, these effects were largely consistent with predictions.

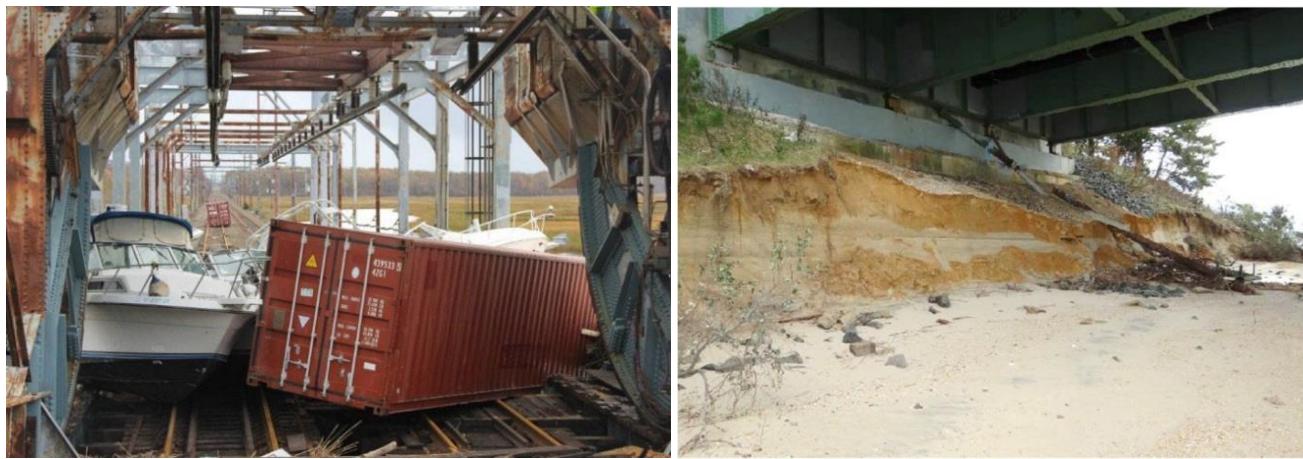
Figure 8. Morgan Drawbridge (left; NJ Transit) and Rt. 72 abutment erosion, looking south-east (right; NJDoT).

GEER observations of seven NJ bridges (NJ 35 - Cheesequake/Manasquan River Drawbridges; Railroad Drawbridge - Manasquan River; NJ 70 - Metedeconk River; NJ 37 - Mathis/Stanley Tunney; NJ 528 - Mantoloking; NJ 72 - Henderson Memorial) and data by the NJ Department of Transportation, Transit Authority, and Ocean County Engineering suggest that bridges remained mostly serviceable immediately or soon after the storm. Two primary themes of damage were identified: (i) flooding effects to drawbridges (e.g., Morgan Drawbridge, Fig. 8) and their electrical systems, and (ii) soil erosion at approaches and abutments (often supported on structures formed by fill within a perimeter soldier pile wall) in several bridges, averaging at 1.5 m (5 ft) of soil removal (e.g., Fig. 8: Rt. 72 Bridge, Fig. 9: Mathis Bridge). The exception was the Mantoloking Bridge that was unserviceable for a long period due to undermining of its abutments and approaches. Figs. 10 and 11 show large floating debris, including houses, that destroyed the T-wall, forcing the coping and sidewalk to cantilever out by about 3 m (10 ft).

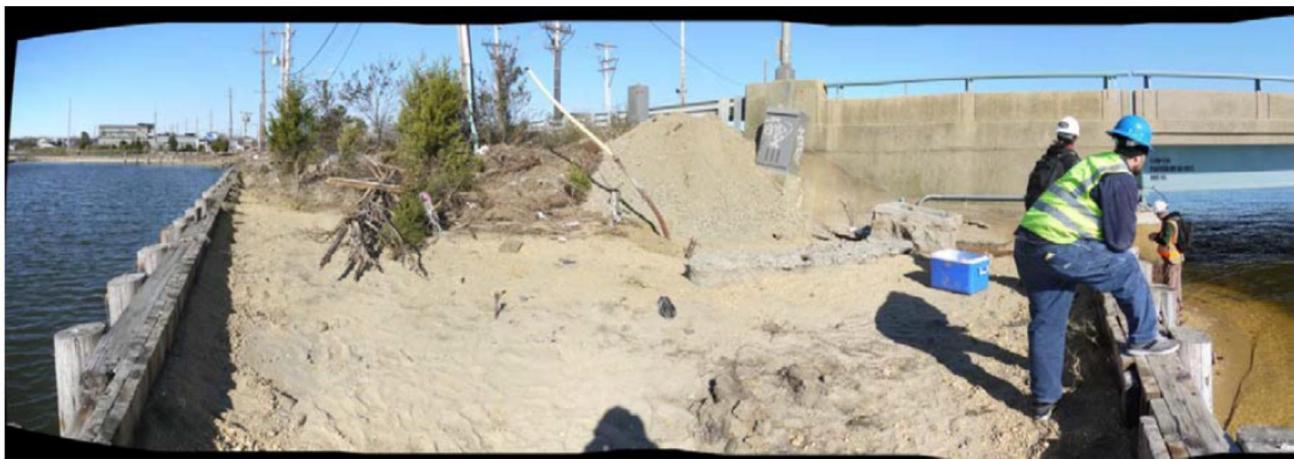
Figure 9. Erosion at Mathis Bridge southwest abutment (eastbound Rt37) ($39.949350^{\circ}\text{N}$, $74.113902^{\circ}\text{W}$; GEER 2014).

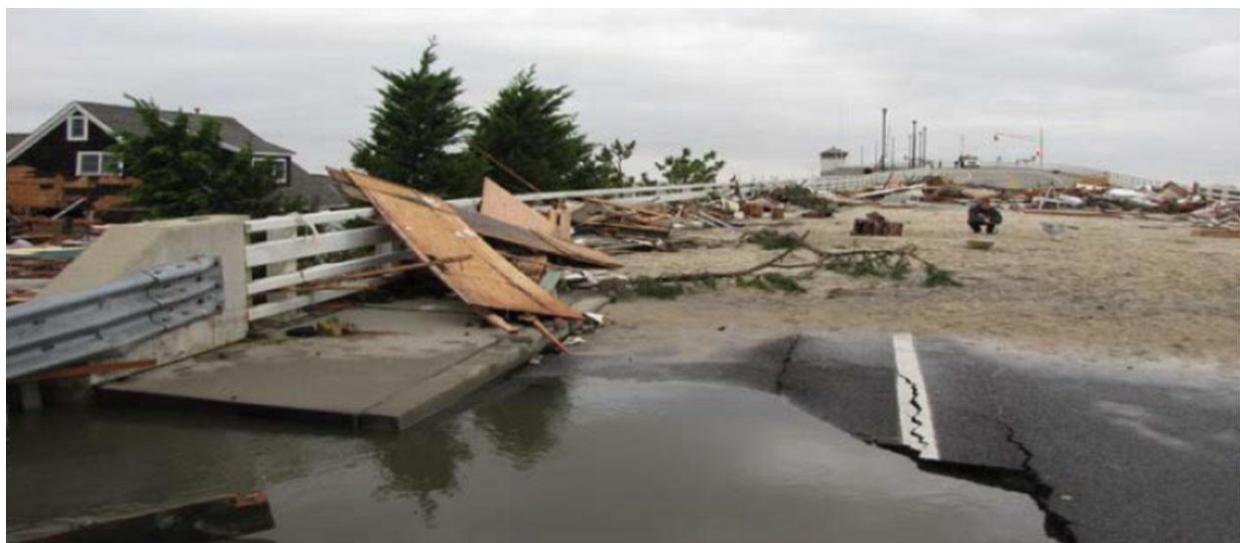
Figure 10. Foundation undermining at east abutment of Mantoloking Bridge ($40.040058^{\circ}\text{N}$, $74.051886^{\circ}\text{W}$; GEER, 2014).

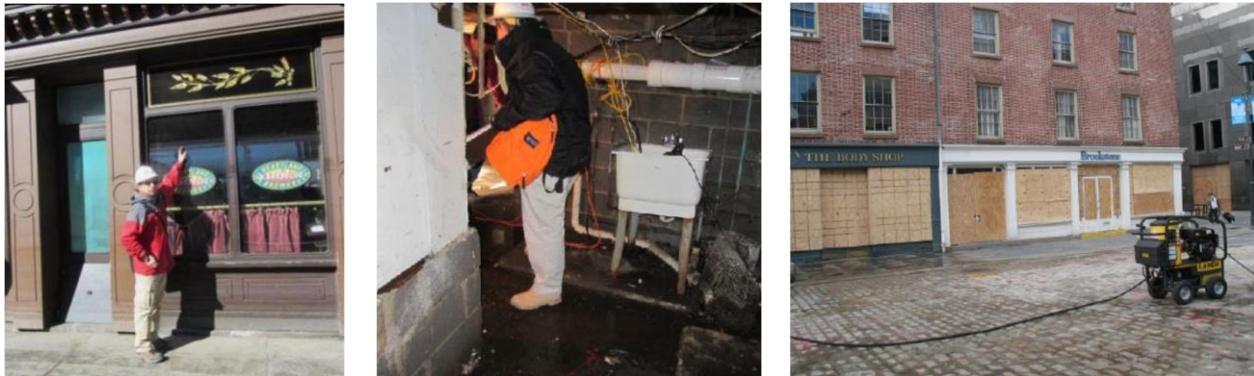
Figure 12. South Street Seaport (40.706685°N, 74.003554°W), 11/4/12: High water line on window of a restaurant (left); typical flooded basement (middle); flood damage (right). (GEER Report, 2014).

Damage in the dense urban NYC area of lower Manhattan was primarily related to flood inundation. High water marks and evidence of flood damage to approximately 1.2-2.1 m (4-7 ft) above street level were observed throughout low-lying neighborhoods (e.g., South Street Seaport) and water front areas (Fig. 12). Below-grade subway stations, tunnels, parking garages, and excavations experienced widespread flooding. While access to many of these locations was restricted to the GEER team due to ongoing recovery work, evidence of flood inundation was visible from the surface, e.g. at the Battery Park underpass and Bellevue Hospital. Based on reports in the days and months following the storm, the flooded tunnels included the Brooklyn Battery, Holland, and Queens-Midtown highway tunnels, the PATH rapid transit tunnels, NJ Transit / Amtrak / LI Railroad Hudson and East River rail, and seven subway tunnels. Several subway stations and open excavations were flooded, including South Ferry, which flooded to the ceiling, as well as an excavation at the World Trade Center site (Figs. 13-14).

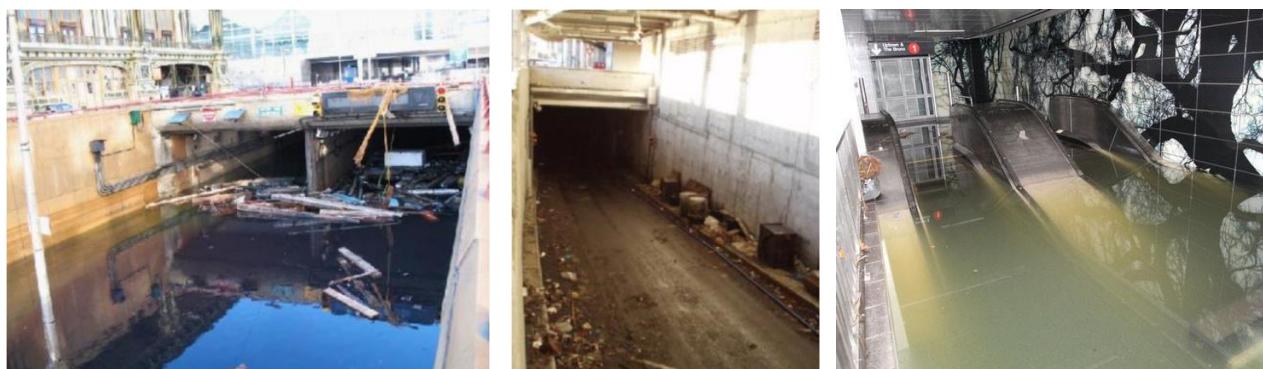
Figure 13. Flooded Battery Park underpass (40.701600°N, 74.011742°W) on 11/4/12 (left, by GEER 11/3/12); E30th St. (40.739830°N, 73.973263°W) Bellevue Hospital (middle, by GEER 11/3/12); South Ferry station (right, by MTA 10/30/12).

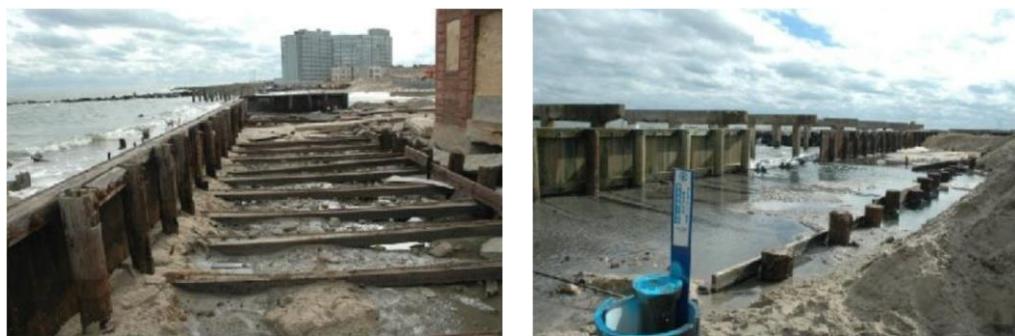
Figure 25. Bulkhead in Atlantic City, NJ: backfill soil washed away, exposing severely corroded tie rods (GEER, 2014).

along a section of the shore in Atlantic City, NJ, were breached.. The breaches were attributed to the destruction and washing away of the timber facing . The surge and water washing through the breaches exposed the tierods and anchors (Fig. 25).

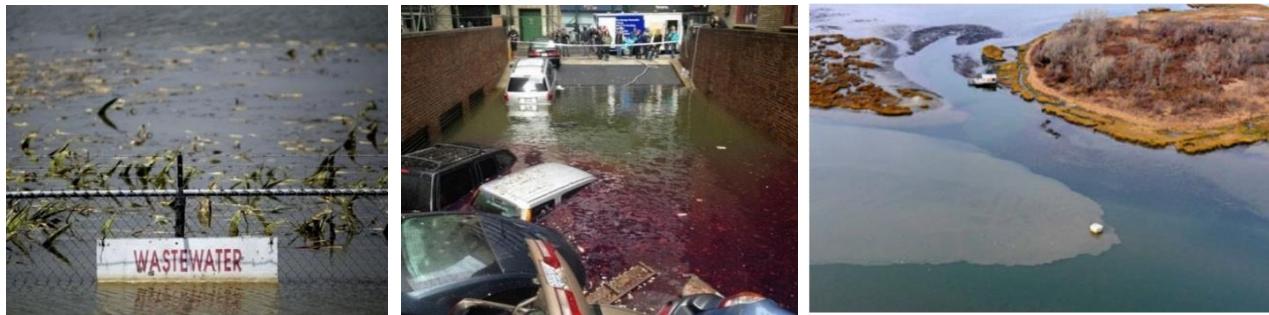
Figure 26. Untreated waste spilled in NY Harbor (left, photo Getty/Tama) and buried cars (middle, photo Bloomberg/Korby). Overflow from Bay Park Sewage Treatment Plant, East Rockaway (right, photo by D. Kuntz; Kenward et al., 2013).

to shut down or divert sewage into waterways due to power outages and flooding (e.g., Fig. 26 shows untreated waste spilled in the LI South Shore Estuary from the Bay Park Sewage Plant in East Rockaway). GEER visited the WWTP that processes waste water from Yonkers. Founded on filled land along the east bank of the Hudson River, it experienced one of the largest overflows with 4.5M m^3 (1.2B gallons). The river frontage has a rip-rap revetment at the south and a steel seawall (Fig. 27) about 1.5 m (5 ft) higher than the north rip-rap. Normally, the plant handles daily 360 m^3 (95M gallons) of waste water; during Hurricane Irene in 2011, it processed $1,150\text{ m}^3$ (300M gallons). After Sandy, loss of gravity flow caused more than 2.8 m (9 ft) of tail water and therefore flooding of below-grade areas (Fig. 27), something that damaged equipment including boilers, the alarm system, pipes, and motors.

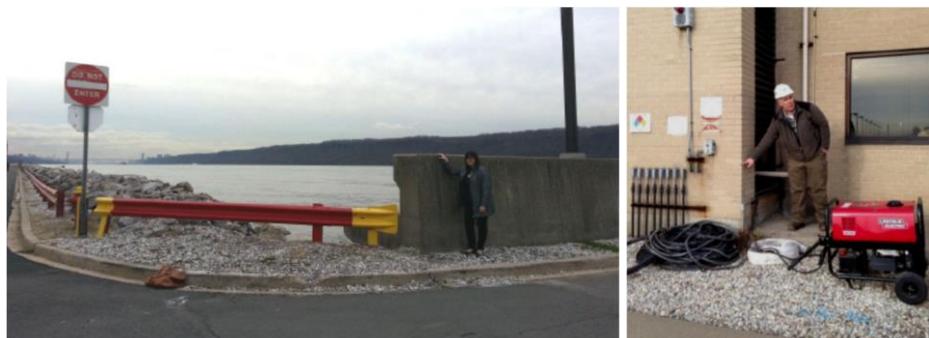
Figure 27. Yonkers Joint WWTP: junction of rip-rap revetment and seawall, looking south (left); vent grates in aeration blower building where water entered, with flood water elevation shown by plant superintendent (right); GEER (2014).
