Scour at the Seawall in Surfside, Texas, During Hurricane Harvey (2017)

ABSTRACT: Hurricane Harvey was a Category 4 hurricane on the Saffir-Simpson hurricane wind scale. National Oceanic and Atmospheric Administration (NOAA) water level gages documented 1.1 m of water level elevation over predicted tide in Freeport, Texas, on 25 – 26 August 2017. The NOAA wave buoy 42019 offshore off Freeport documented wave heights > 7 m. A reconnaissance team of the Geotechnical Extreme Events Reconnaissance (GEER) Association visited Surfside, Texas, on 3 September 2017. While no significant damage to infrastructure was observed, the GEER team identified a significant scour runnel parallel to the Surfside seawall. The purpose of this article is to present the detailed observations of the scour runnel parallel to the Surfside seawall during Hurricane Harvey (2017). The sloped seawall is separating a shore-parallel street from the beach and is composed of angular boulders of approximately 30-50 cm in diameter. The observed runnel represented a depression of up to ~ 0.3 m in depth and ~ 4 m in width. It maintained mostly a distance of 0-5 m from the visible toe of the seawall. Boulders seemed part

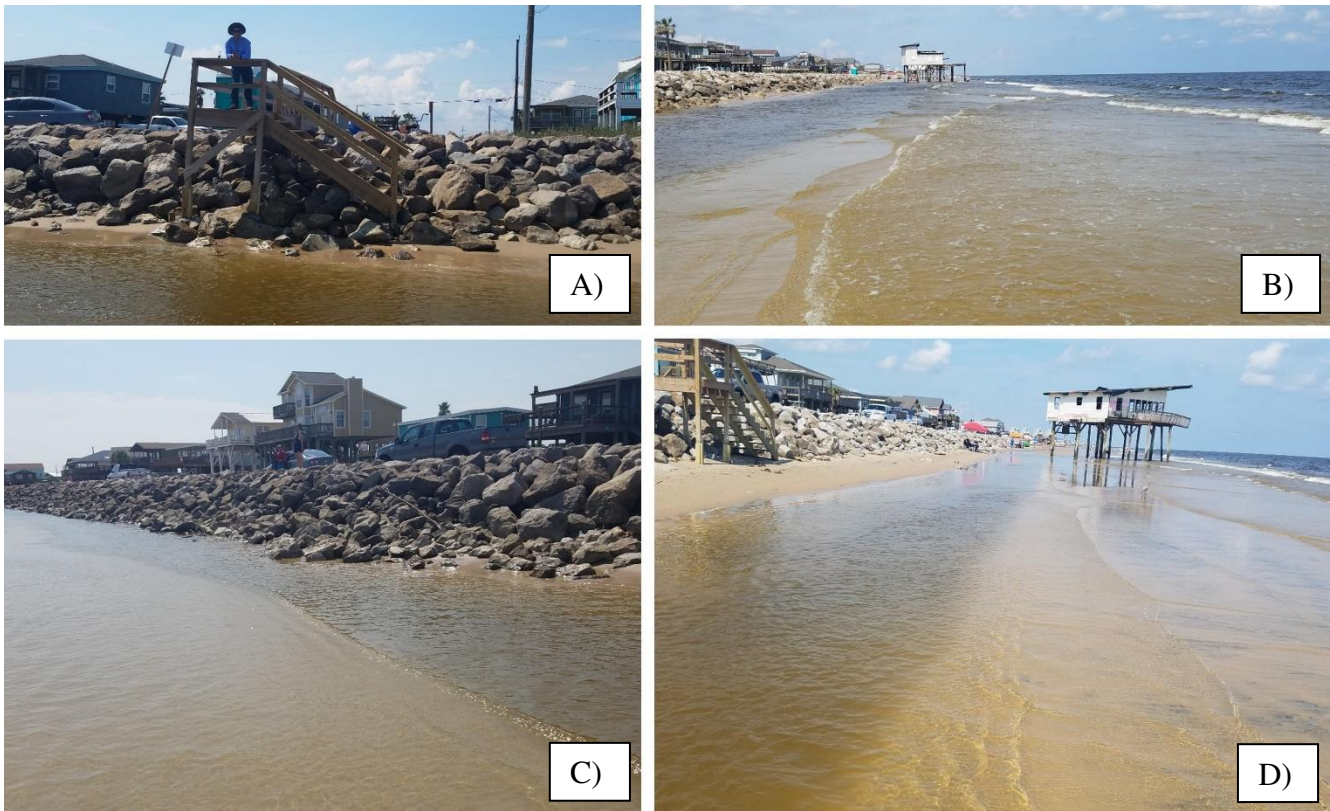
Figure 6. Seawall-beach-runnel-ridge system observed on yearday 246 at approximately 20:00 UTC (15:00 local time) at Surfside Beach, Texas. The following coordinates represent the position of the photographer for each image: A) and B) 28.9433°N 95.2920°W, C) 28.9434°N 95.2918°W, D) 28.9461°N 95.2890°W.

Small waves approached the beach at the time of the visit (Fig. 7 right). Offshore significant wave heights on that day were less than 0.5 m (Fig. 4). These small waves were visibly breaking at the offshore side of the flat ridge (Fig. 6 right) with a

swash bore running over the ridge and into the runnel (Fig. 6 right, Fig. 7). Wave reflection within the runnel seemed apparent, and little to no swash was observed at the onshore runnel edge (Figs. 6 and 7).

At the offshore runnel edge, a significant amount of sediment transport was observed, and recorded in an underwater video. Sand was mobilized from the edge and carried into the runnel, likely actively infilling the runnel, and decreasing the height of the ridge. This observation was also expressed in a sediment cloud and murkiness of water at the offshore runnel edge in Figure 6 (lower right).

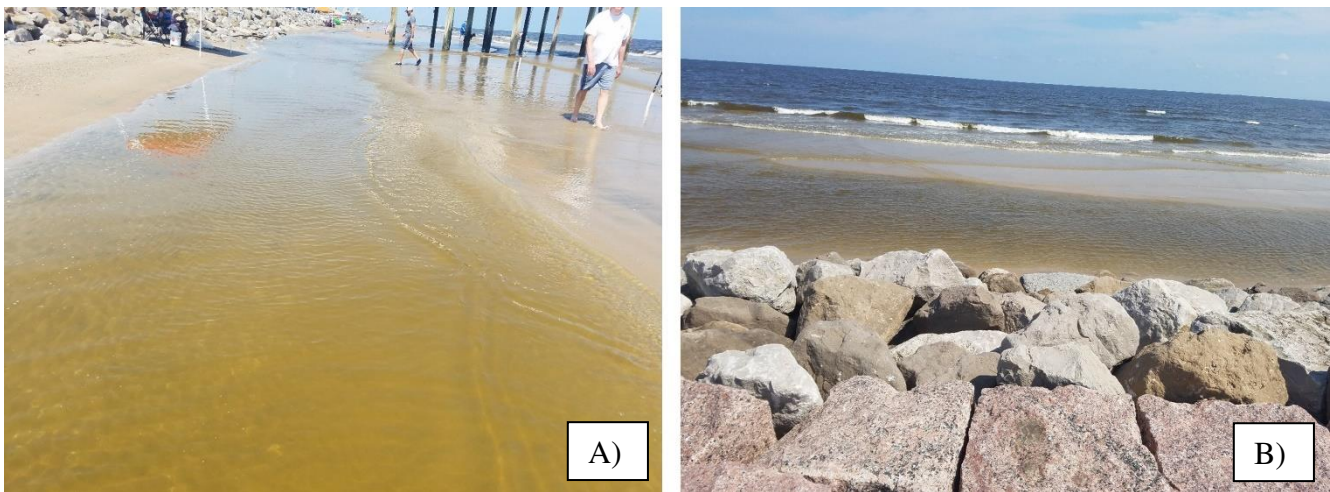
Figure 7. Seawall-beach-runnel-ridge system observed on yearday 246 at approximately 20:00 UTC (15:00 local time) at Surfside Beach, Texas. The following coordinates represent the position of the photographer for each image: A) 28.9460°N 95.2890°W, B) 28.9451°N 95.2903°W.

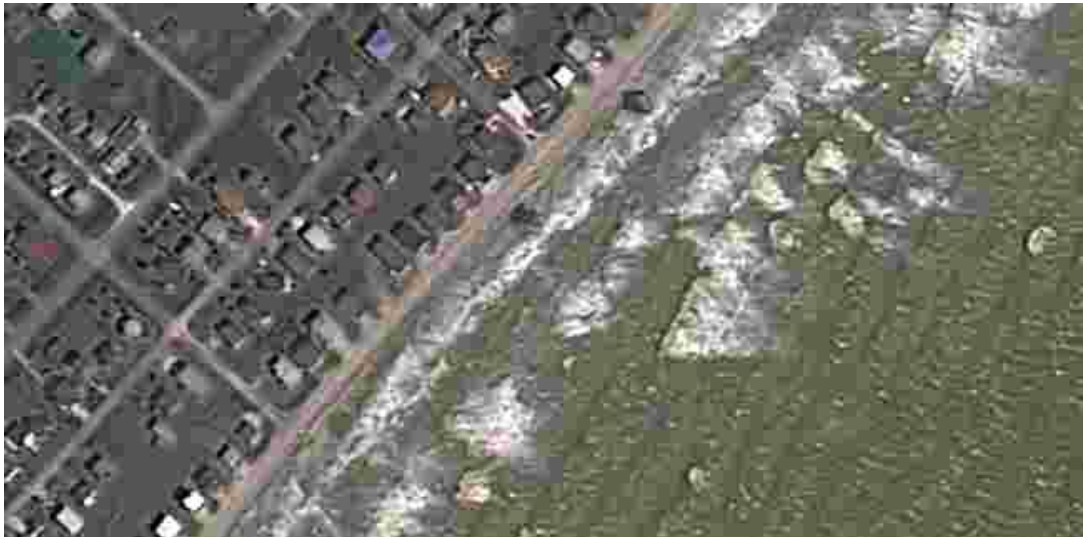
Figure 12 shows a satellite image from yearday 250, displaying clearly increased wave action. Nevertheless, the runnel seemed to be sustained during these wave conditions, and wave breaking closest to the shore appeared to occur along the previous location of the ridge. A second line of wave breaking appeared to be co-located with the previous second ridge. These observations may also be compared to the evolution and destruction of a shore-parallel bar system (e.g., as noted in Lippmann et al. 1989, Shand et al. 2001).

Figure 12. Satellite image from the area of interest collected on yearday 250 by KOMPSAT-2 with a resolution of 1 m.

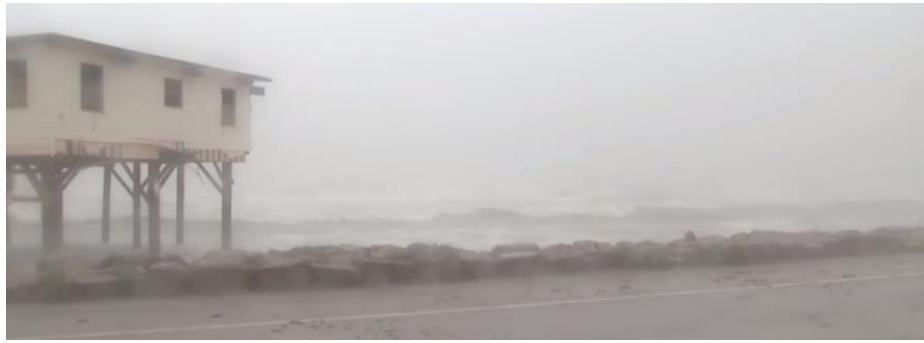
Sumer and Fredsoe (2002) depicted different flow processes leading to two-dimensional scour at seawalls: wave breaking near the wall, wave breaking on the wall, wave reflection, and overtopping of the seawall. News outlets presented video footage from Surfside Beach from yearday 237 with no visible overtopping of the seawall, but rather waves breaking offshore of the beach house structures (Fig. 13). While the video footage provided limited images of the beach, it suggested that wave breaking on the wall and overtopping of the seawall were unlikely. Even wave breaking near the seawall seems unlikely based on the video footage, the shallow water conditions, and an overall flat nearshore slope. Therefore, wave reflection after initial wave breaking may be a likely mechanism. Sumer and Fredsoe (2002) depicted that in the case of a rubble-mound breakwater and dominant bedload transport, sediment deposition (formation of a ridge) occurs at the nodes of a standing wave resulting from wave reflection. Nodes and antinodes (i.e., runnel and ridge) have a distance of a quarter of a wave length, and in the case of a sloped rubble-mound wall the first antinode in contact with the wall is practically located on the sloped surface of the seawall. This means the seawall slope impacts the location of the runnels and ridges. Furthermore, sediment suspension changes the organization pattern. However, dominant near-bed transport may be an acceptable assumption, considering the shallow water depth. Another impact on the ridge-runnel profile is wave irregularity, which also likely contributed to the longshore variability in addition to some minor local variations in seawall slope.

Figure 13. Screenshot from video footage from Surfside Beach on yearday 237 extracted and modified after Henry (2017).
