Scour at the Seawall in Surfside, Texas, During Hurricane Harvey (2017)

Reference: Stark N., Shafii I., Jafari N., Ravichandran N., Figlus J., Smallegan S. M., and Bassal P. (2020). Scour at the Seawall in Surfside, Texas, During Hurricane Harvey (2017). International Journal of Geoenvironmental Engineering Case Histories, Volume 5, Issue 4, pp. 62-76, doi: 10.4417/IJGCH-05-04-04

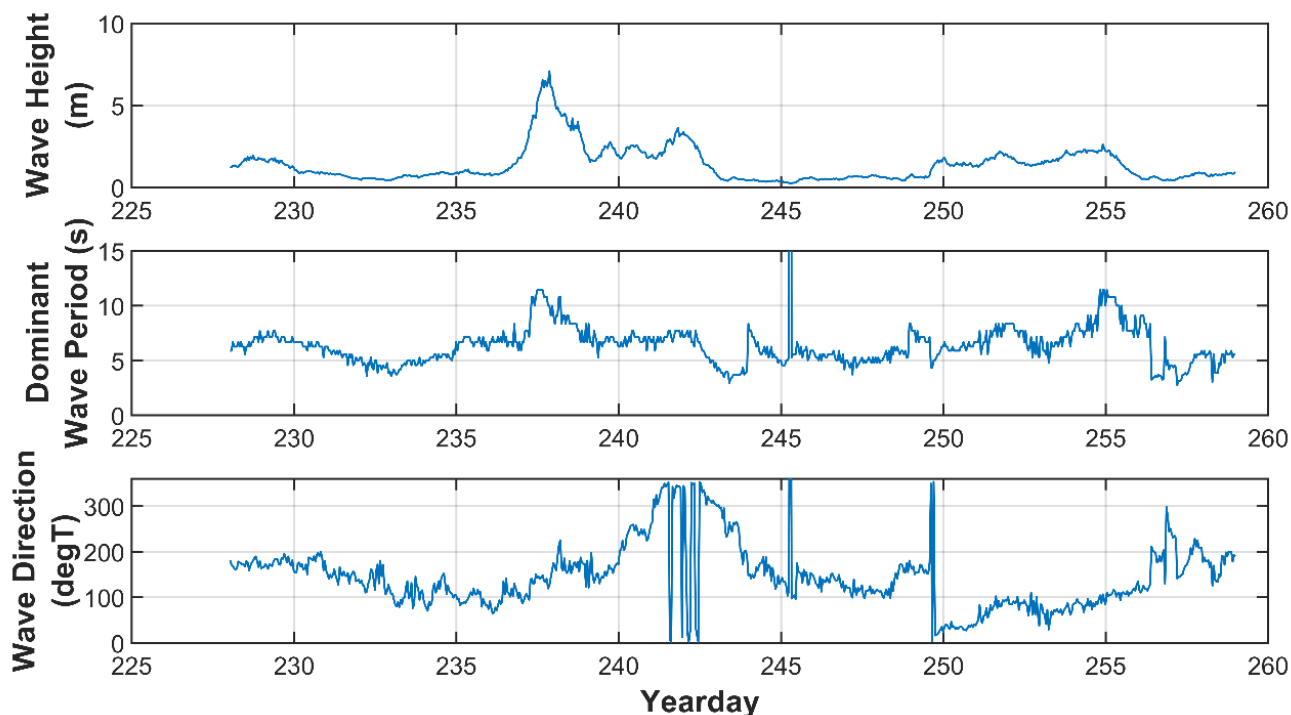
Figure 5. Significant wave heights (top panel), dominant wave periods (center panel), and wave direction (bottom panel) at NOAA station 42019 south of Freeport, Texas, (28.907°N 95.359°W) from 16 August 2017 (yearday 228) to 15 September 2017 (yearday 258).

Wave data were collected at NOAA station 42019 (LLNR 1205), being located 60 nautical miles south of Freeport at a water depth of ~ 82 m (Fig. 5). The measured values can be considered deep-water conditions. Wave heights were generally low in the investigated month with significant offshore wave heights mostly < 2 m, and wave periods ~ 5.5 s. On yearday 238, significant wave heights of ~ 7m with dominant wave periods of ~ 11 s were recorded, followed by significant wave heights of 2-4 m with dominant wave periods of 7-9 s until yearday 243. Waves came mostly from the South (~ 180°) during the event, and turned to the opposite direction toward the end of the wave event.
