# Scour at the Seawall in Surfside, Texas, During Hurricane Harvey (2017)

**ABSTRACT:** Hurricane Harvey was a Category 4 hurricane on the Saffir-Simpson hurricane wind scale. National Oceanic and Atmospheric Administration (NOAA) water level gages documented 1.1 m of water level elevation over predicted tide in Freeport, Texas, on 25 – 26 August 2017. The NOAA wave buoy 42019 offshore off Freeport documented wave heights > 7 m. A reconnaissance team of the Geotechnical Extreme Events Reconnaissance (GEER) Association visited Surfside, Texas, on 3 September 2017. While no significant damage to infrastructure was observed, the GEER team identified a significant scour runnel parallel to the Surfside seawall. The purpose of this article is to present the detailed observations of the scour runnel parallel to the Surfside seawall during Hurricane Harvey (2017). The sloped seawall is separating a shore-parallel street from the beach and is composed of angular boulders of approximately 30-50 cm in diameter. The observed runnel represented a depression of up to ~ 0.3 m in depth and ~ 4 m in width. It maintained mostly a distance of 0-5 m from the visible toe of the seawall. Boulders seeme

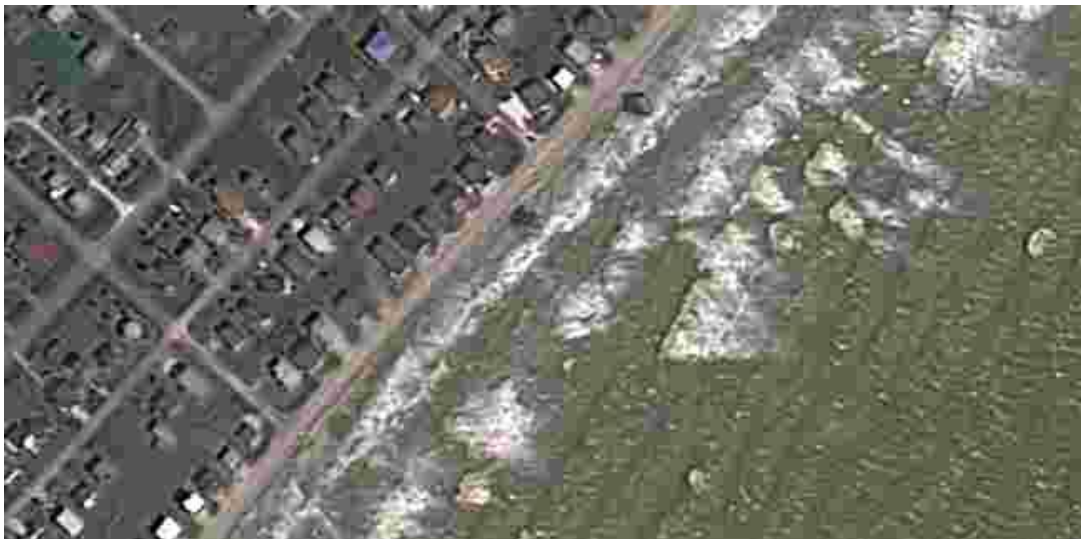
*Figure 12. Satellite image from the area of interest collected on yearday 250 by KOMPSAT-2 with a resolution of 1 m.*

Figure 12 shows a satellite image from yearday 250, displaying clearly increased wave action. Nevertheless, the runnel seemed to be sustained during these wave conditions, and wave breaking closest to the shore appeared to occur along the previous location of the ridge. A second line of wave breaking appeared to be co-located with the previous second ridge. These observations may also be compared to the evolution and destruction of a shore-parallel bar system (e.g., as noted in Lippmann et al. 1989, Shand et al. 2001).
