# Scour at the Seawall in Surfside, Texas, During Hurricane Harvey (2017)

**ABSTRACT:** Hurricane Harvey was a Category 4 hurricane on the Saffir-Simpson hurricane wind scale. National Oceanic and Atmospheric Administration (NOAA) water level gages documented 1.1 m of water level elevation over predicted tide in Freeport, Texas, on 25 – 26 August 2017. The NOAA wave buoy 42019 offshore of Freeport documented wave heights > 7 m. A reconnaissance team of the Geotechnical Extreme Events Reconnaissance (GEER) Association visited Surfside, Texas, on 3 September 2017. While no significant damage to infrastructure was observed, the GEER team identified a significant scour runnel parallel to the Surfside seawall. The purpose of this article is to present the detailed observations of the scour runnel parallel to the Surfside seawall during Hurricane Harvey (2017). The sloped seawall is separating a shore-parallel street from the beach and is composed of angular boulders of approximately 30-50 cm in diameter. The observed runnel represented a depression of up to ~ 0.3 m in depth and ~ 4 m in width. It maintained mostly a distance of 0-5 m from the visible toe of the seawall. Boulders seemed

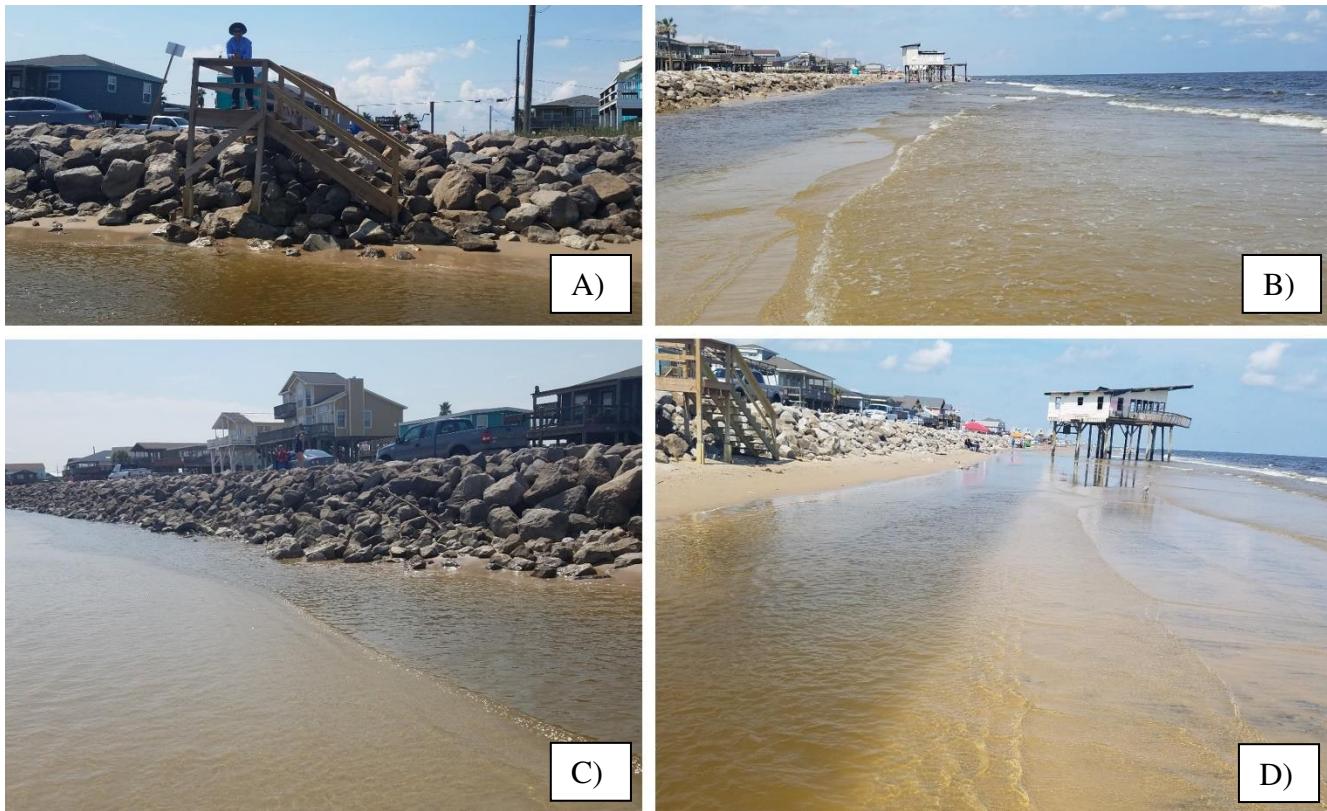
Figure 6. Seawall-beach-runnel-ridge system observed on yearday 246 at approximately 20:00 UTC (15:00 local time) at Surfside Beach, Texas. The following coordinates represent the position of the photographer for each image: A) and B)  $28.9433^{\circ}\text{N } 95.2920^{\circ}\text{W}$ , C)  $28.9434^{\circ}\text{N } 95.2918^{\circ}\text{W}$ , D)  $28.9461^{\circ}\text{N } 95.2890^{\circ}\text{W}$ .

Small waves approached the beach at the time of the visit (Fig. 7 right). Offshore significant wave heights on that day were less than 0.5 m (Fig. 4). These small waves were visibly breaking at the offshore side of the flat ridge (Fig. 6 right) with a

swash bore running over the ridge and into the runnel (Fig. 6 right, Fig. 7). Wave reflection within the runnel seemed apparent, and little to no swash was observed at the onshore runnel edge (Figs. 6 and 7).

At the offshore runnel edge, a significant amount of sediment transport was observed, and recorded in an underwater video. Sand was mobilized from the edge and carried into the runnel, likely actively infilling the runnel, and decreasing the height of the ridge. This observation was also expressed in a sediment cloud and murkiness of water at the offshore runnel edge in Figure 6 (lower right).

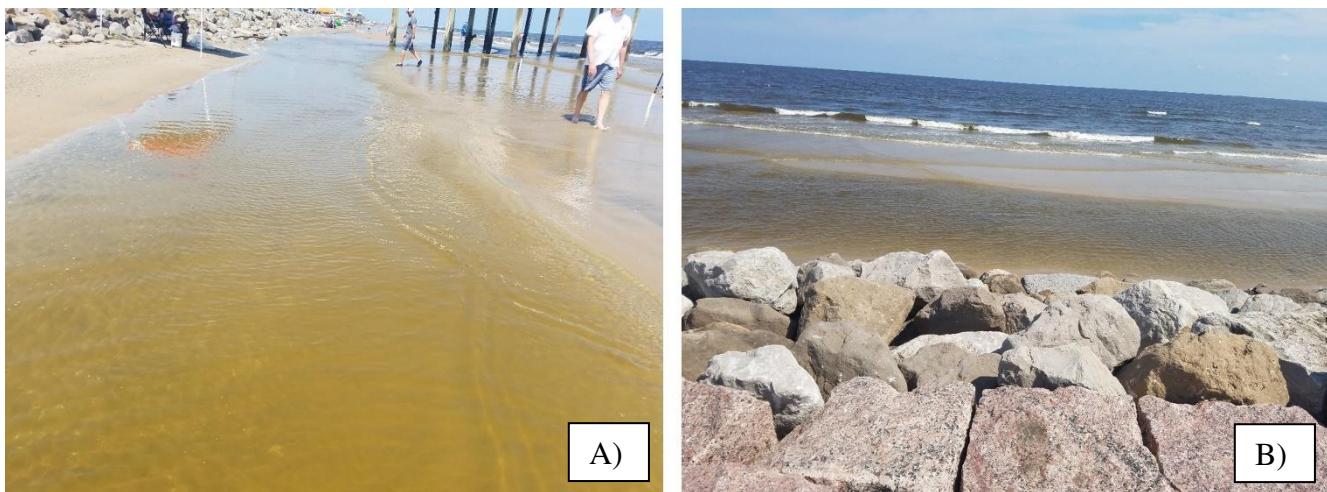
Figure 7. Seawall-beach-runnel-ridge system observed on yearday 246 at approximately 20:00 UTC (15:00 local time) at Surfside Beach, Texas. The following coordinates represent the position of the photographer for each image: A)  $28.9460^{\circ}\text{N } 95.2890^{\circ}\text{W}$ , B)  $28.9451^{\circ}\text{N } 95.2903^{\circ}\text{W}$ .

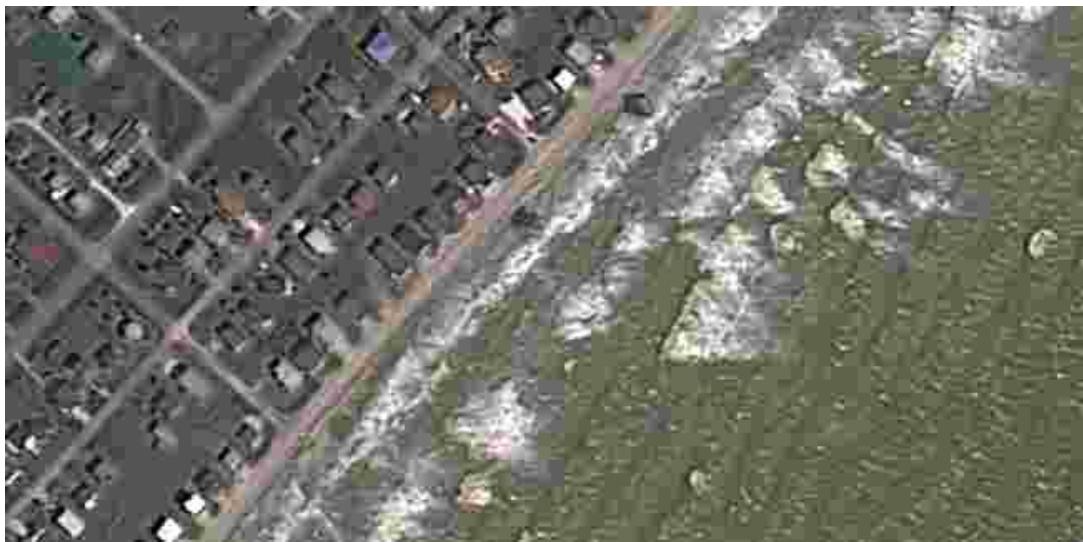
*Figure 12. Satellite image from the area of interest collected on yearday 250 by KOMPSAT-2 with a resolution of 1 m.*

Figure 12 shows a satellite image from yearday 250, displaying clearly increased wave action. Nevertheless, the runnel seemed to be sustained during these wave conditions, and wave breaking closest to the shore appeared to occur along the previous location of the ridge. A second line of wave breaking appeared to be co-located with the previous second ridge. These observations may also be compared to the evolution and destruction of a shore-parallel bar system (e.g., as noted in Lippmann et al. 1989, Shand et al. 2001).

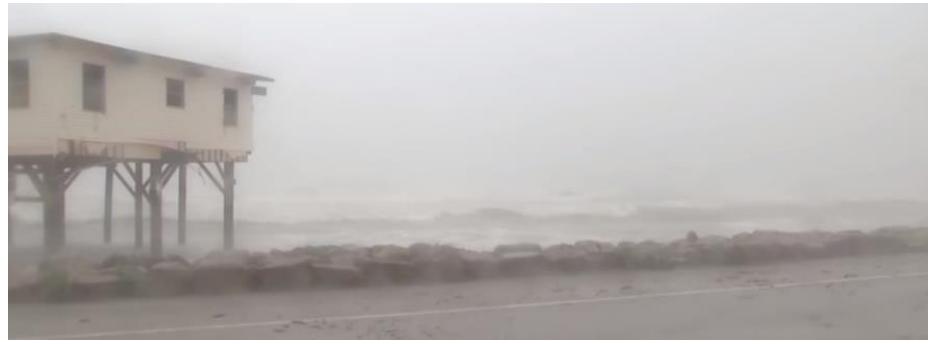
Figure 13. Screenshot from video footage from Surfside Beach on yearday 237 extracted and modified after Henry (2017).

Sumer and Fredsoe (2002) depicted different flow processes leading to two-dimensional scour at seawalls: wave breaking near the wall, wave breaking on the wall, wave reflection, and overtopping of the seawall. News outlets presented video footage from Surfside Beach from yearday 237 with no visible overtopping of the seawall, but rather waves breaking offshore of the beach house structures (Fig. 13). While the video footage provided limited images of the beach, it suggested that wave breaking on the wall and overtopping of the seawall were unlikely. Even wave breaking near the seawall seems unlikely based on the video footage, the shallow water conditions, and an overall flat nearshore slope. Therefore, wave reflection after initial wave breaking may be a likely mechanism. Sumer and Fredsoe (2002) depicted that in the case of a rubble-mound breakwater and dominant bedload transport, sediment deposition (formation of a ridge) occurs at the nodes of a standing wave resulting from wave reflection. Nodes and antinodes (i.e., runnel and ridge) have a distance of a quarter of a wave length, and in the case of a sloped rubble-mound wall the first antinode in contact with the wall is practically located on the sloped surface of the seawall. This means the seawall slope impacts the location of the runnels and ridges. Furthermore, sediment suspension changes the organization pattern. However, dominant near-bed transport may be an acceptable assumption, considering the shallow water depth. Another impact on the ridge-runnel profile is wave irregularity, which also likely contributed to the longshore variability in addition to some minor local variations in seawall slope.
