## A Constructability Problem in a Deep Shoring System

Reference: Köpüklü H., Ekli O., Akçakal Ö., Durgunoğlu H. T. (2021). A Constructability Problem in a Deep Shoring System. International Journal of Geoengineering Case Histories, Volume 6, Issue 1, pp. 53-66, doi: 10.4417/IJGCH-06-01-03

study of the design and construction details of the waterproof retaining wall for the seven levels of basement which required an excavation depth of 30.0m.

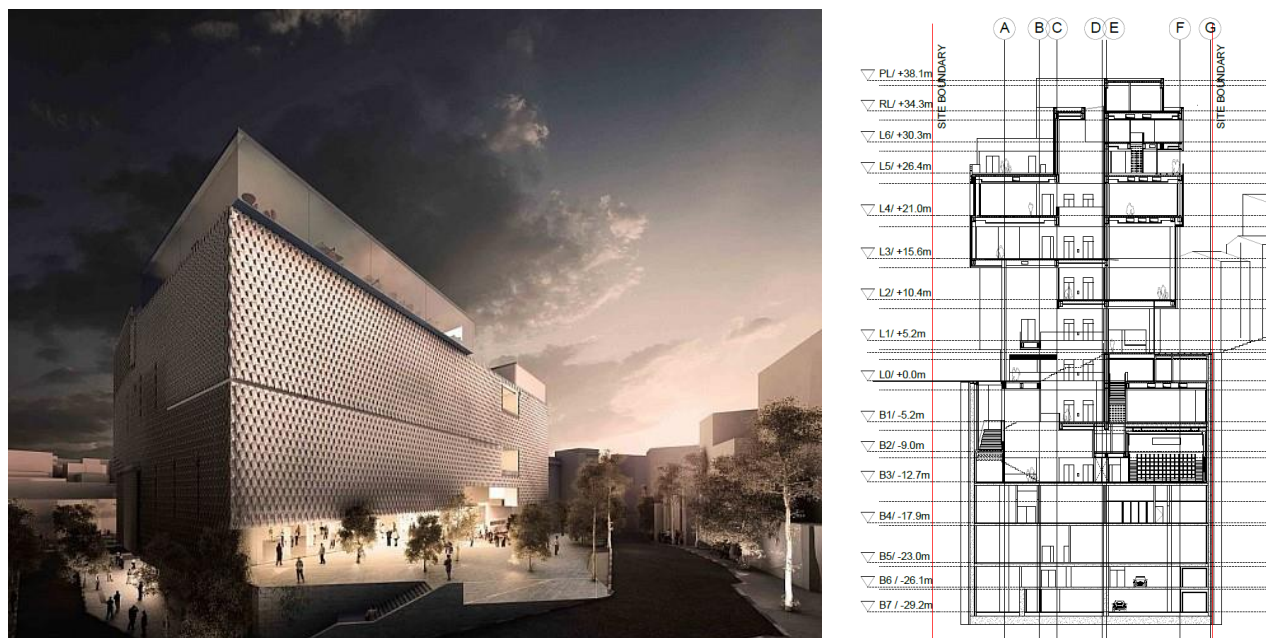
Figure 1. Architectural View and Section of Building.

The subject site is at the Dolapdere District of İstanbul, covering an area of approximately 3397.0m<sup>2</sup> with additional green areas. The project area is located at Dereboyu Street, and is surrounded by Can Eriği, Yeni Bostan, and Keresteci Ali Streets. After the demolition of the old existing building, plans are made for a contemporary gallery with 7 stories and 7 basements to be constructed. The gallery covers approximately 1214.0m<sup>2</sup> area, with 18621.0m<sup>2</sup> total construction area. According to the conveyed information the architectural  $\pm 0.00\text{m}$  elevation will be as +22.00m. The foundation depth is 31.2m and base elevation will be -9.15m. The architectural view and cross section of the building is given in Figure 1.

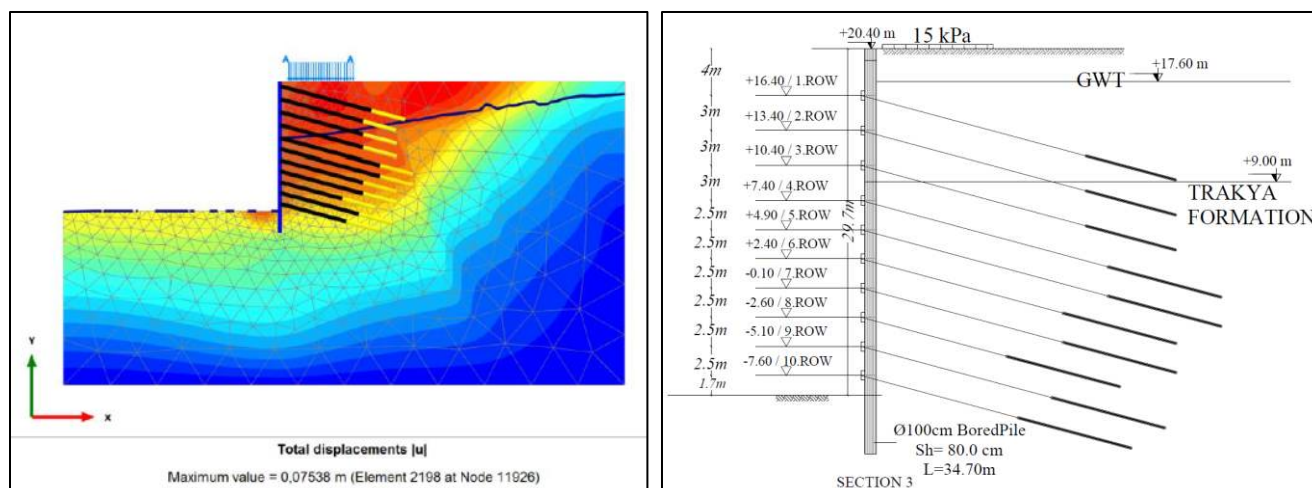
Figure 7. Section View of the Retaining System.

Three types of anchors were used for the calculations. Type 1 has 4.0m-20.0m free length, 8.0m grout length, at a 15° angle from the horizontal placed with 3.20m spacing in alluvial units. The other two are located in the rock unit. The first has 20.0m free length, 8.0m grout length, at a 15° angle from the horizontal (Type 2) placed with 1.6m spacing. The second has 17.0m-22.0m free length, 10.0m grout length, at a 15° angle from the horizontal (Type 3) placed with 1.6m spacing. Ten (10) levels of prestressed anchor rows are considered in the analysis.

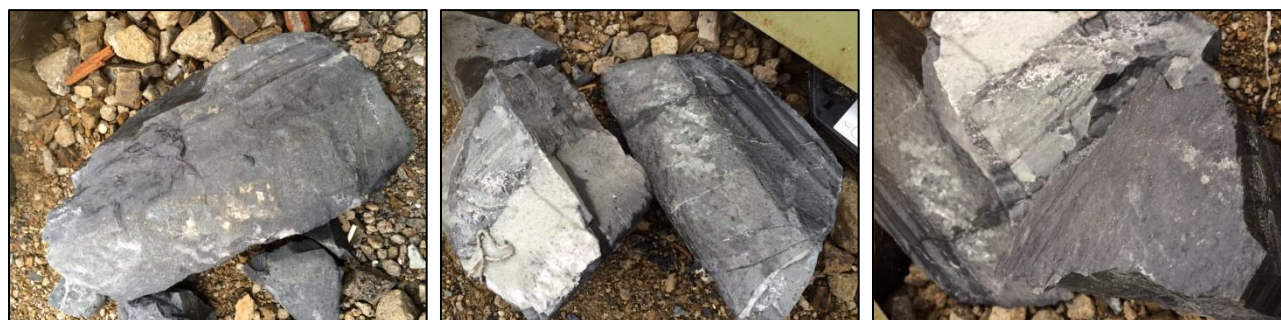
Figure 8. Encountered Diabase Units.

During the pile installation, it was observed that the strength of the Trakya Formation rock units fared better than expected, especially below the 25.0m depth (-4.6m elevation). The progress rate of the drilling unit was controlled regularly for each pile; it is shown that the progress rate was less than 1.0m/hour after 25.0m depth. Additionally, magmatic origin diabase blocks were encountered after a certain depth.

Diabase, also called Dolerite, is a fine- to medium-grained, dark gray to black intrusive igneous rock. It is extremely hard and tough and compositionally equivalent to gabbro and basalt but is texturally between them. It occurs mostly in shallow intrusions (dikes and sills) of basaltic composition. It grades to basalt when it solidifies rapidly and to gabbro when more time is provided for the crystals to grow.

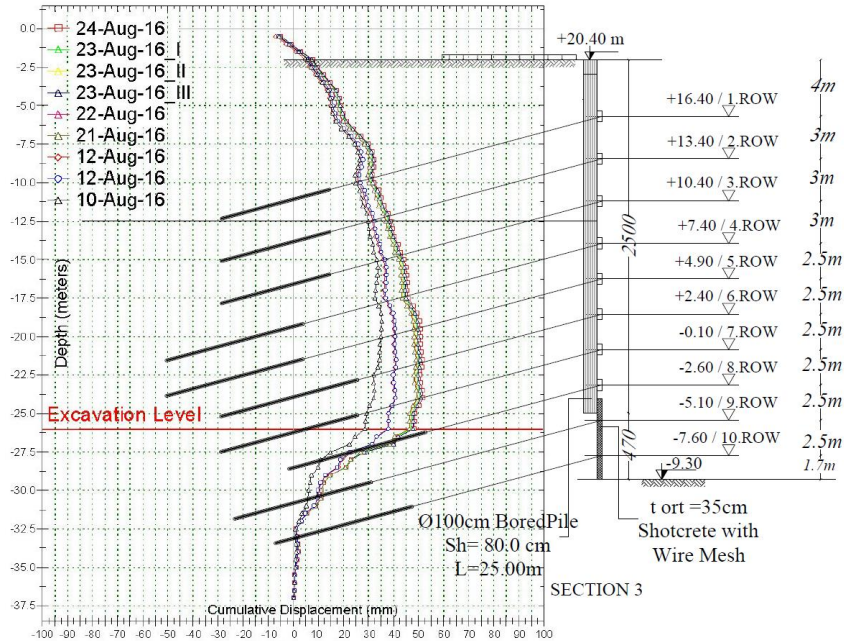
Figure 10. Encountered Excessive Displacements on Section 3.

In the excavation phase of Section 3, the lateral displacement exceeded the critical limit (45mm) in the middle of August 2016. Following immediate discussion by the client, contractor, and project engineers, mitigation measures were determined.

In the second half of August 2016, toe filling was carried out up to the middle of 6<sup>th</sup> and 7<sup>th</sup> row prestressed anchor levels (19.25m depth, +1.15m elevation), and six additional prestressed anchors (each 32.0m in length) were installed.

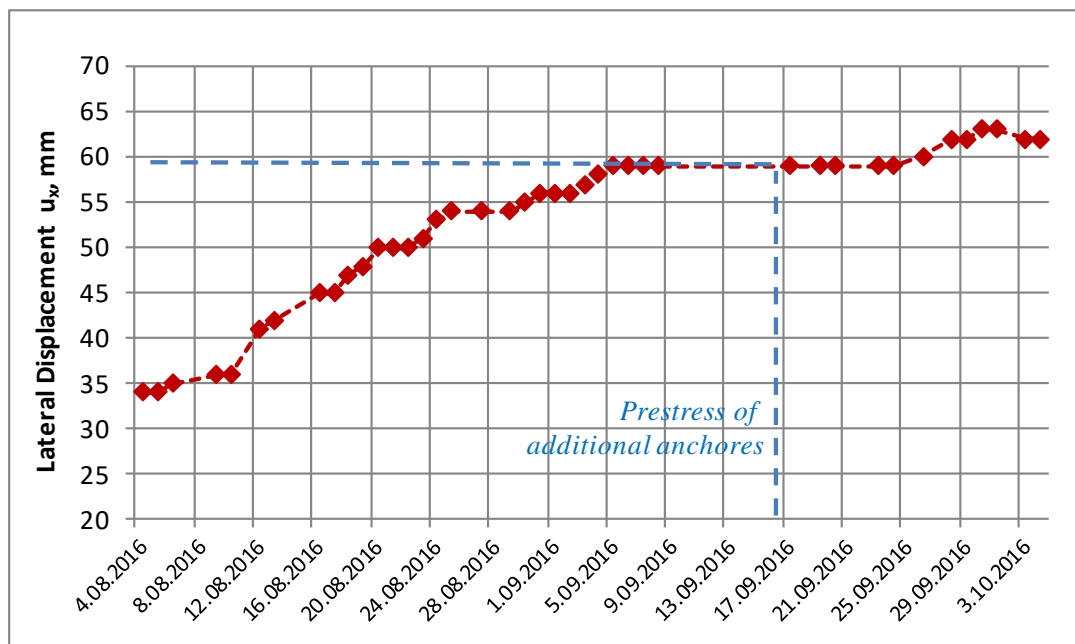
Figure 12. Section 3 Lateral Displacements.

During the prestressing of the additional anchors on September 17<sup>th</sup>, 2016, the lateral displacement was measured as 58.0mm. Due to the stage excavation of 9<sup>th</sup> row anchors, the lateral displacement was increased to 62.0mm on September 26<sup>th</sup>, 2016. From the completion of the stage excavation till October 4<sup>th</sup>, 2016, inclinometer readings were regularly collected and it was observed that the increase of the lateral displacement stopped. The graph of the measured lateral displacements between the -22.5m and -25m elevations of Section 3 is presented in Figure 12.
