A Constructability Problem in a Deep Shoring System

Reference: Köpüklü H., Ekli O., Akçakal Ö., Durgunoğlu H. T. (2021). A Constructability Problem in a Deep Shoring System. International Journal of Geoengineering Case Histories, Volume 6, Issue 1, pp. 53-66, doi: 10.4417/IJGCH-06-01-03

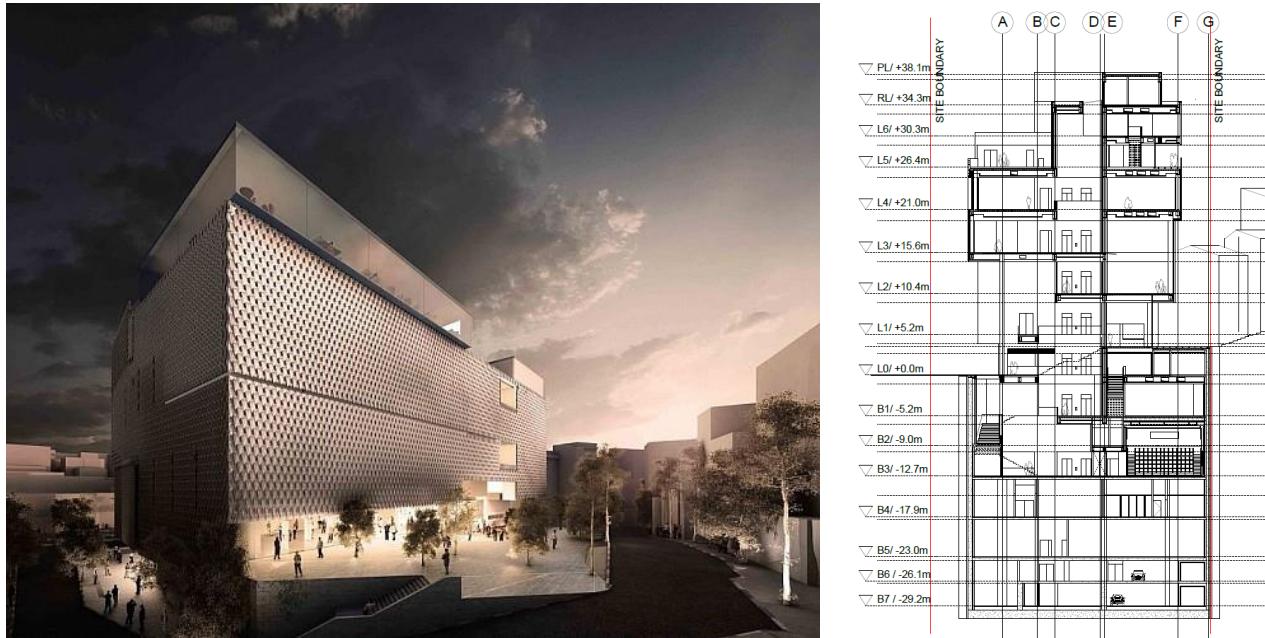
Figure 1. Architectural View and Section of Building.

The subject site is at the Dolapdere District of Istanbul, covering an area of approximately 3397.0m² with additional green areas. The project area is located at Dereboyu Street, and is surrounded by Can Eriği, Yeni Bostan, and Keresteci Ali Streets. After the demolition of the old existing building, plans are made for a contemporary gallery with 7 stories and 7 basements to be constructed. The gallery covers approximately 1214.0m² area, with 18621.0m² total construction area. According to the conveyed information the architectural ±0.00m elevation will be as +22.00m. The foundation depth is 31.2m and base elevation will be -9.15m. The architectural view and cross section of the building is given in Figure 1.

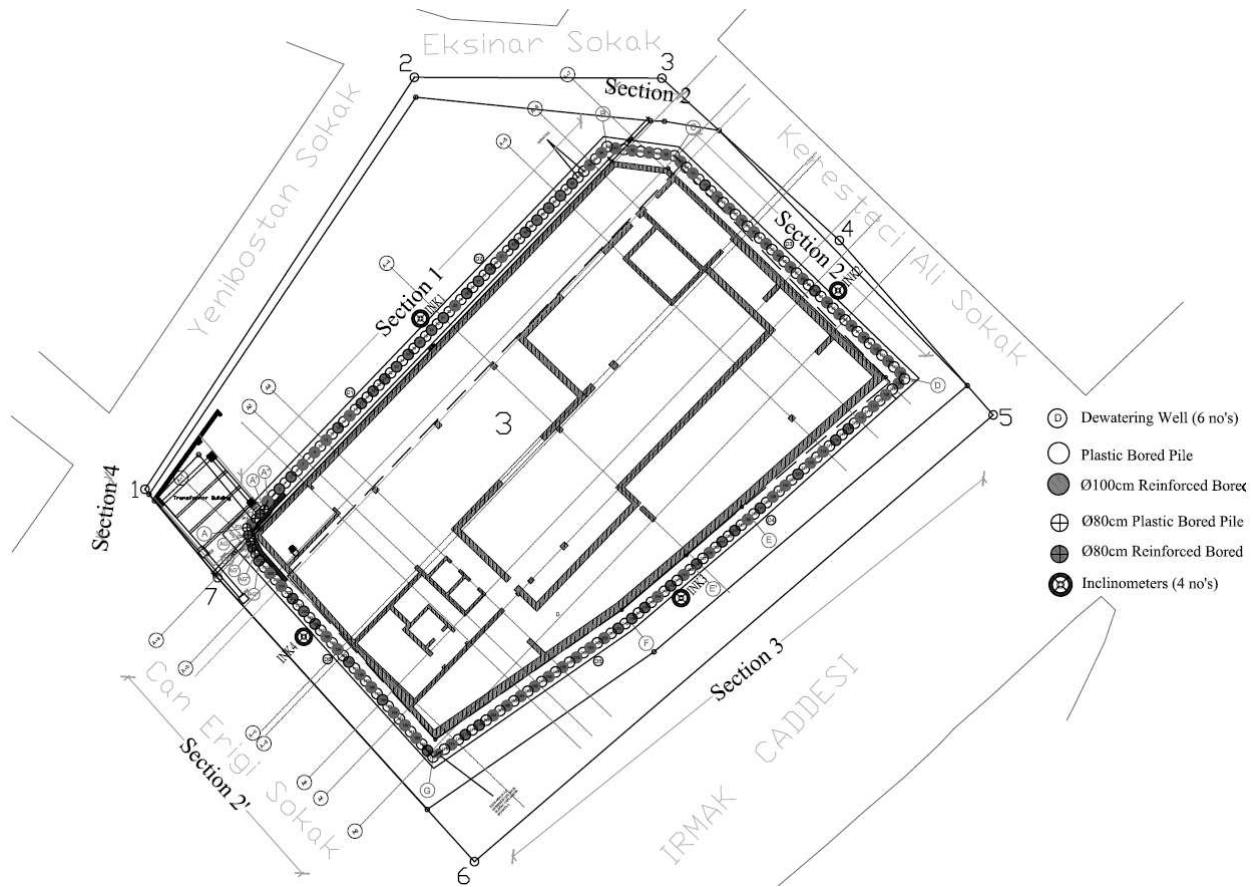
Figure 6. The Plan View of the Retaining System.

In all sections, the diameters of the secant piles are 1.0m with 0.2m overlapping. The lengths of the piles are 34.7m. However, due to the lack of sufficient construction area, the diameter of the secant piles was reduced to 80cm with 0.1m-0.2m overlapping where the transformer building exists. The plan view of the retaining wall is presented in Figure 6.

As can be seen from Figure 6, four inclinometer boreholes were drilled around the project site and used to measure lateral displacements of the soil/rock mass behind the secant pile wall. Measurements for inclinometers were taken for each construction phase and at frequent intervals during the construction period.

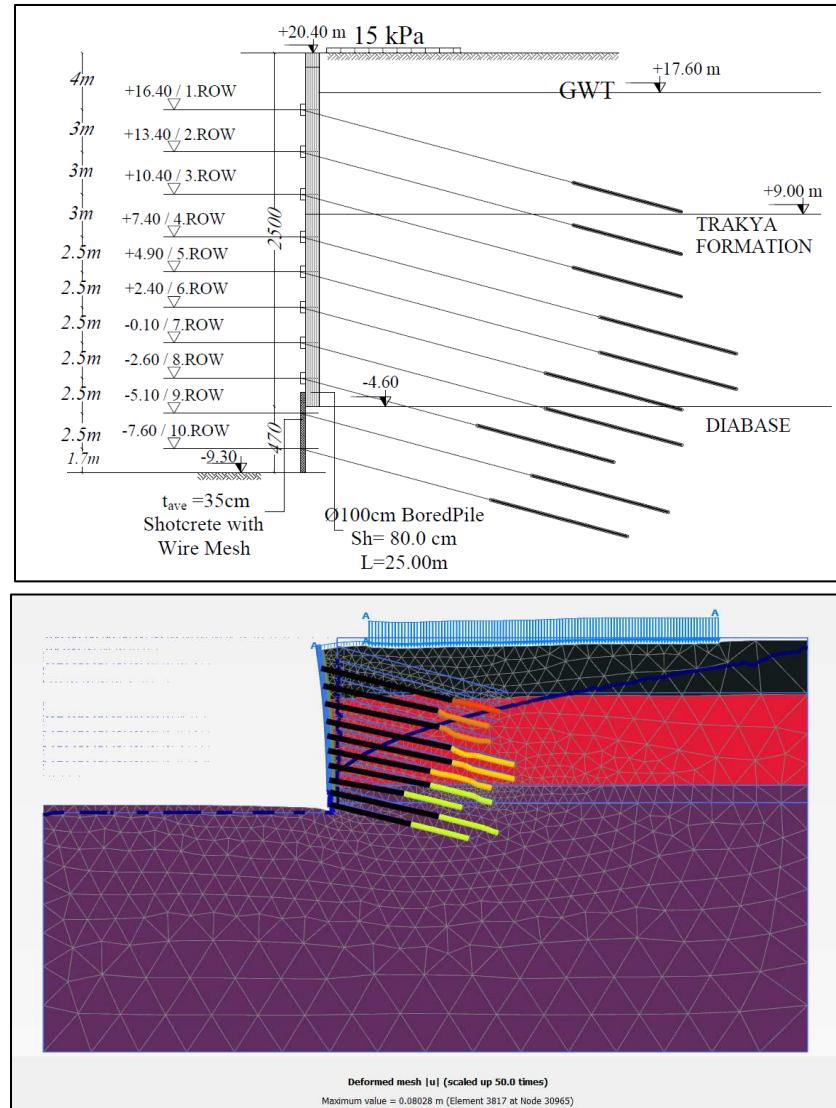
Figure 9. Section View of the Revised Retaining System.

Considering the aforementioned reasons, due to the challenges encountered in such hard units, the design of the retaining system was revised. The length of secant bored piles was reduced to 25.0m and the remaining part of the excavation was designed to be supported by shotcrete with wire mesh having thickness, t , equal to 35cm.

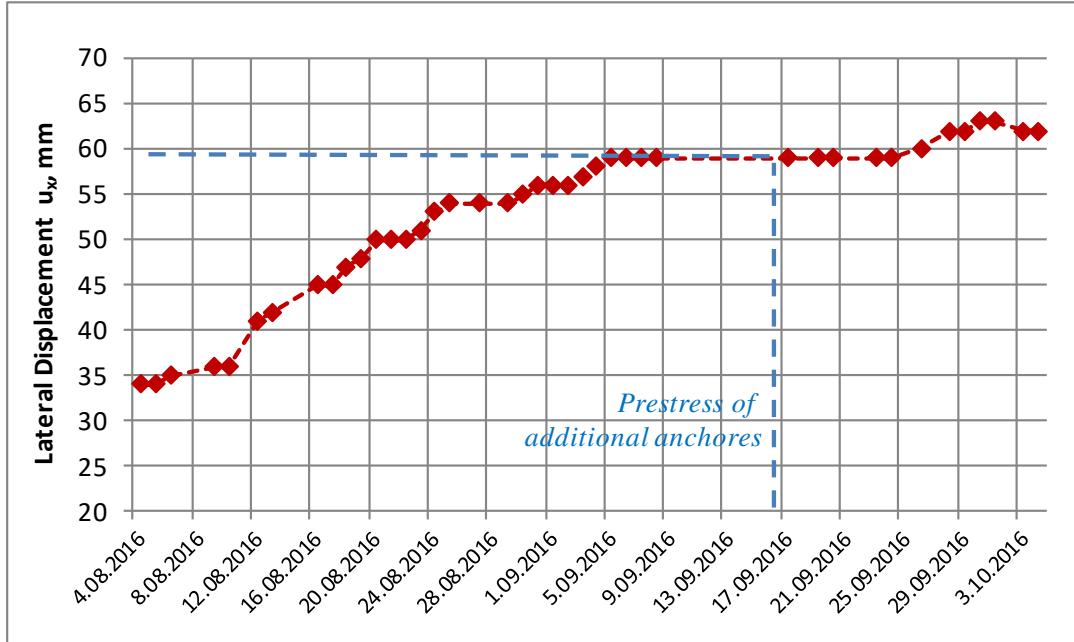
Figure 12. Section 3 Lateral Displacements.

During the prestressing of the additional anchors on September 17th, 2016, the lateral displacement was measured as 58.0mm. Due to the stage excavation of 9th row anchors, the lateral displacement was increased to 62.0mm on September 26th, 2016. From the completion of the stage excavation till October 4th, 2016, inclinometer readings were regularly collected and it was observed that the increase of the lateral displacement stopped. The graph of the measured lateral displacements between the -22.5m and -25m elevations of Section 3 is presented in Figure 12.
