A Constructability Problem in a Deep Shoring System

Reference: Köpüklü H., Ekli O., Akçakal Ö., Durgunoğlu H. T. (2021). A Constructability Problem in a Deep Shoring System. International Journal of Geoengineering Case Histories, Volume 6, Issue 1, pp. 53-66, doi: 10.4417/IJGCH-06-01-03

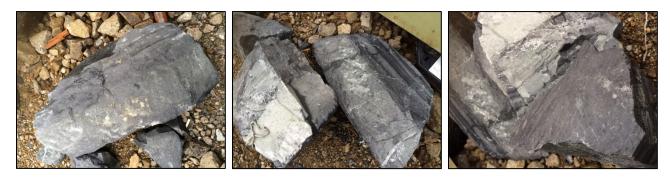
Figure 8. Encountered Diabase Units.

During the pile installation, it was observed that the strength of the Trakya Formation rock units fared better than expected, especially below the 25.0m depth (-4.6m elevation). The progress rate of the drilling unit was controlled regularly for each pile; it is shown that the progress rate was less than 1.0m/hour after 25.0m depth. Additionally, magmatic origin diabase blocks were encountered after a certain depth.

Diabase, also called Dolerite, is a fine- to medium-grained, dark gray to black intrusive igneous rock. It is extremely hard and tough and compositionally equivalent to gabbro and basalt but is texturally between them. It occurs mostly in shallow intrusions (dikes and sills) of basaltic composition. It grades to basalt when it solidifies rapidly and to gabbro when more time is provided for the crystals to grow.

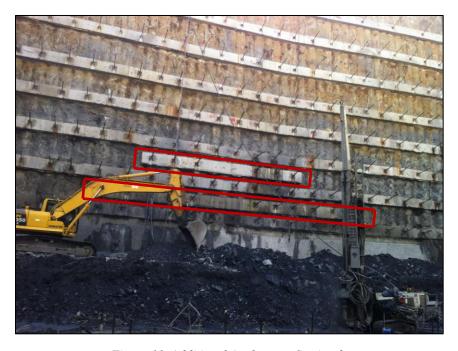
Figure 11. Additional Anchors on Section 3.

At the beginning of September 2016, excessive lateral displacements were observed again in the inclinometer readings. An additional ten prestressed anchors, each 32.0m in length, were also implemented between the 7th and 8th row anchor levels. A frontal view of Section 3 is shown in Figure 11.
