The Multi-Purpose Bottom Plug for the Galataport Project

Salvatore Miranda, Technical Manager, TREVI Turkey, Istanbul (Turkey); email: smiranda@trevispa.com

ABSTRACT: The paper describes an innovative geotechnical engineering solution that was provided by TREVI for the renovation project at Galataport in Istanbul, Turkey. Among other interesting geotechnical works included in the project, this paper also presents the design considerations and construction of the multi-purpose bottom plug (MPBP). This original geotechnical engineering solution was employed for a three-basement excavation in Karaköy and consists of a combination of seepage control, ground improvement, and load bearing elements, which were executed with double-fluid jet grouting, pseudo-elliptical jet grouting, and permanent micropiles, respectively. The paper describes each step of the design, execution, and the preliminary and final testing phases. Moreover, it highlights the importance of employing cutting-edge technologies used in deep foundation geo-construction and state-of-the-art electronic control devices, along with expertise, to obtain the desired results for this high-profile project.

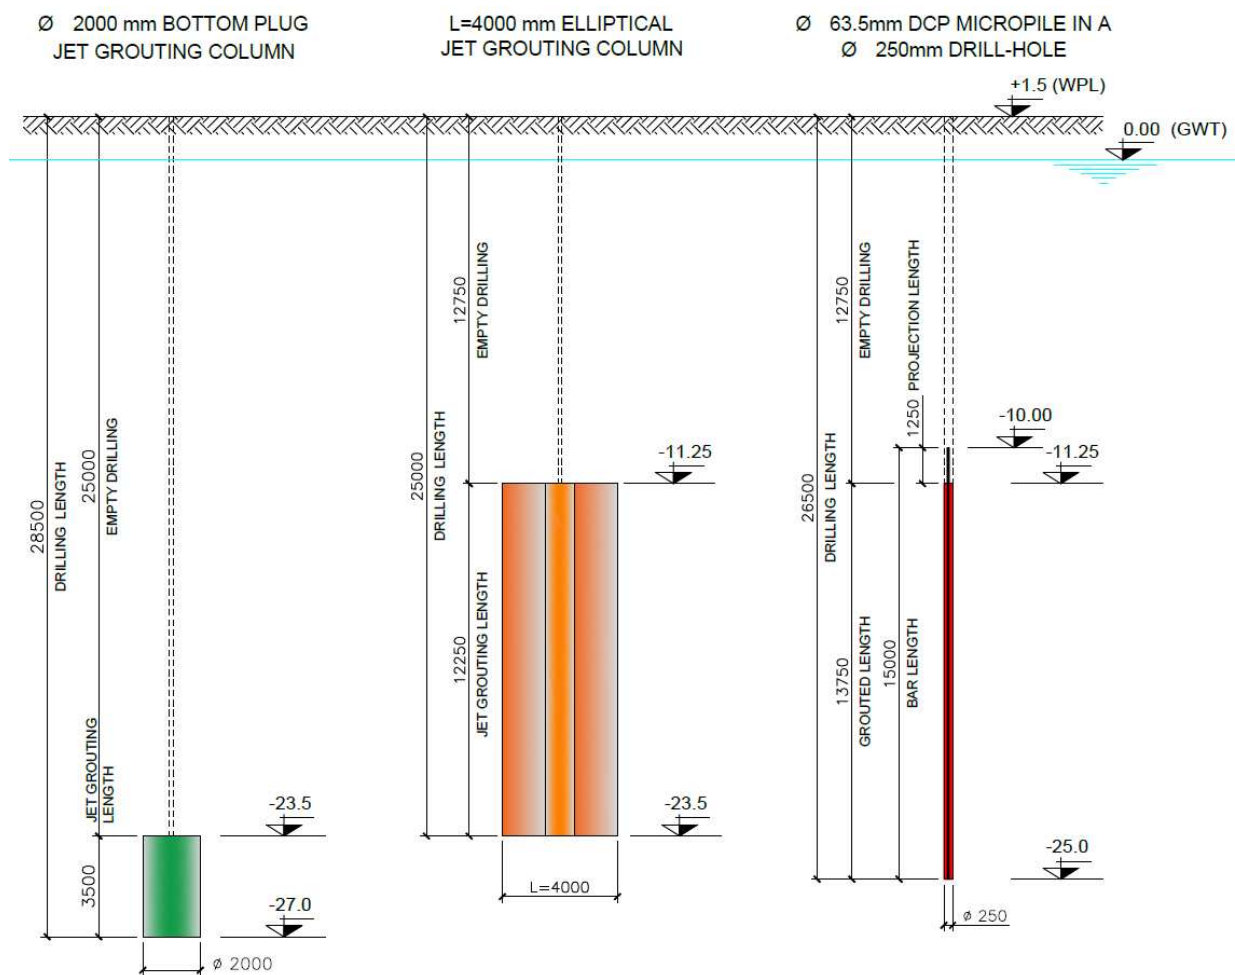
Figure 12. Details of single MPBP element – Vertical section.

The stability against uplift is ensured by the permanent DCP steel bars, which are installed as drilled-and-grouted micropiles through the previously-executed elliptical jet grout columns. The DCP steel bars have a diameter of 63.5 mm and are installed within a 250 mm diameter drill hole. The system is designed with the uplift force acting in the temporary condition (only the three basement floors constructed), which represents the worst scenario.

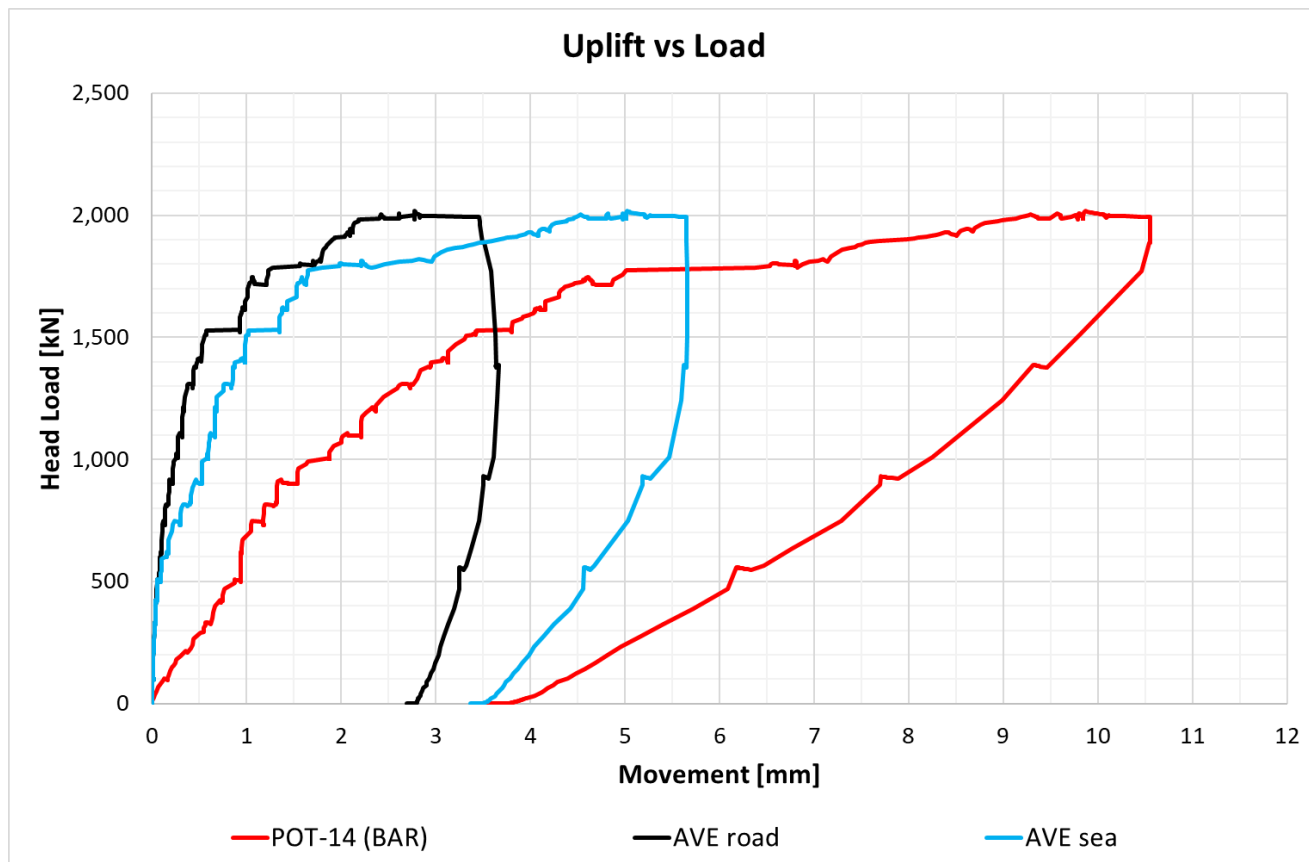
Figure 31. Tension load test results - Measured uplift.

The results of head displacement showed a non-uniform uplift of the jet grouting column, which varied between 3.5 and 5.6 mm, while the maximum uplift measured on the DCP steel bar was 10.5 mm (Figures 31 and 32). This is possibly due to the irregular shape and mechanical properties of the jet grouting column or to the presence of lean concrete above the jet grouting.

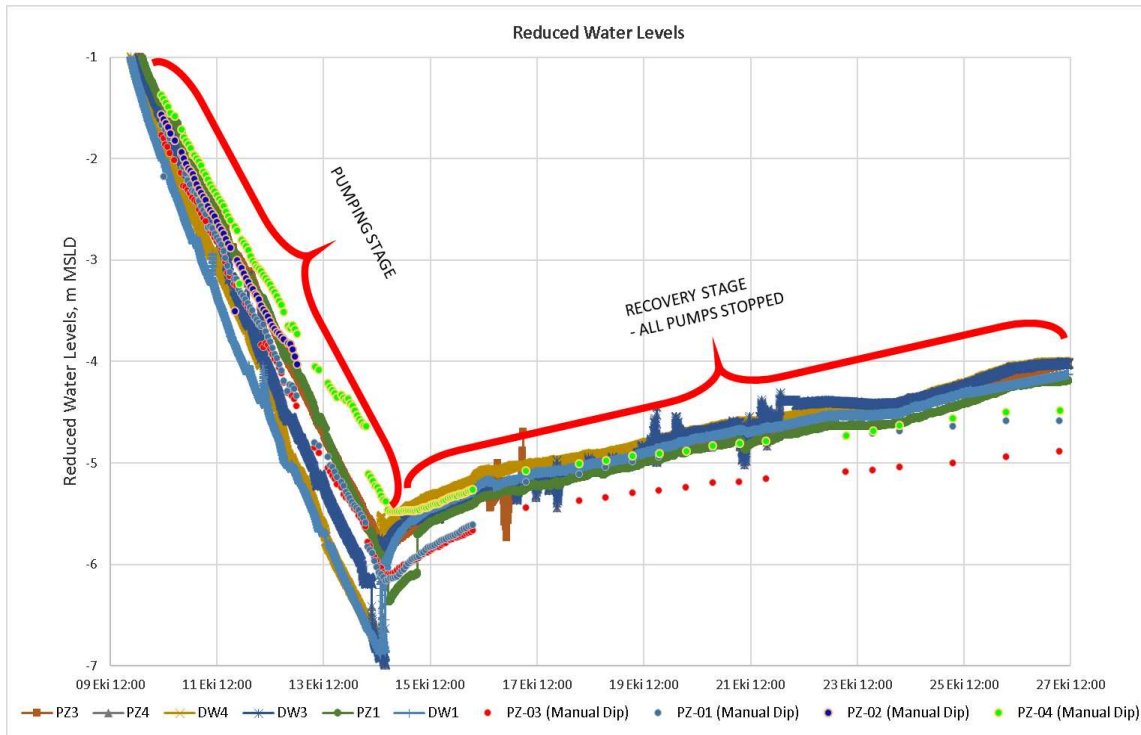
Figure 43. Water levels during pumping test.

The drawdown phase was run from 9 to 14 October 2017, and the groundwater table was lowered from the original El. 0.00 msl to around El. -5.0 msl. The recharge phase followed. In addition to the manual readings, the water level in three deepwells (DW-1-3-4) and three piezometers (PZ-1-3-4) was automatically measured by means of level loggers. The two phases can be separated and the trendlines generated. The manual and automatic readings taken during the drawdown phase are shown in Figures 44 and 45 and relevant trendlines have an average slope of -1 m/day, showing that for every one day period, there is a 1 m drop in water level. During the recharge phase, a slope between 0.05 and 0.07 m/day was measured with manual readings (Figure 46), while 0.10 to 0.12 m/day was measured by the automatic level logger (Figure 47).

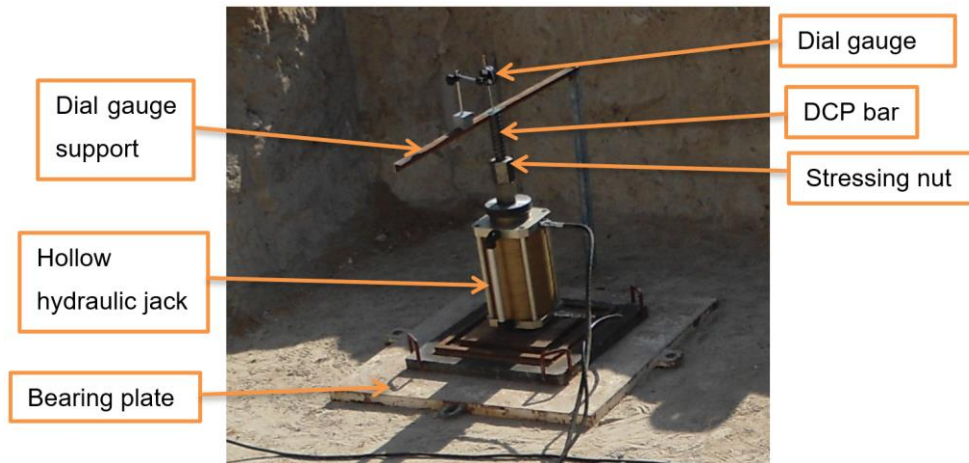
Figure 51. Typical arrangement of acceptance test.

Once the final excavation level was reached, all permanent micropiles were subjected to acceptance testing up to 125% of the design working load (test load of 1,731 kN and design working load of 1,385 kN) to evaluate the micropile response. The typical acceptance test arrangement is shown in Figure 51.
