The Multi-Purpose Bottom Plug for the Galataport Project

Salvatore Miranda, Technical Manager, TREVI Turkey, Istanbul (Turkey); email: smiranda@trevispa.com

Reference: Miranda S. (2020). The Multi-Purpose Bottom Plug for the Galataport Project. International Journal of Geoengineering Case Histories, Volume 6, Issue 1, pp. 1-36, doi: 10.4417/IJGCH-06-01-01

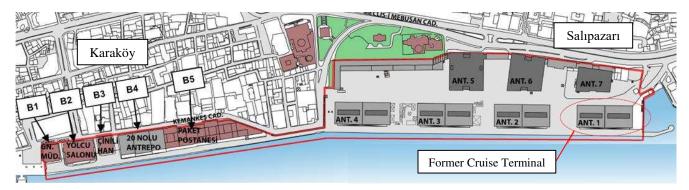
Figure 3. Schematic view of the original site condition, with highlighted existing buildings.

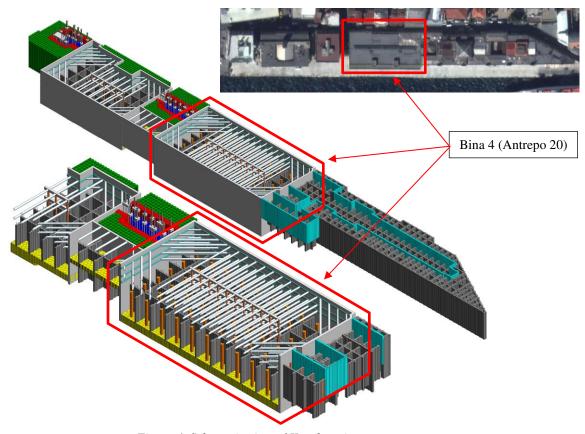
Figure 4. Schematic view of Karaköy site.

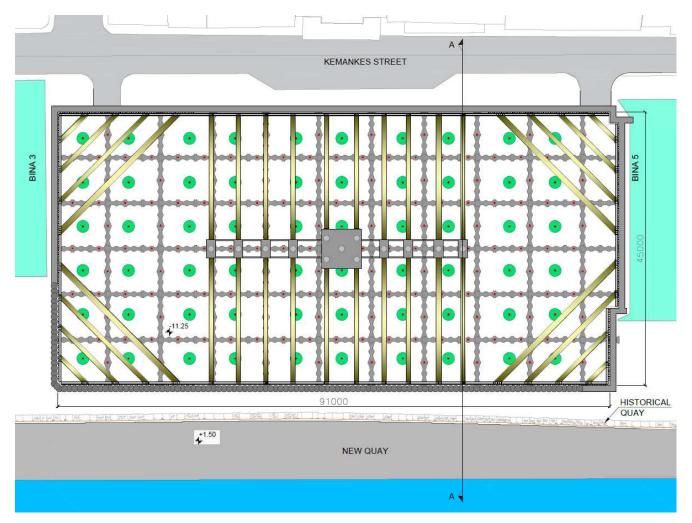
Figure 8. Plan view of Bina 4 geotechnical works.

The three basement floors in Bina 4 have a rectangular footprint of about 45 m x 90 m in plan and a design excavation depth of 12.65 m, which is 11.25 m below sea level (Figures 8 and 9). The related excavation had to be conducted in a very confined area, which presented many associated risks. For example, on the two short sides of the excavation, there were two historical buildings: Bina 3 and Bina 5. The clear distance between the shoring system and the buildings was less than 0.5 m. On the landside of the excavation, Kemankeş Street is located only a few meters away from the shoring system and there are historical buildings that are 5 to 8 stories high on the opposite side of the road, at less than 15 m clear distance from the edge of excavation. Finally, at seaside, the shoring had to be executed at about 3 m clear distance from the existing quay, which was constructed in the 1900s and was constructed using rock blocks.

- <u>Difficulties related to the lateral support of shoring</u>. The site condition surrounding the shoring did not allow the installation of ground anchors. Therefore, a steel propping system, composed of 3 levels of 36 struts, was designed and constructed as lateral support of the shoring. This complicated the construction phases of the building with strut installation and removal phases and also complicated the logistics of the site due to the need of a tower crane and no free space for its installation. Horizontal struts were designed to span from the seaside to the roadside shoring, while inclined struts were designed for the four corners. Due to the significant length of the horizontal struts (about 45 m), it was decided to utilize intermediate king post piles to increase the buckling resistance of the strutting system. Moreover, king post piles were specially designed to be used also as the foundation of the tower crane so that one of the difficulties related to site logistics could be addressed (Figures 8 and 9).

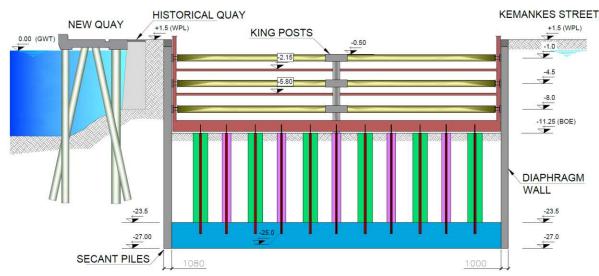
Figure 9. Section view of Bina 4 geotechnical works.

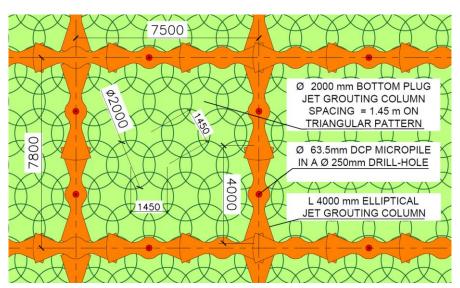
Figure 10. Details of single MPBP element – Plan view.

The multi-purpose bottom plug (MPBP) is an innovative geotechnical solution, which is formed by a combination of seepage control, ground improvement, and load bearing elements (Figures 10 and 12).

The main body of the bottom plug is composed of overlapping jet grouted circular columns executed with the double-fluid method and designed to have a diameter of 2,000 mm. The columns are executed on a triangular pattern with an average center-to-center spacing of 1,450 mm. The thickness of the bottom plug is the one constraint necessary to ensure the hydraulic stability of the excavation.

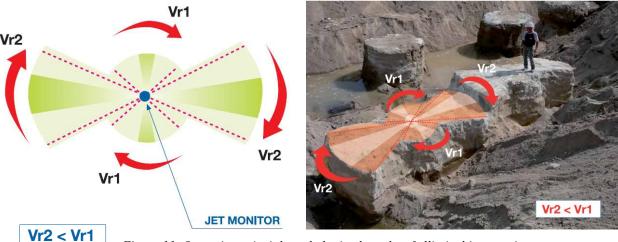
Figure 11. Operating principle and obtained results of elliptical jet grouting.

The pseudo-elliptical jet grout columns are executed from the top of the bottom plug up to the excavation level on a lattice-type pattern to act as a mitigation element against liquefaction. The pseudo-elliptical shape of the jet grout columns was chosen instead of a circular shape to optimize the lattice geometry, by minimizing the amount of jetting and the related time of execution. The lattice-type jet grouting treatment also acts as a foundation for the future building and will carry the vertical structural loads in the permanent condition in the areas with localized compression loads at the foundation. The average length of the elliptical jet grout columns, in the plan view, is 4.0 m.

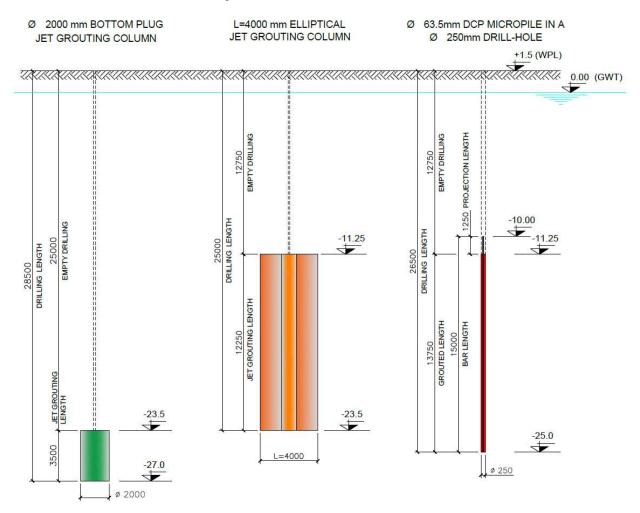
Figure 12. Details of single MPBP element – Vertical section.

The stability against uplift is ensured by the permanent DCP steel bars, which are installed as drilled-and-grouted micropiles through the previously-executed elliptical jet grout columns. The DCP steel bars have a diameter of 63.5 mm and are installed within a 250 mm diameter drill hole. The system is designed with the uplift force acting in the temporary condition (only the three basement floors constructed), which represents the worst scenario.

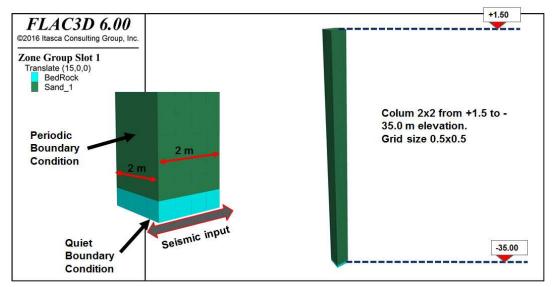
Figure 13. FDM model of natural soil for non-linear time history analysis.

To design the MPBP unit cell, a non-linear time history 3D FDM analysis was carried out using FLAC3D. The liquefaction potential of the natural soil was analyzed on a 35 m deep, 2 m x 2 m sand column bordered by periodic boundaries (Figure 13). The seismic input was applied at a bedrock elevation of El. -35.0 m msl (quite boundary). Regarding the assessment of the mitigation effect on the treated soil, three different cell net sizes were considered: 5 m x 5 m, 7 m x 7 m, and 10 m x 10 m. The main details of the models are shown in Figure 14. The strength and deformation properties of the soil improved by the jet grouting were defined as UCS = 5 MPa and Es = 5 GPa.

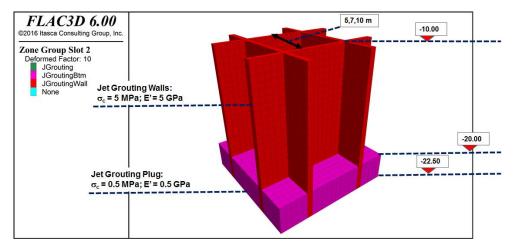
Figure 14. FDM model of lattice-type jet grouting cell for non-linear time history analysis.

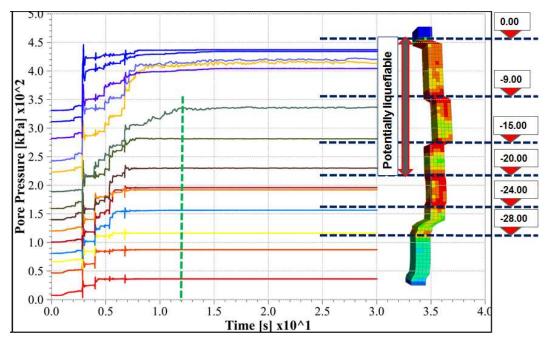
Figure 16. Pore pressure history and Max Ru in natural soil.

The results of the main analysis are shown in Figures 16 and 17: the red points are those where the ratio R_u between the excess pore pressure and the effective vertical stress reach the value of 1. It is possible to notice that, in natural soil, liquefaction occurs down to a depth of 24 m below the groundwater table. Instead, in the presence of the soil improvement, the value of R_u approaches 1 in just a thin band beneath the soil treatment. The 7 m x 7 m grid was selected; the 10 m x 10 m option provided satisfactory results but presented some local liquefaction phenomena at the surface of the excavation.

The different coloured lines in Figures 16 and 17 represent the pore pressure history at various depths. The two green rectangular blocks in Figure 17 represent the cross section of the jet grouting cell.

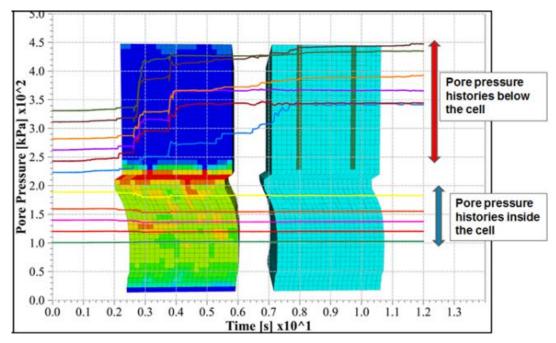
Figure 17. Pore pressure history and Max Ru in improved soil.

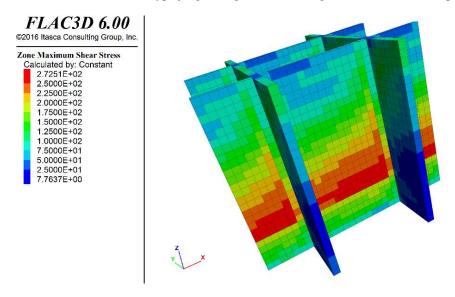
Figure 18. Maximum recorded shear stress in jet grouting cell, expressed in kPa.

The maximum recorded shear stress in lattice-type jet grouting is shown in Figure 18 below and is expressed in kPa.

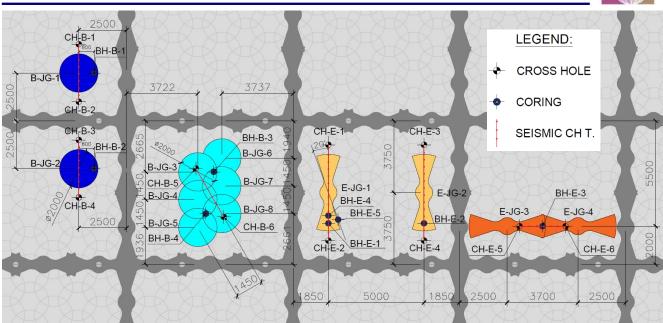
Figure 22. Plan view of the jet grouting preliminary field test.

General details of the preliminary field tests can be found in Figures 22 and 23. Based on the results of the seismic crosshole tomography for the double fluid jet grouting for the bottom plug, both of the single columns fulfilled the design diameter; however, the B-JG-2 column showed a slightly bigger and better defined diameter as well as more satisfactory results of homogeneity of the treatment (Figure 24). Therefore, the operational parameters of column B-JG-2 were used to install a

Regarding the elliptical jet grouting, it was necessary to verify that the design column length of 4 m could be obtained (i.e., column E-JG-2 in plan Figure 22). This was an ambitious goal since it had been rarely achieved in previous attempts. Based on the seismic crosshole tomography, an anomaly emerged for column E-JG-1 since its length in plan resulted to be around 1 m. For column E-JG-2, instead, a column width in plan greater than 4 m was assessed (Figure 26). This was not in agreement with the utilized operation parameters and, after further investigation, it was found that the column E-JG-1 had been executed with a rotation in plan of about 20° (Figure 22). This was defined by means of specifically executing coring BH-E-1, 4, and

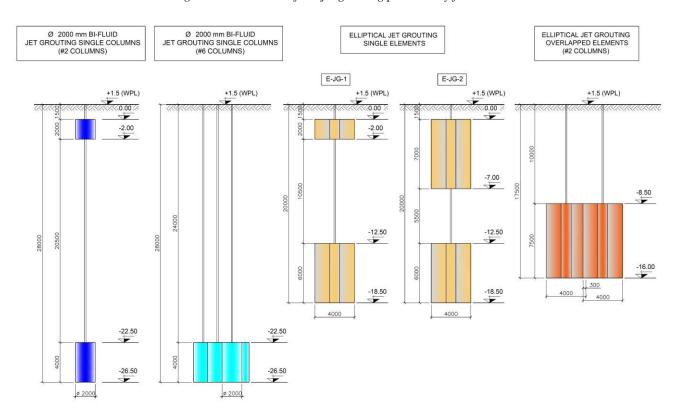
Figure 23. Section view of the jet grouting preliminary field test.

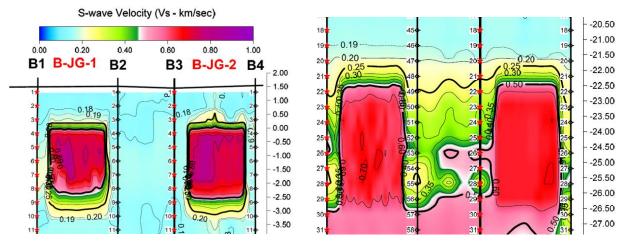
Figure 24. Measured Vs for columns B-JG-1 and B-JG-2 at two different depths.

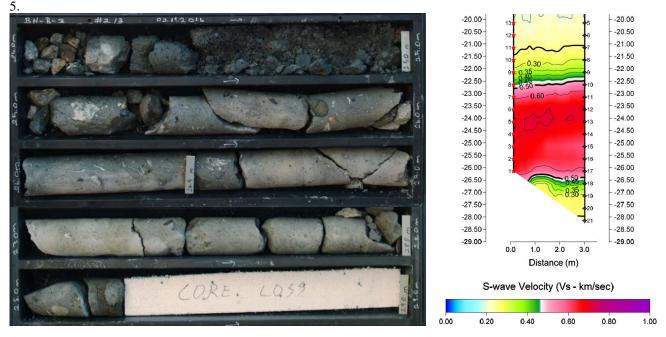
Figure 25. Core box photos of coring BH-B-3 between 24 and 29 m depth. Measured Vs across overlapping columns. Several cracks were visible on the extracted core, which could be due to the coring effects but could be also related to the overlapping of two different jet grouting columns.

group of six overlapping columns (B-JG-3 to 8) at the design depth of bottom plug. Two continuous corings were executed in the overlapping zones and one seismic crosshole tomography line was also conducted across the columns to verify the presence and quality of the overlapping. Pictures of one coring (BH-B-3) and measured values of shear wave velocity (Vs) can be found in Figure 25. The results of the seismic crosshole tomography executed on the overlapping columns show a full overlapping and continuity in the block of treated soil without relevant defects. The median measured value of Vs was 640 m/s.

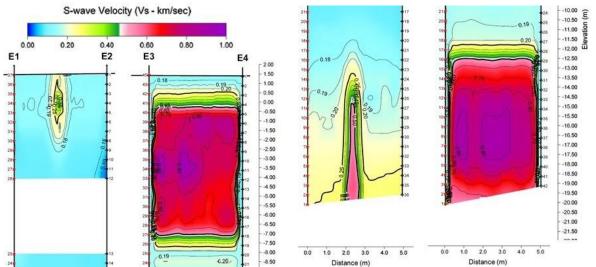
Figure 26. Measured Vs for E-JG-1 and E-JG-2.

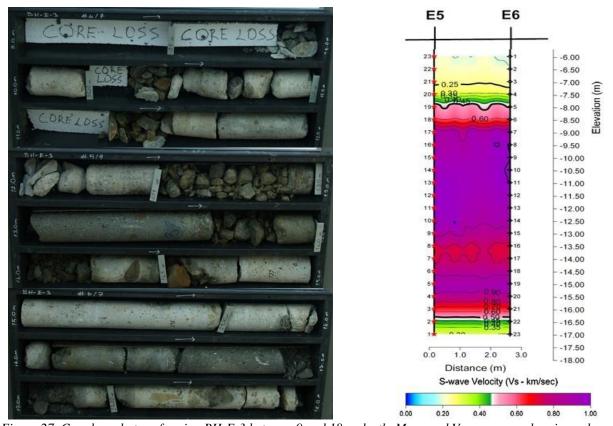
Figure 27. Core box photos of coring BH-E-3 between 9 and 18 m depth. Measured Vs across overlapping columns.

The operational parameters of column E-JG-2 were used to install a set of two overlapping columns (E-JG-4 and 5). One continuous coring was executed through the overlapping and one seismic crosshole tomography line was also conducted across the columns to verify the presence and quality of the overlapping. Pictures of the core boxes and the measured values of shear wave velocity (Vs) can be found in Figure 27. Several cracks could be seen on the extracted core, which could be due to the coring effects but could be also related to the overlapping of two different jet grouting columns. Moreover, it should also be considered that these jet grouting columns were executed within the man-made fill, which included bricks and blocks.

The results of the seismic crosshole tomography executed on the overlapping columns show a full overlapping and continuity between the two columns without relevant defects. The median measured value of Vs is 920 m/s.

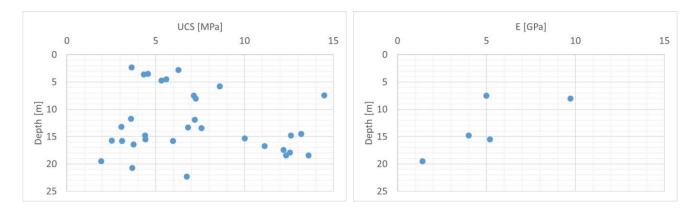
Figure 28. UCS and elastic modulus of laboratory tested elliptical jet grouting samples.

The elliptical jet grouting forming the MPBP was designed to create a stiff grid that would prevent the loose sand from liquefying in the event of earthquakes. For this reason, it was specified that the soil improved by jet grouting should have an average unconfined compression strength (UCS) greater than 5 MPa and an average elastic modulus (Es) greater than 5 GPa. This was verified by laboratory tests on core samples taken from the preliminary field trial test columns. The results were satisfactory (Figure 28).

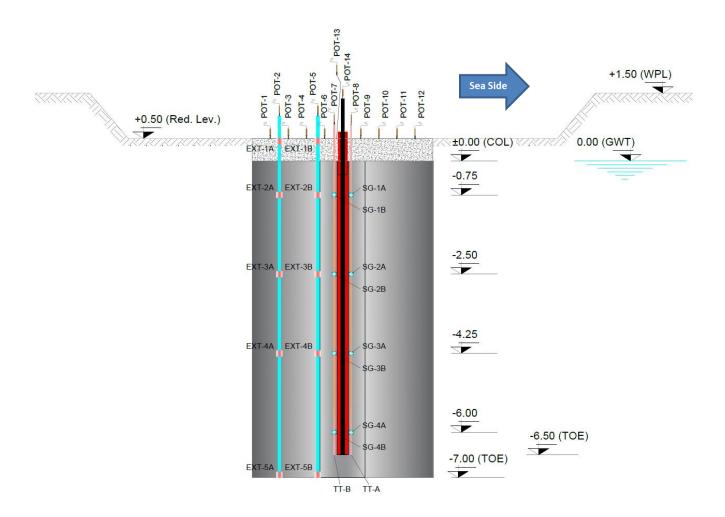
Figure 29. Main geometry of tension load test on DCP micropile.

- To bring the surface of the jet grouting column above the groundwater table for conducting the test in dry condition, a 500 mm thick, clean concrete block was cast at the ground surface (Figures 29 and 30c). The lack of structural continuity and the considerable difference in stiffness between the jet grouting column and lean concrete affected most of the test readings of the displacement transducers at the surface.
- For the strain measurements during the testing, the miniature embedment type strain gauges didn't provide satisfactory results beginning at low levels of load due to the mobilized high tension strain concentrations.

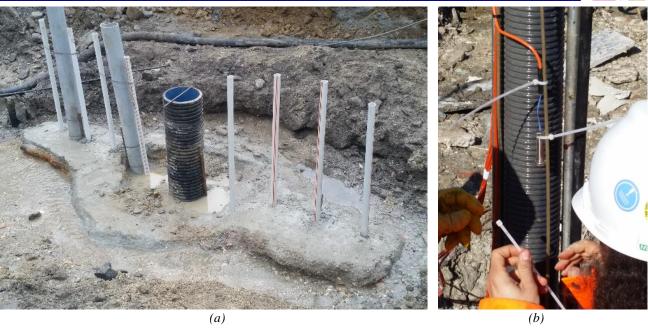
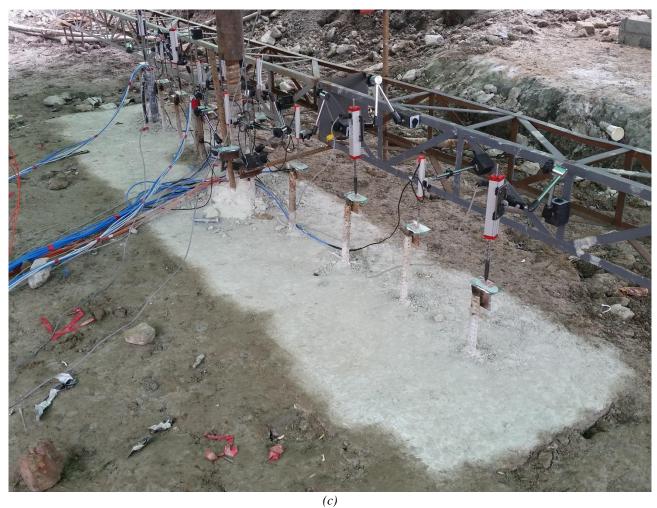
Figure 30. (a) Exposed jet grouting column and preparation for drilling; (b) Installation of instrumented DPC bar, with visible vibrating wire miniature embedment strain gauges; and (c) General view of test set-up.

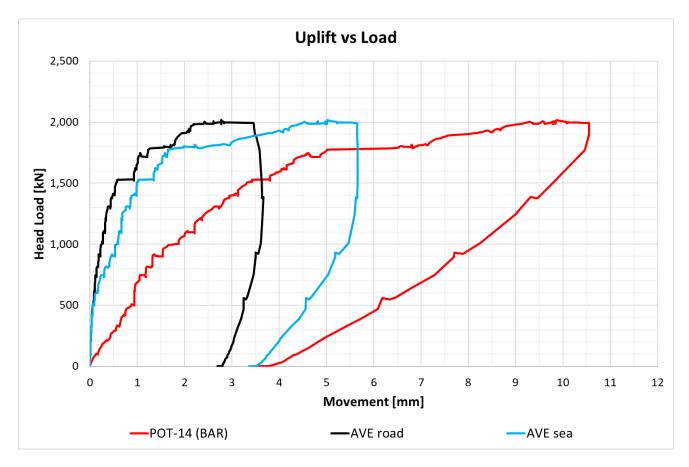
Figure 31. Tension load test results - Measured uplift.

The results of head displacement showed a non-uniform uplift of the jet grouting column, which varied between 3.5 and 5.6 mm, while the maximum uplift measured on the DCP steel bar was 10.5 mm (Figures 31 and 32). This is possibly due to the irregular shape and mechanical properties of the jet grouting column or to the presence of lean concrete above the jet grouting.

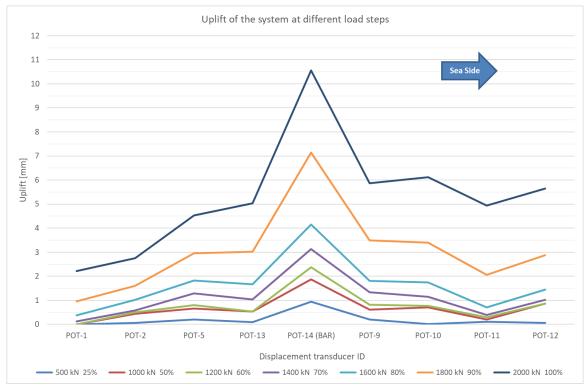
Figure 32. Uplift of elliptical jet grouting column and DCP bar at different load steps.

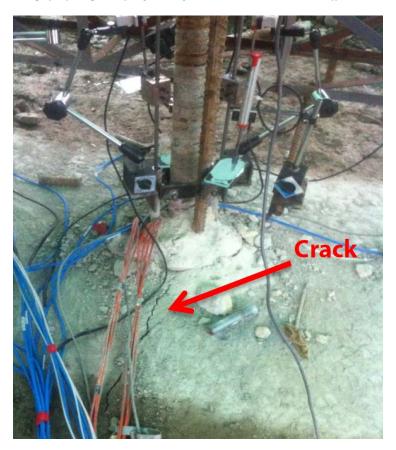
Figure 33. Surface crack development at 90% of test load (1800 kN).

It is possible to notice that concentrated surface cracks occurred at the load of 1800 kN (Figure 33).

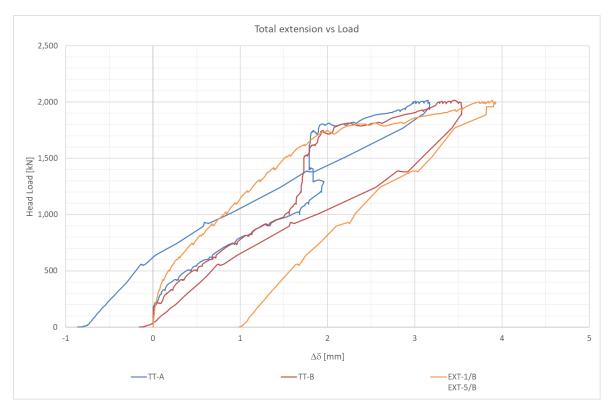
Figure 34. Total extension versus load.

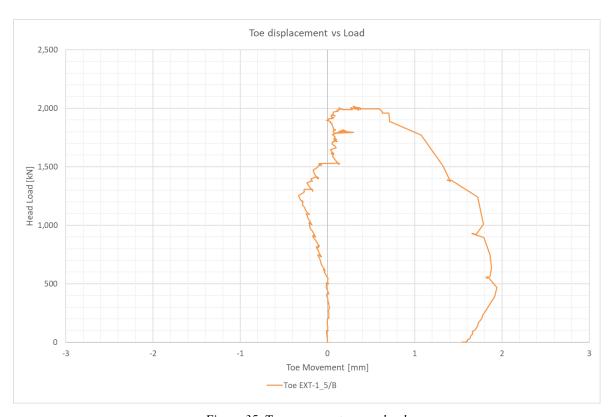
Figure 35. Toe movement versus load.

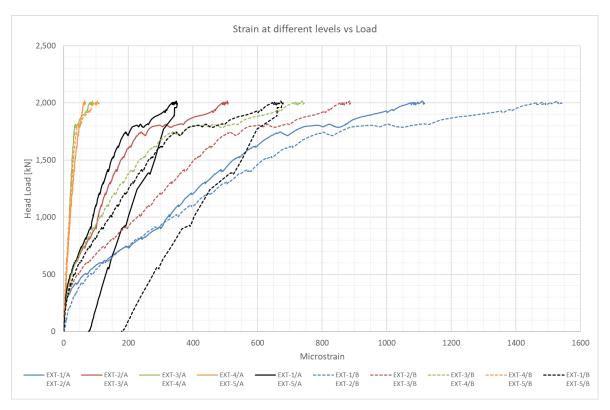
Figure 36. Average strain measured by the extensometers A and B.

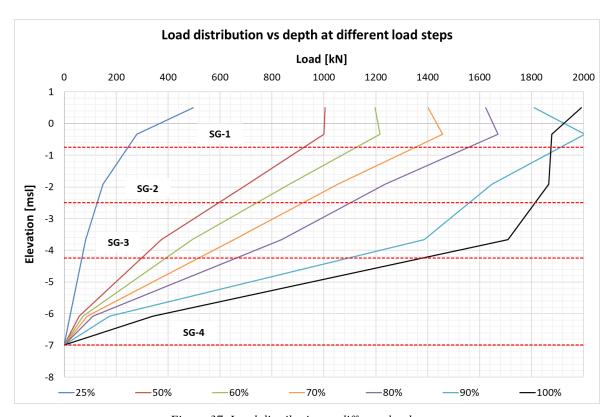
Figure 37. Load distribution at different load steps.

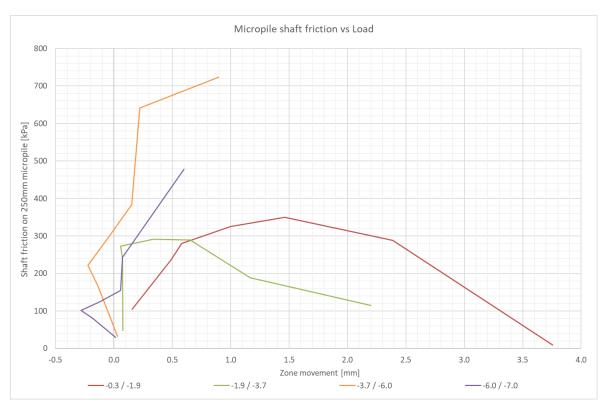
Figure 38. Micropile-to-jet grouting shaft friction vs zone movement.

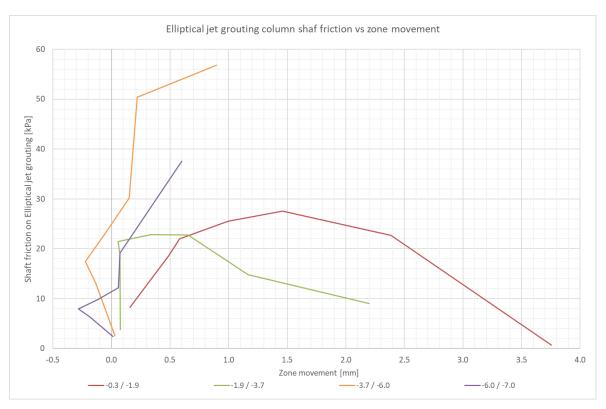
Figure 39. Jet grouting-to-soil shaft friction vs zone movement.

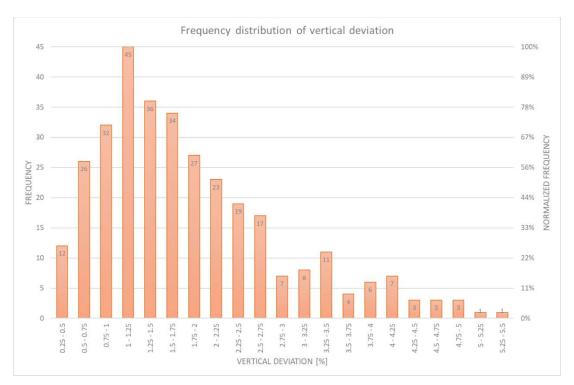
Figure 40. Frequency distribution of vertical deviation during drilling, measured with DPS.

The technologies involved and the electronic control devices employed for the execution of the MPBP are latest-generation. For the execution of the double fluid jet grout bottom plug, the drill rigs were equipped with the "Jet-Vision System" and with the "Drilling Position System" (DPS) electronic devices. The former controls and monitors the automatic rising of the drilling tool/rods during the jetting phase; the latter controls the 3D position of the drilling tool during the drilling phase, which is needed to ensure the overlapping between the jet grouting columns and the consequent successful execution of the bottom plug. The DPS conists of an inclinometer attached to the bottom of a drilling rod string, which takes readings at predetermined depths (usually every 0.5 m to 1.0 m) during the drilling process. Recorded deviation data are downloaded at the end of each executed jet grouting column. As an example, the measured frequency distribution of vertical deviation is shown in Figure 40 and has a median of 1.41 % and a standard deviation of 1.33 %.

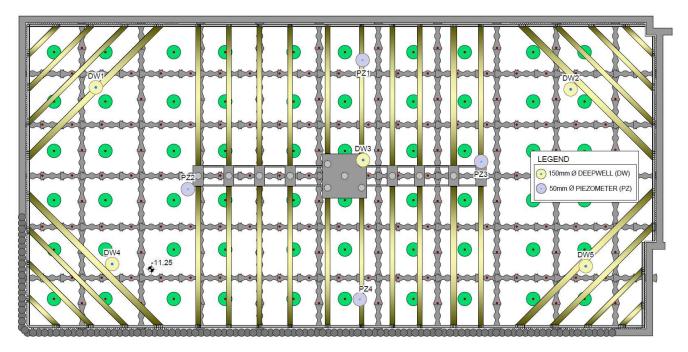
Figure 42. Pumping test layout.

Five deepwells and four piezometers were installed in the Bina 4 excavation area (Figure 42). In reality, the ingress of water can happen through the whole system consisting of the jet grout bottom plug, secant piles, and diaphragm wall; however, it is assumed that the surrounding shoring is almost watertight and that the water inflow affects mainly the bottom plug.

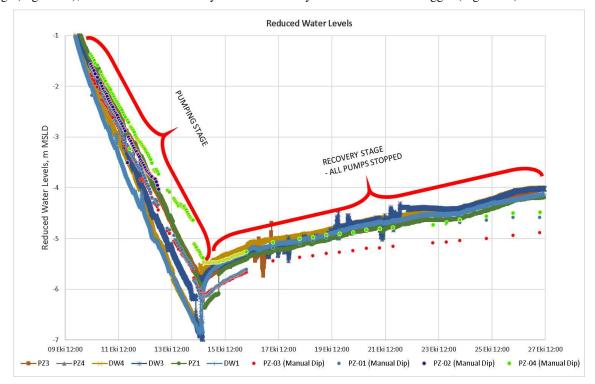
Figure 43. Water levels during pumping test.

The drawdown phase was run from 9 to 14 October 2017, and the groundwater table was lowered from the original El. 0.00 msl to around El. -5.0 msl. The recharge phase followed. In addition to the manual readings, the water level in three deepwells (DW-1-3-4) and three piezometers (PZ-1-3-4) was automatically measured by means of level loggers. The two phases can be separated and the trendlines generated. The manual and automatic readings taken during the drawdown phase are shown in Figures 44 and 45 and relevant trendlines have an average slope of -1 m/day, showing that for every one day period, there is a 1 m drop in water level. During the recharge phase, a slope between 0.05 and 0.07 m/day was measured with manual readings (Figure 46), while 0.10 to 0.12 m/day was measured by the automatic level logger (Figure 47).

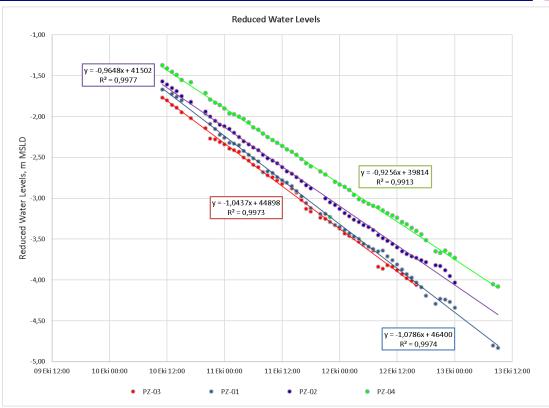
Figure 44. Graph of Manual Dipmeter Readings in Drawdown Stage.

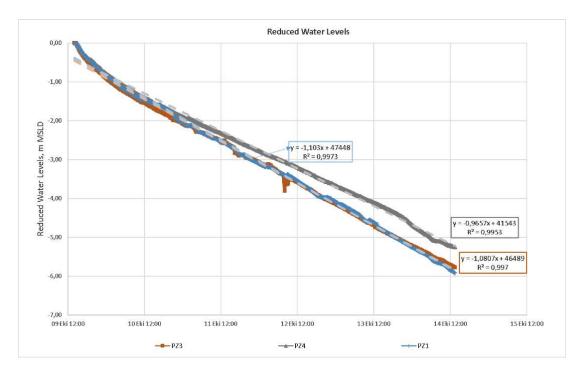
Figure 45. Graph of Automatic Levellogger Readings in Drawdown Stage.

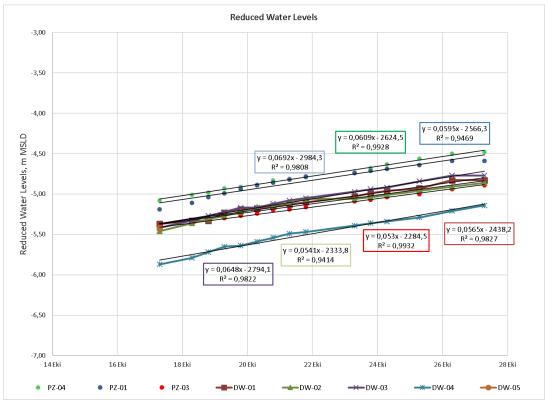
Figure 46. Graph of Manual Dipmeter Readings in Recovery Stage.

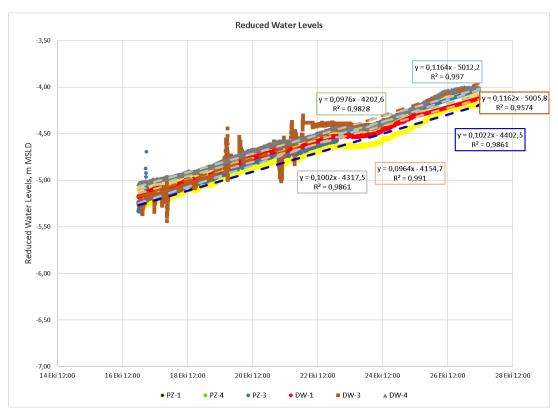
Figure 47. Graph of Automatic Levelloger Readings in Recovery Stage.

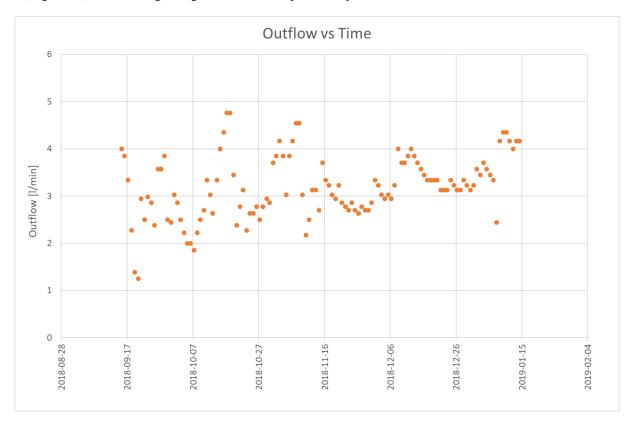
Figure 48. Recorded total outflow at bottom of excavation.

The actual records of water outflow were obtained at the bottom of excavation range between 2 and 5 l/s, with a median value of 3 l/s (Figure 48), which is in good agreement with the preliminary calculations.

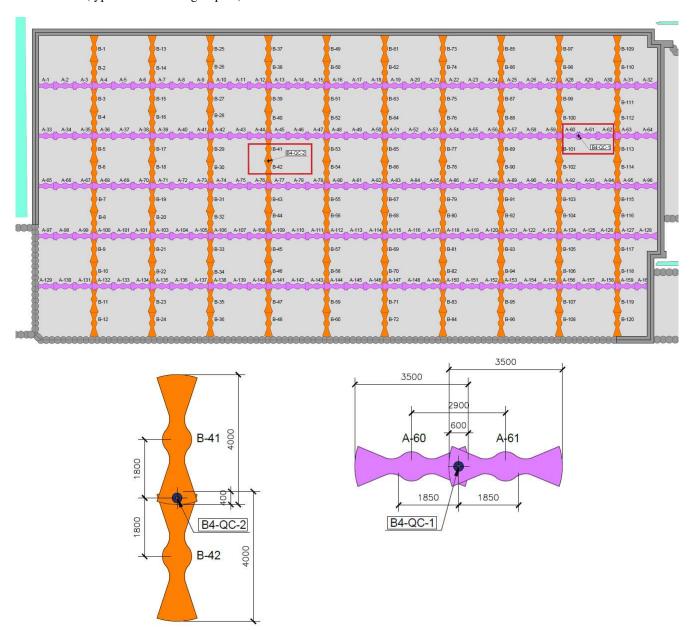
Figure 49. Details of corings with respect to executed columns.

Two rotary core drillings up to a depth of 25 m were performed as quality control checks on the executed jet grout columns between 2 and 6 June 2017 in Bina 4. Samples were taken from both boreholes to test them in the laboratory. Quality control corings were executed in the overlapping of two adjacent columns: B-41 and B-42 (type B = 4 m long in plan) as well as A-60 and A-61 (type A = 3.5 m long in plan).

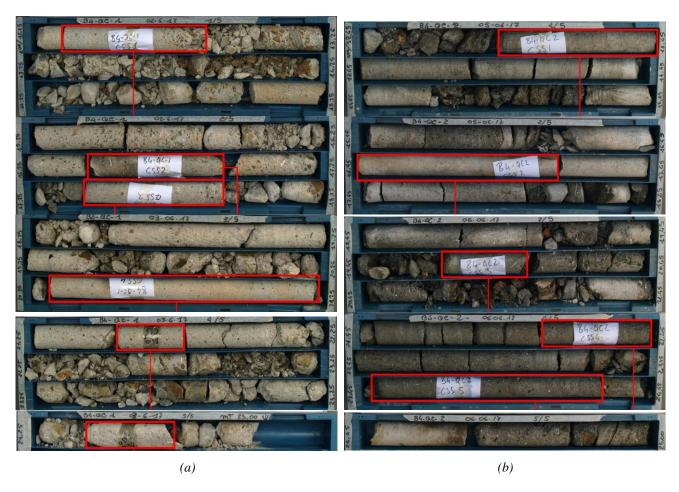
Figure 50. Core box photos of executed continuous coring: (a) QC-1 and (b) QC-2.

For both cores, full core recovery was obtained (Figure 50), which confirm a satisfactory quality of the soil improvement and a continuous overlapping between two adjacent columns. As also shown in Figure 50, the samples selected for laboratory testing are highlighted by a red rectangle. The cylinders (100 mm x 200 mm) were prepared and tested to determine the UCS and elastic modulus. The average value of UCS was 6.43 MPa and the average Es was 8.79 GPa. Both values were greater than the specified 5 MPa and 5 GPa for UCS and Es, respectively.

The different quality of the cores at different depths might be related to the heterogenous nature of the man-made fill.

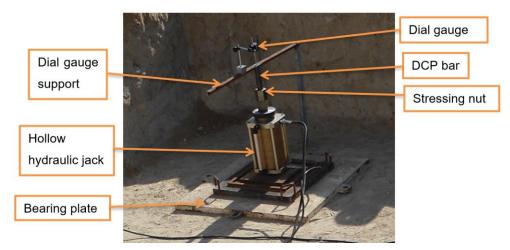
Figure 51. Typical arrangement of acceptance test.

Once the final excavation level was reached, all permanent micropiles were subjected to acceptance testing up to 125% of the design working load (test load of 1,731 kN and design working load of 1,385 kN) to evaluate the micropile response. The typical acceptance test arrangement is shown in Figure 51.

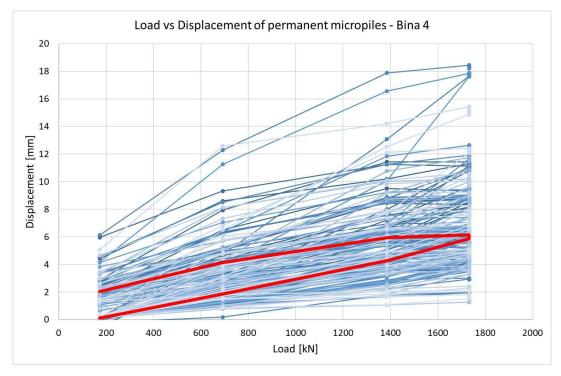
Figure 52. Load – Displacement graph of all tested micropiles.

The micropiles were loaded from the datum (P_a) load to proof load (P_p) in three increments: 50%, 100% (P_w) , and 125% (P_p) of working load (P_w) . The proof load was maintained for 15 minutes. Readings were recorded at 1 minute intervals at 50% and 100% (P_w) and at 1, 2, 3, 4, 7, and 15 minutes at 125% (P_p) . The micropiles were unloaded from the proof load (P_p) to 100% (P_w) , = then to 50%, and then to the datum load (P_a) . Readings were recorded at 1 minute intervals at each step during unloading. Graphs of load vs. displacement for each of the tested micropiles are shown in Figure 52. The uplift under the maximum test load of 1731 kN ranged between 1.8 mm and 18.4 mm, with a median value of 6.15 mm. The median micropile response is shown in thick red lines in Figure 52.
