# The Multi-Purpose Bottom Plug for the Galataport Project

Salvatore Miranda, Technical Manager, TREVI Turkey, Istanbul (Turkey); email: [smiranda@trevispa.com](mailto:smiranda@trevispa.com)

**ABSTRACT:** The paper describes an innovative geotechnical engineering solution that was provided by TREVI for the renovation project at Galataport in Istanbul, Turkey. Among other interesting geotechnical works included in the project, this paper also presents the design considerations and construction of the multi-purpose bottom plug (MPBP). This original geotechnical engineering solution was employed for a three-basement excavation in Karaköy and consists of a combination of seepage control, ground improvement, and load bearing elements, which were executed with double-fluid jet grouting, pseudo-elliptical jet grouting, and permanent micropiles, respectively. The paper describes each step of the design, execution, and the preliminary and final testing phases. Moreover, it highlights the importance of employing cutting-edge technologies used in deep foundation geo-construction and state-of-the-art electronic control devices, along with expertise, to obtain the desired results for this hig

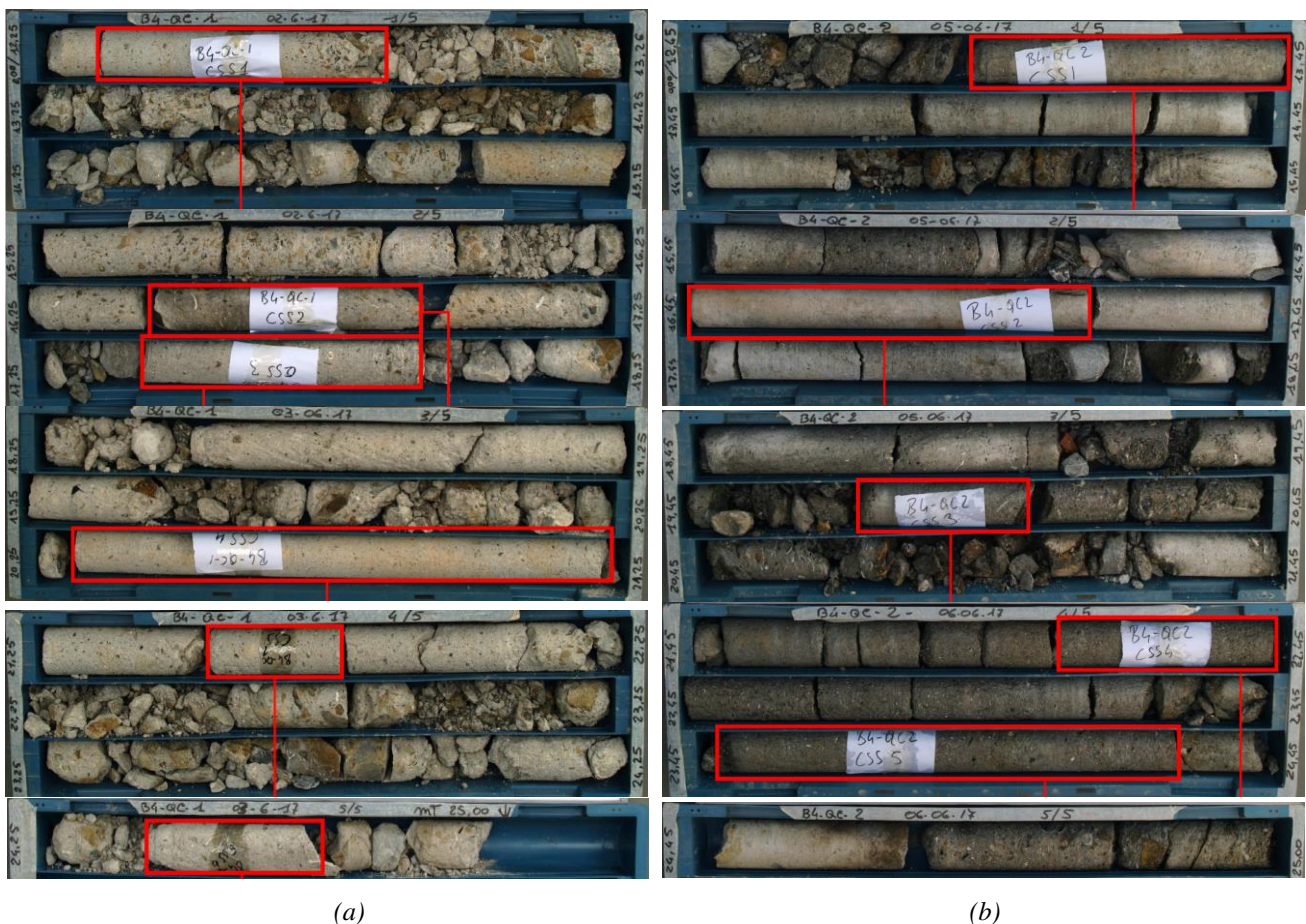
Figure 50. Core box photos of executed continuous coring: (a) QC-1 and (b) QC-2.
