The Multi-Purpose Bottom Plug for the Galataport Project

Salvatore Miranda, Technical Manager, TREVI Turkey, Istanbul (Turkey); email: smiranda@trevispa.com

ABSTRACT: The paper describes an innovative geotechnical engineering solution that was provided by TREVI for the renovation project at Galataport in Istanbul, Turkey. Among other interesting geotechnical works included in the project, this paper also presents the design considerations and construction of the multi-purpose bottom plug (MPBP). This original geotechnical engineering solution was employed for a three-basement excavation in Karaköy and consists of a combination of seepage control, ground improvement, and load bearing elements, which were executed with double-fluid jet grouting, pseudo-elliptical jet grouting, and permanent micropiles, respectively. The paper describes each step of the design, execution, and the preliminary and final testing phases. Moreover, it highlights the importance of employing cutting-edge technologies used in deep foundation geo-construction and state-of-the-art electronic control devices, along with expertise, to obtain the desired results for this high-profile project.

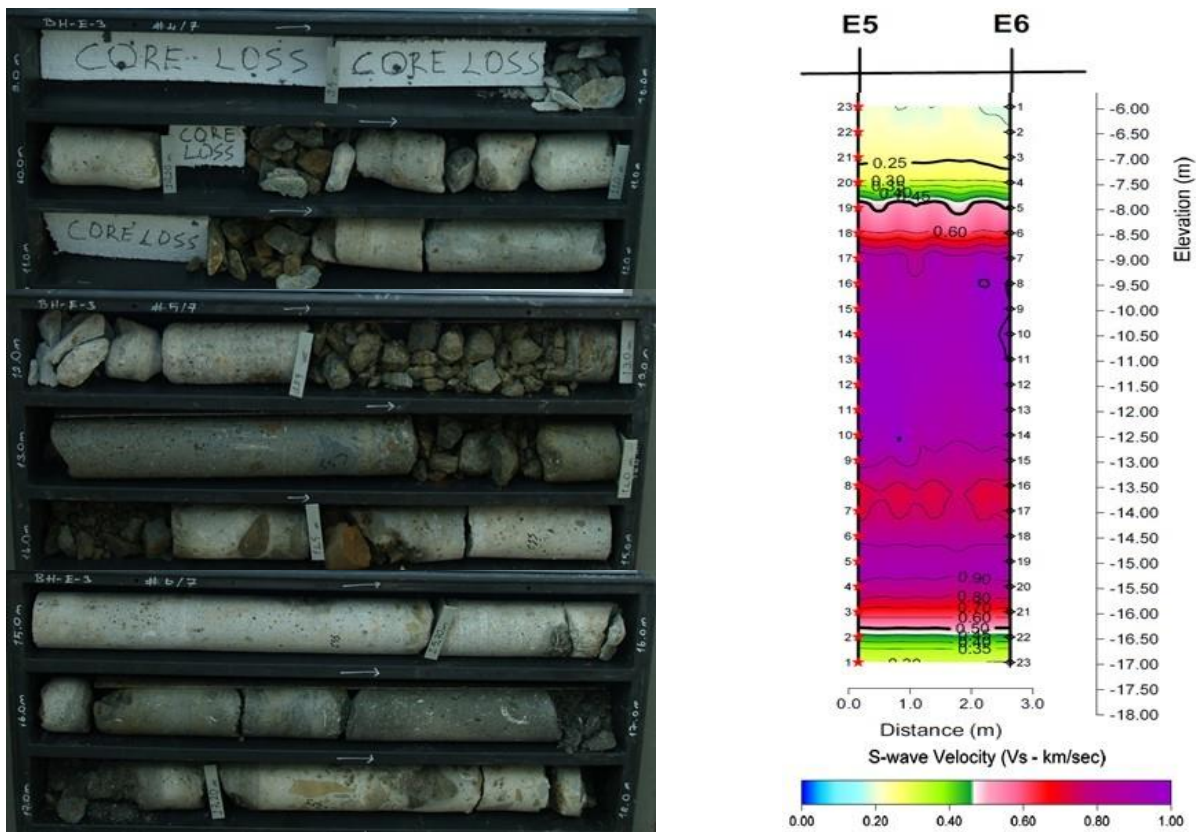
Figure 27. Core box photos of coring BH-E-3 between 9 and 18 m depth. Measured Vs across overlapping columns.

The results of the seismic crosshole tomography executed on the overlapping columns show a full overlapping and continuity between the two columns without relevant defects. The median measured value of V_s is 920 m/s.
