The Multi-Purpose Bottom Plug for the Galataport Project

Salvatore Miranda, Technical Manager, TREVI Turkey, Istanbul (Turkey); email: smiranda@trevispa.com

ABSTRACT: The paper describes an innovative geotechnical engineering solution that was provided by TREVI for the renovation project at Galataport in Istanbul, Turkey. Among other interesting geotechnical works included in the project, this paper also presents the design considerations and construction of the multi-purpose bottom plug (MPBP). This original geotechnical engineering solution was employed for a three-basement excavation in Karaköy and consists of a combination of seepage control, ground improvement, and load bearing elements, which were executed with double-fluid jet grouting, pseudo-elliptical jet grouting, and permanent micropiles, respectively. The paper describes each step of the design, execution, and the preliminary and final testing phases. Moreover, it highlights the importance of employing cutting-edge technologies used in deep foundation geo-construction and state-of-the-art electronic control devices, along with expertise, to obtain the desired results for this high-profile project.

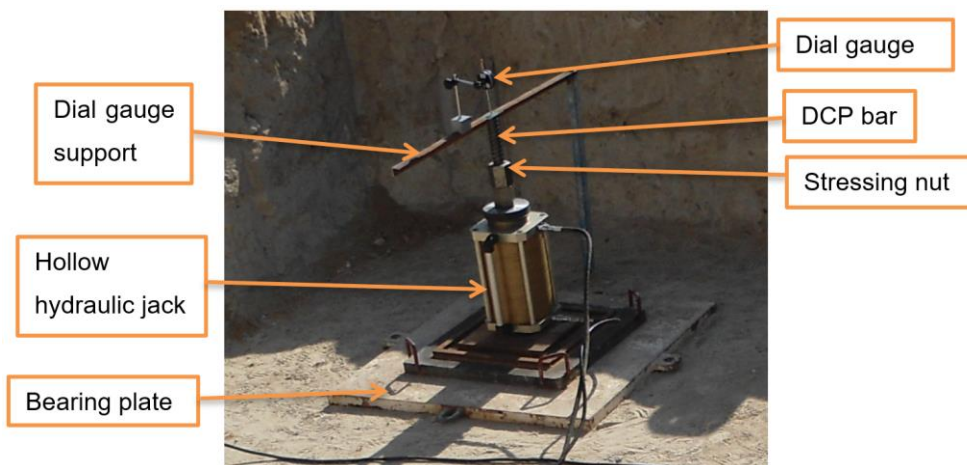
Figure 51. Typical arrangement of acceptance test.

Once the final excavation level was reached, all permanent micropiles were subjected to acceptance testing up to 125% of the design working load (test load of 1,731 kN and design working load of 1,385 kN) to evaluate the micropile response. The typical acceptance test arrangement is shown in Figure 51.

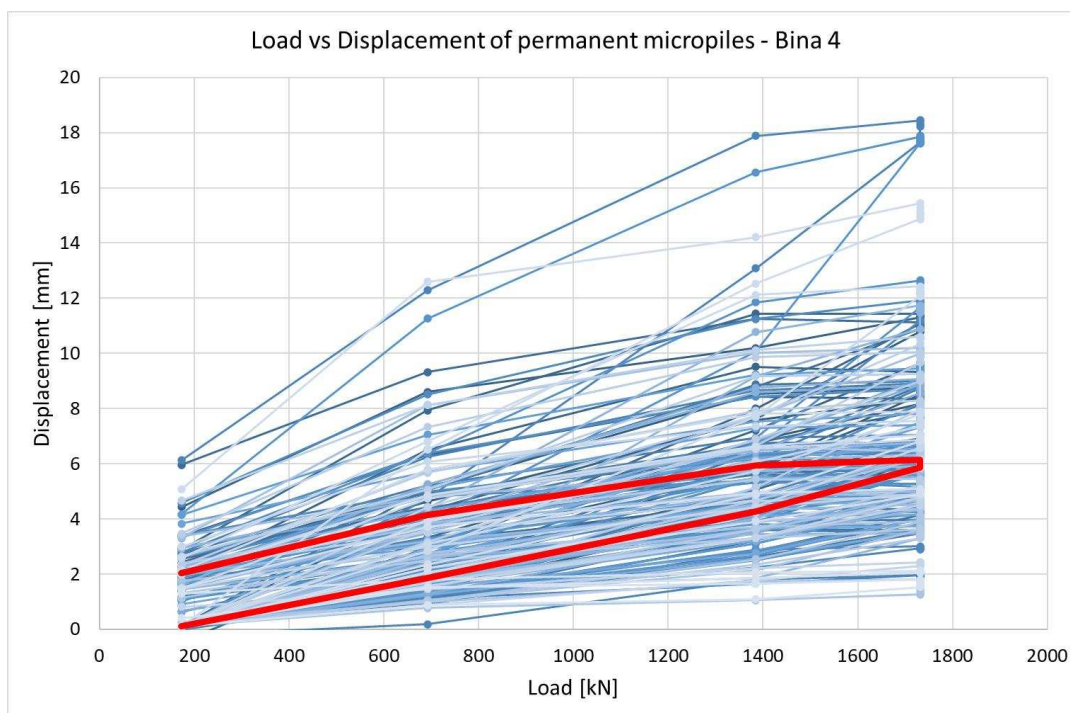
Figure 52. Load – Displacement graph of all tested micropiles.

The micropiles were loaded from the datum (P_a) load to proof load (P_p) in three increments: 50%, 100% (P_w), and 125% (P_p) of working load (P_w). The proof load was maintained for 15 minutes. Readings were recorded at 1 minute intervals at 50% and 100% (P_w) and at 1, 2, 3, 4, 7, and 15 minutes at 125% (P_p). The micropiles were unloaded from the proof load (P_p) to 100% (P_w), = then to 50%, and then to the datum load (P_a). Readings were recorded at 1 minute intervals at each step during unloading. Graphs of load vs. displacement for each of the tested micropiles are shown in Figure 52. The uplift under the maximum test load of 1731 kN ranged between 1.8 mm and 18.4 mm, with a median value of 6.15 mm. The median micropile response is shown in thick red lines in Figure 52.
