40 Years of Full-Scale Infrastructure Testing at a National Geotechnical Experimentation Site: Sand Site.

Reference: Briaud J.L. (2021). 40 Years of Full-scale Infrastructure Testing at a National Geotechnical Experimentation Site: Sand Site. International Journal of Geoengineering Case Histories, Volume 6, Issue 3, pp. 25-53, doi: 10.4417/IJGCH-06-03-02

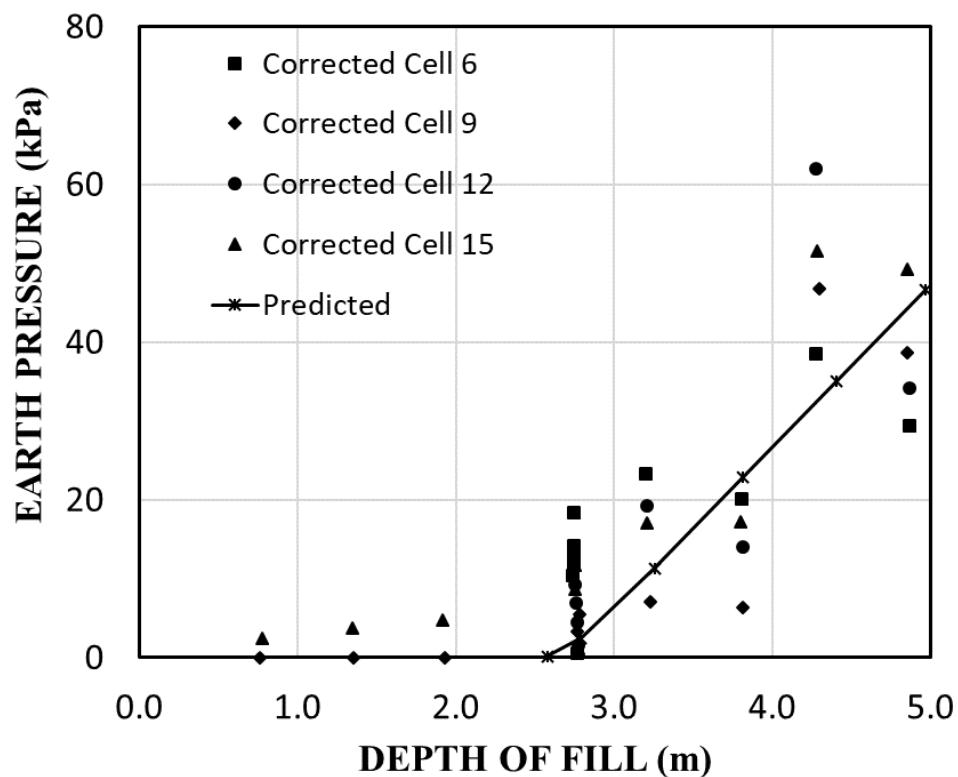
Figure 6. Pressure cell readings as a function of the fill height (after James et al., 1986).

The pressure on the top of the culvert, given by the pressure cells, increased as the fill increased in height (Fig. 6). As can be seen, the scatter is not negligible but the trend matches the total vertical stress σ expressed as γz where γ is the soil total unit weight of 20 kN/m³ and z is the depth of fill. This depth of fill refers to the thickness of the fill; it was zero when the fill level is near the bottom of the culvert, thus the pressure cells on top of the culvert only started to record pressure when the fill reached the top of the culvert. The pressure cell readings as the rear axle of the truck passed on top of the cells and for different depth of cover are shown in Fig. 7. Remember that the tire pressure was of the order of 550 kPa, yet the pressures on the cells placed on the roof of the culvert were much smaller than 550 kPa. In fact, they seemed to obey the stress distribution that one would have obtained from a bulb of pressure elastic approach (Briaud, 2013).

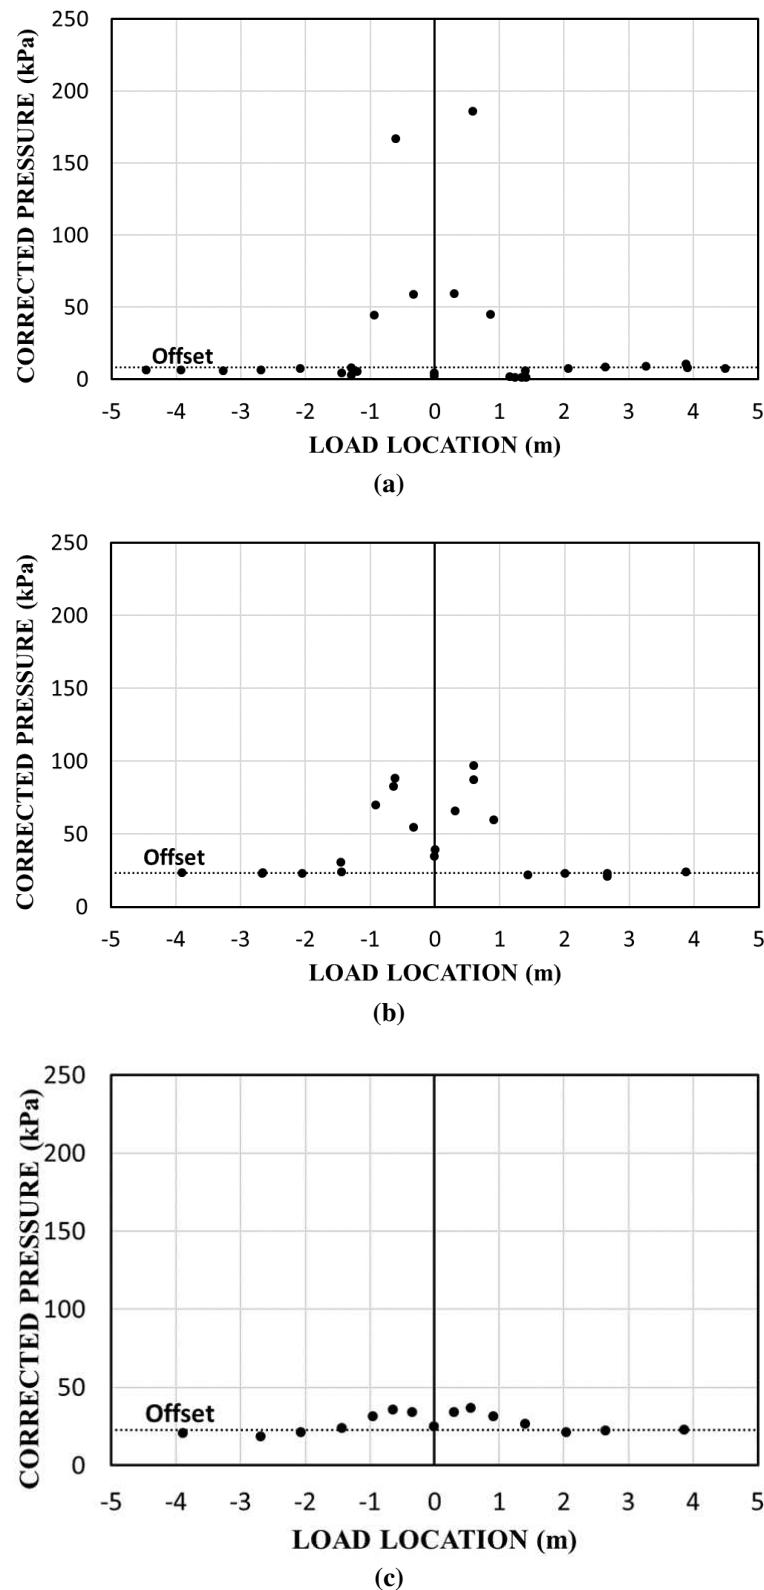
Figure 7. Pressure on top of the culvert for different heights of cover as the truck passes:
 a) 0.2 m of cover, b) 0.61 m of cover, c) 1.22 m of cover (after James *et al.*, 1986).

Indeed, for a 0.25 m diameter loaded area of the tire, as discussed above, the vertical stress increase at a depth of 0.20 m, or 0.8 times the diameter of the loaded area, was 0.44 times the pressure at the surface according to the elastic approach. This would be $0.44 \times 550 \text{ kPa} = 242 \text{ kPa}$ while the maximum recorded pressure in that case was 190 kPa. At a depth of 0.61 m, the stress increase was 69 kPa—more than that given by the elastic approach for one tire (39 kPa), likely because of the overlap of stress bulbs between the two tires on one side of the axle. At a depth of 1.22 m, the vertical stress increase under the tires was insignificant. The horizontal pressure on the pressure cells mounted on the side walls of the culvert indicated pressures about two times higher than the active pressure and was likely induced by the compaction process (Fig. 8).

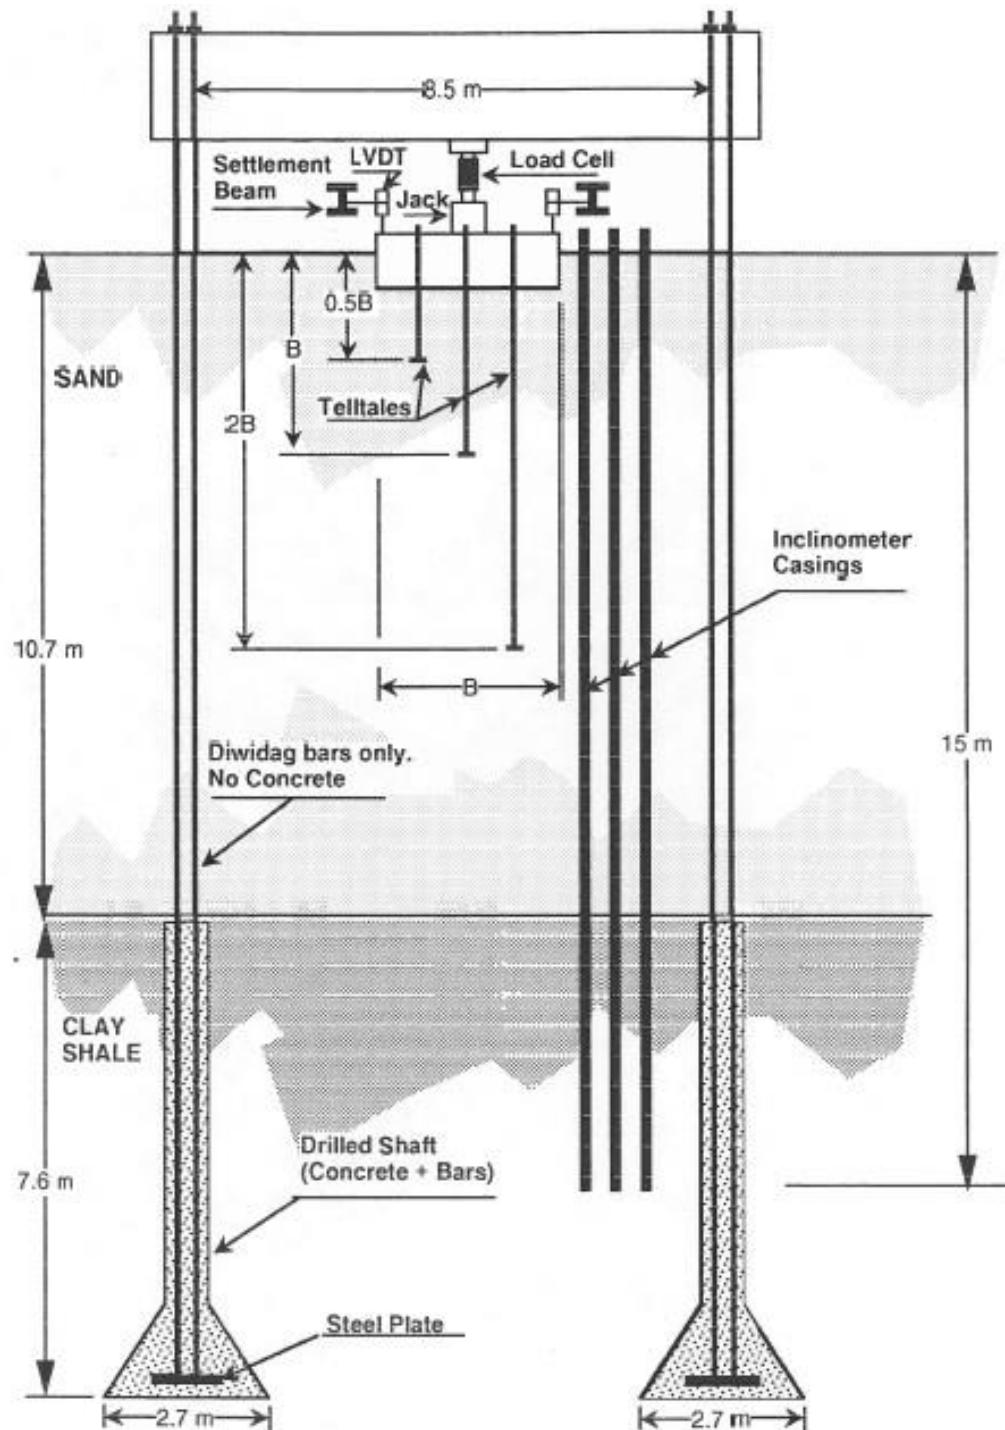
Figure 9. Load test setup for footing tests (Briaud, Gibbens, 1999).

Five square footings were load tested in 1993 (Briaud, Gibbens, 1999; Briaud, 2007). The footing sizes were 1 m, 1.5 m, 2.5 m, 3 m, and 3 m; all were embedded 0.75 m into the sand. They were all pushed to 150 mm of penetration into the sand using the load test setup of Fig. 9. The load test results are shown in a normalized fashion on Fig. 10. The soil around and under the footings was instrumented to monitor the vertical soil movement versus depth by using tell tales and the lateral soil movement versus depth and versus lateral extent by using inclinometers on the side of the footings. The vertical movement with depth revealed that the zone of influence was shallower than given by elastic theories (i.e., bulbs of pressure); this was confirmed by the lateral measurements as well.

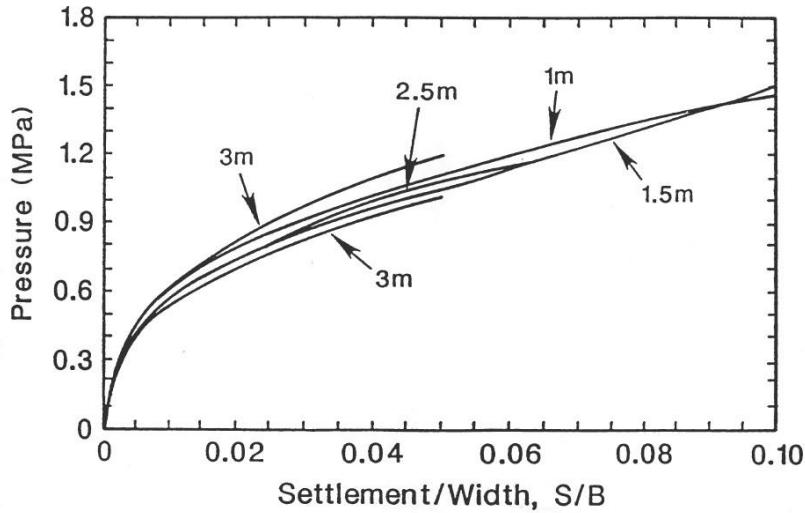
Figure 10. Normalized load test results for the five footings (Briaud, Gibbens, 1999).

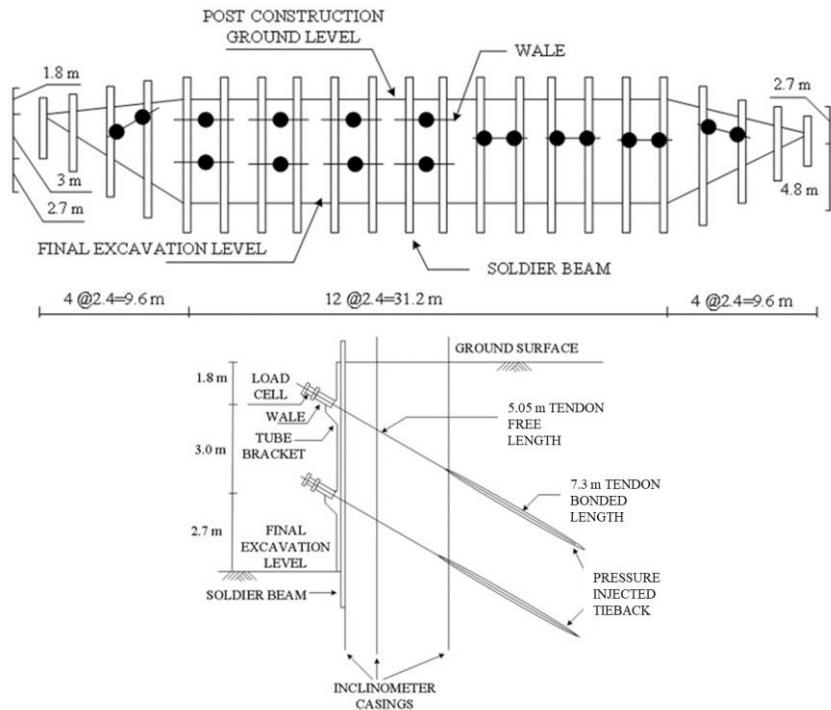
Figure 17. Tieback soldier pile and lagging wall (Chung, Briaud, 1992).

This 1990 project was a team effort between the Schnabel Foundation, FHWA, and Texas A&M University (Chung, Briaud, 1992, Kim, Briaud, 1992). The wall was a tieback soldier pile and lagging wall (Fig. 17). The H-piles were 9.15 m long with a spacing of 2.4 m center to center and the excavation wall height was 7.62 m. Half of this 50-m long wall had one row of anchors at a depth of 2.75 m and the H piles were HP 10 X 57 soldier piles; the other half had two rows of anchors at a depth of 1.8 and 4.9 m and the H piles were HP 6 X 25 soldier piles. The anchors were inclined downward at 30° with the horizontal and had a 2.4-m spacing (Fig. 17). Together with the wall, the anchors applied an average horizontal pressure against the soil of 20 kN/m². Eight of the 22 soldier piles were instrumented with about 450 vibrating wire strain gauges for bending moment and axial-load determination. Furthermore, 19 inclinometer casings were installed for wall and soil mass movement. The water table was at the bottom of the excavation.

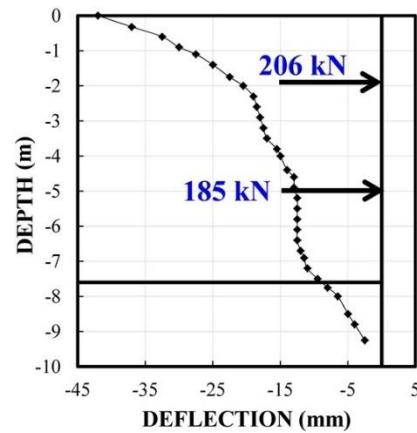
Figure 18. Wall deflection profile at end of construction for two rows of anchors (after Chung, Briaud, 1992).

Figs. 18, 19, and 20 show the average results for the section of the wall with two rows of anchors. Fig. 18 shows the horizontal deflection profile at the end of construction, Fig. 19 shows the bending moment profile, and Fig. 20 depicts the vertical load in the soldier piles. The same results are shown for the section of the wall with the one row of anchors in Figs. 21, 22, and 23. One of the many lessons learned from this project was that to limit the horizontal deflection of a tieback wall, the wall must have good vertical capacity. Indeed, such walls are subjected to significant downdrag from the retained mass (Figs. 20, 23), which is likely to induce settlement of the facing. This settlement generates rotation around the back of the anchors and an associated horizontal movement even if the anchors properly resist the horizontal load. Another outcome was the development of P-y curves, which do well in predicting the bending moment distribution in the soldier piles. The P-y curve approach was unable to accurately predict the deflection; only the finite element method could accomplish a good fit.

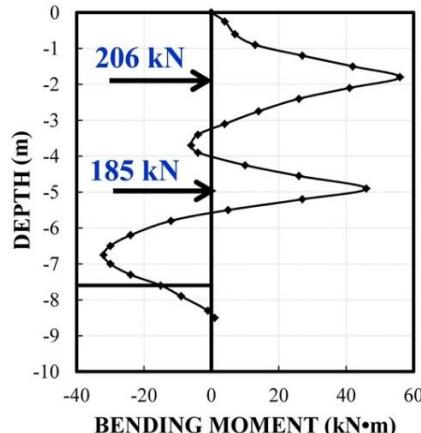
Figure 19. Wall bending moment profile at end of construction for two rows of anchors (after Chung, Briaud, 1992).

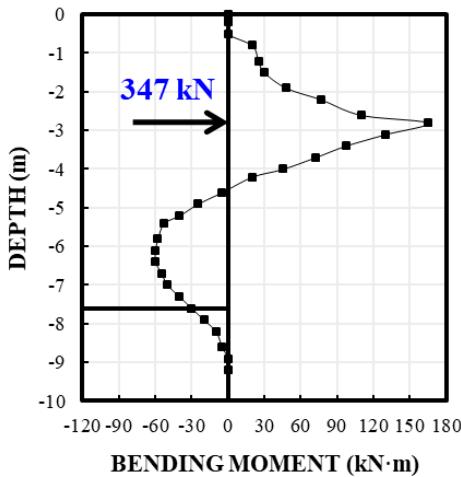
Figure 22. Wall bending moment profile at end of construction for one row of anchors (after Chung, Briaud, 1992).

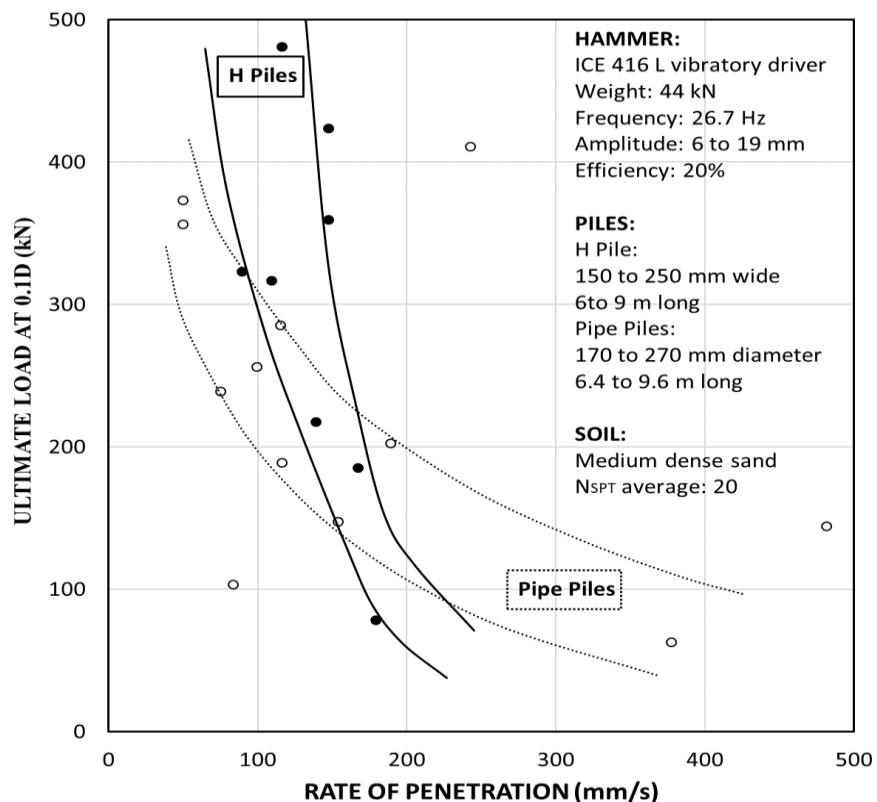
Figure 29. Ultimate pile capacity ($D/10$ criterion) vs. vibration rate of penetration (after Bossher et al., 1998).

Fig. 29 shows the rate within the last 0.5 m of penetration vs. the ultimate capacity of the pile defined as the load reached at a displacement equal to 1/10th of the pile diameter in the static load test. Note that the penetration rate profile was sometimes erratic at the end of vibrating; this makes the case for using the end of re-vibrating to improve upon the predictions. Nonetheless, the trend is as expected with a decrease in capacity as the penetration rate increases, but the plot exhibits quite a bit of scatter. The Briaud Tucker method, meant to calculate the ultimate capacity of impact driven piles in sand on the basis of SPT blow count (Briaud, 2013), was used and compared well with the measured data after applying a 0.75 reduction factor for vibro-driven piles. Thus, it seems reasonable to propose that:

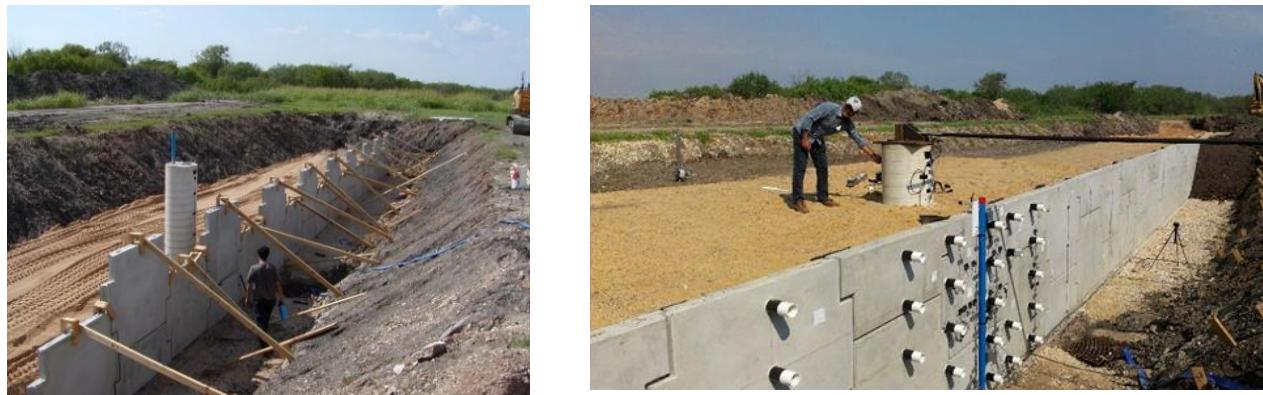
Figure 30. Construction of the MSE wall.

A 2.3 m high instrumented MSE wall was constructed and a 0.6 m diameter drilled shaft was placed behind the facing of the wall, with a clear spacing between the drilled shaft and the panel of the wall equal to 0.6 m (Figs. 30 and 31). The 5.5m long

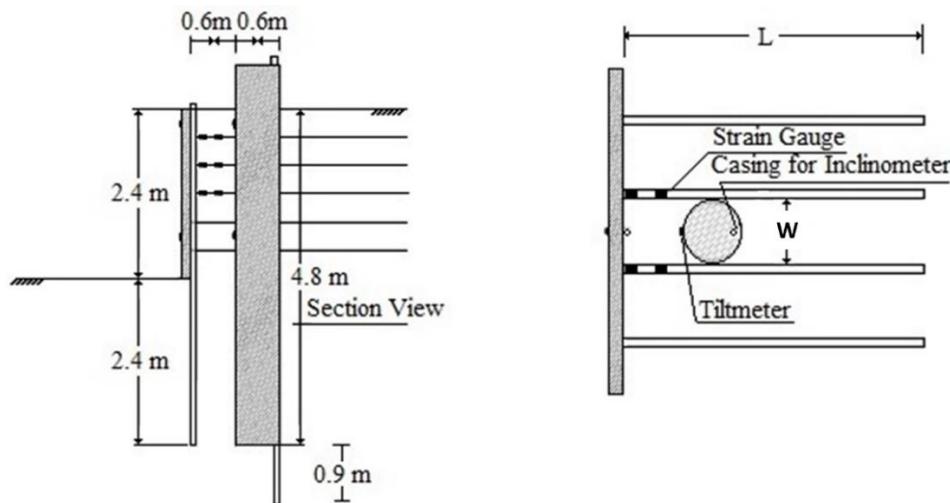
Figure 31. Setup and dimensions.

drilled shaft was embedded 2.3m below the bottom of the MSE wall in medium dense sand, with the next 2.3 m being in the MSE wall backfill. The MSE wall backfill was a compacted uniform medium dense sand with a friction angle equal to 27.5 degrees; this clean uniform backfill is different from the native sand at the site. The drilled shaft was loaded horizontally to 0.15m of displacement while recording all instruments.

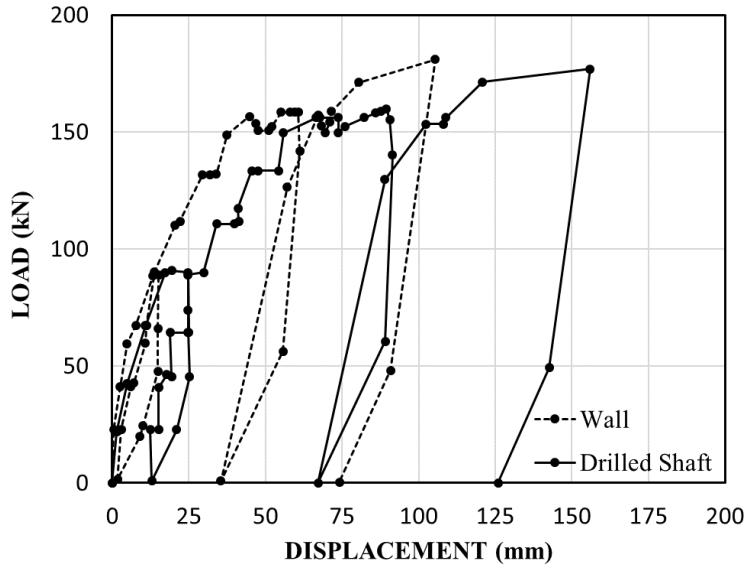
Figure 32. Measured load vs. displacement results for the drilled shaft and for the wall.

The data collected included the measurement of the horizontal load, the horizontal movement of the drilled shaft, the horizontal movement of the wall in front of the drilled shaft, and the pressure on the wall in front of the drilled shaft and on the drilled shaft. In addition, numerical simulations were conducted using FLAC 3D. All components of the MSE wall-drilled shaft system were simulated. The simulations were first calibrated against the full-scale experiment. A parametric study was then performed to identify the influence of each parameter on the MSE wall reinforcement. The load on the drilled shaft vs. the horizontal displacement of the drilled shaft, as well as the load on the drilled shaft vs. the horizontal displacement of the wall in front of the drilled shaft, are shown in Fig. 32.

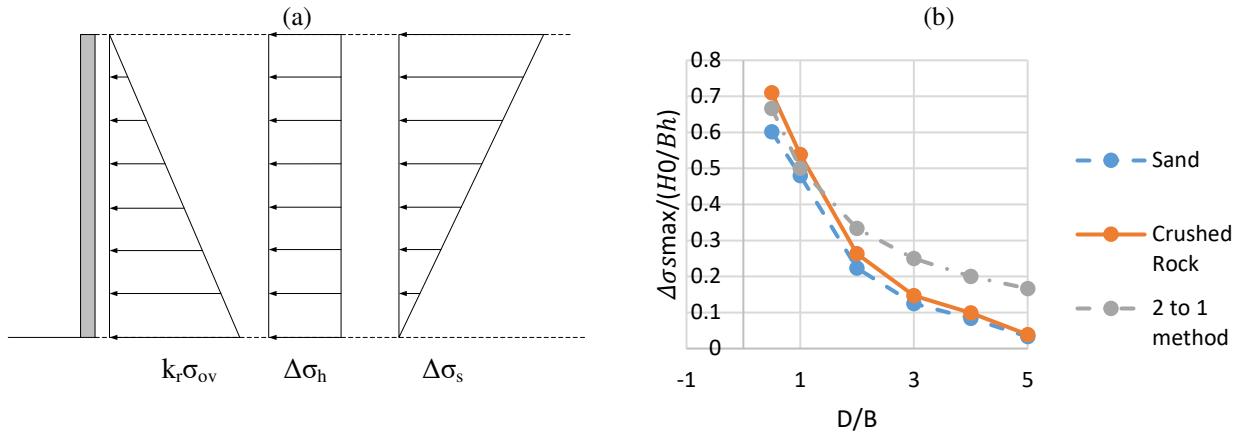
Figure 33. Recommended pressure diagram for drilled shaft behind MSE wall (Briaud et al., 2015): (a) pressure diagrams, (b) obtaining $\Delta \sigma_{max}$, where: k_r is the coefficient of earth pressure used for MSE walls (Briaud, 2013), σ_{ov} is the vertical stress at depth z below the ground surface, $\Delta \sigma_h$ is the increase in horizontal stress due to any surcharge applied at the top of the wall, $\Delta \sigma_s$ is the increase in horizontal stress due to the horizontal load on the pile, $\Delta \sigma_{max}$ is the maximum pressure at the top of the inverted triangular diagram in (a), $H0$ is the horizontal load on the pile, B is the pile diameter, h is the height of the wall, and D is the clear horizontal distance between the front edge of the pile and the wall panel.

It was found that at the maximum horizontal displacement in the horizontal load test, the maximum pressure on the drilled shaft was consistent with the calculated ultimate bearing capacity of the sand wedge between the drilled shaft and the MSE wall panel. This ultimate bearing capacity was calculated by assuming that the drilled shaft was a vertical strip footing with a width equal to the drilled shaft diameter. Based on the experiments and the simulations, MSE wall design guidelines were proposed. Among these guidelines is the inclusion of an additional pressure diagram $\Delta\sigma_s$ (Fig. 33) due to the design load on the drilled shaft; this additional pressure diagram is triangular and is to be resisted by the MSE wall reinforcement. The maximum pressure $\Delta\sigma_{s(\max)}$ at the top of the diagram depends on the horizontal load H_o on the drilled shaft, the diameter B of the drilled shaft, the height h of the wall, and on the clear distance D between the drilled shaft and the front of the MSE wall (Fig. 33).

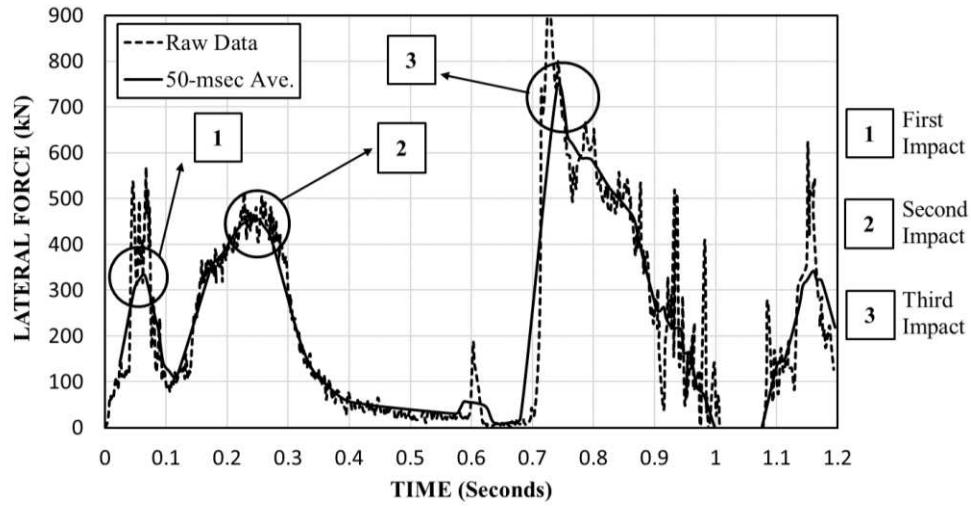
Figure 35. Impact load on the barrier during the event from numerical simulation.

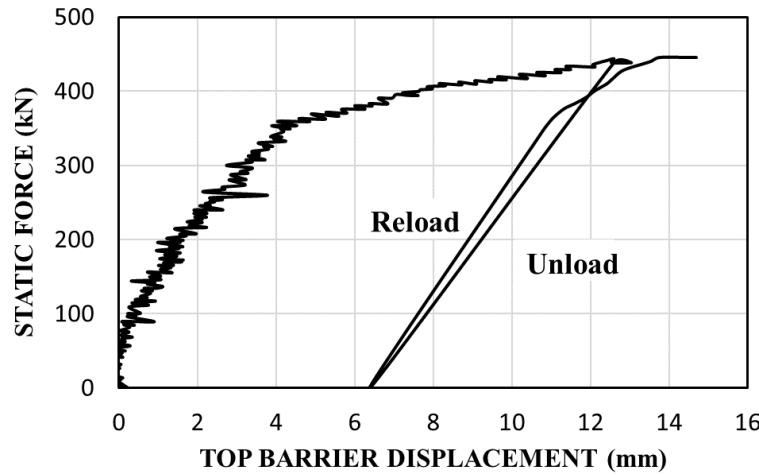
Figure 36. Static horizontal load-displacement curve for the barrier.

A static horizontal load test was later conducted on an unused part of the barrier by pulling on the barrier horizontally and away from the wall at the height of the truck’s impact; it gave a maximum static resistance of 445 kN, which corresponded to the lifting of the moment slab (Fig. 36). During the impact, the load in the reinforcement was recorded and the most highly stressed 3 m long reinforcing strip was located in the top layer of reinforcement and experienced a peak dynamic force of 9.34 kN which was reasonably well reproduced by the numerical simulation (Fig. 37). Because the calculated static capacity of a 3 m long strip in the first layer of reinforcement is 10.1 kN according to the AASHTO design rules (AASHTO, 2012), it is considered that the reinforcement was close to pull out failure during the impact. However, because the duration of the impact was so short, the associated displacement was limited and allowable; therefore, the design was acceptable. Note that the rupture load of a strip is much higher and about 58 kN. More details on this test and other tests can be found in Bligh et al. (2017).

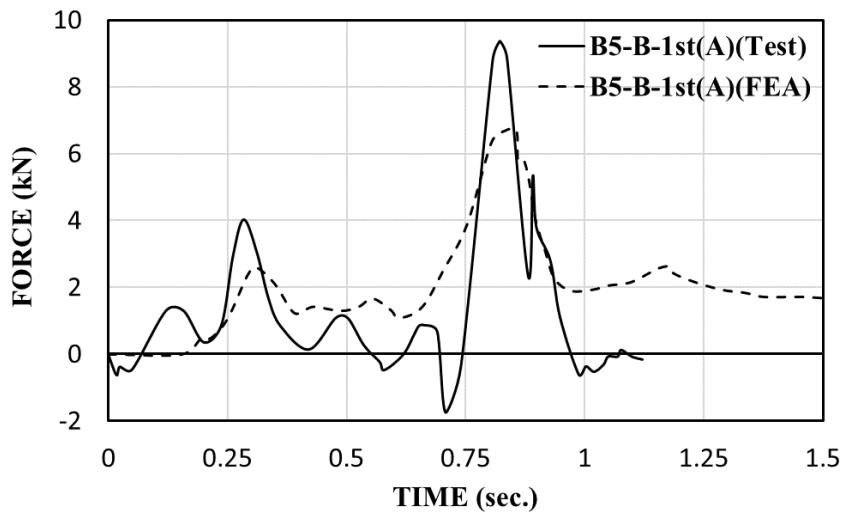
Figure 37. Tension load in the reinforcement.
