40 Years of Full-Scale Infrastructure Testing at a National Geotechnical Experimentation Site: Sand Site.

Jean-Louis Briaud, Distinguished Professor, Zachry Dpt. of Civil Engineering, Texas A&M University, College Station, Texas, 77834-3136, U.S.A.; email: briaud@tamu.edu

Reference: Briaud J.L. (2021). 40 Years of Full-scale Infrastructure Testing at a National Geotechnical

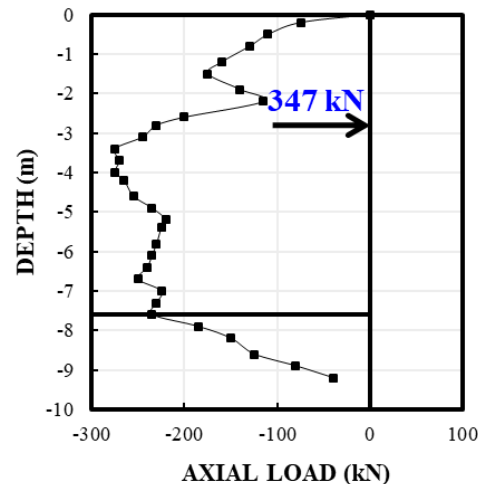
Figure 23. Wall vertical load at end of construction for one row of anchors (after Chung, Briaud, 1992).

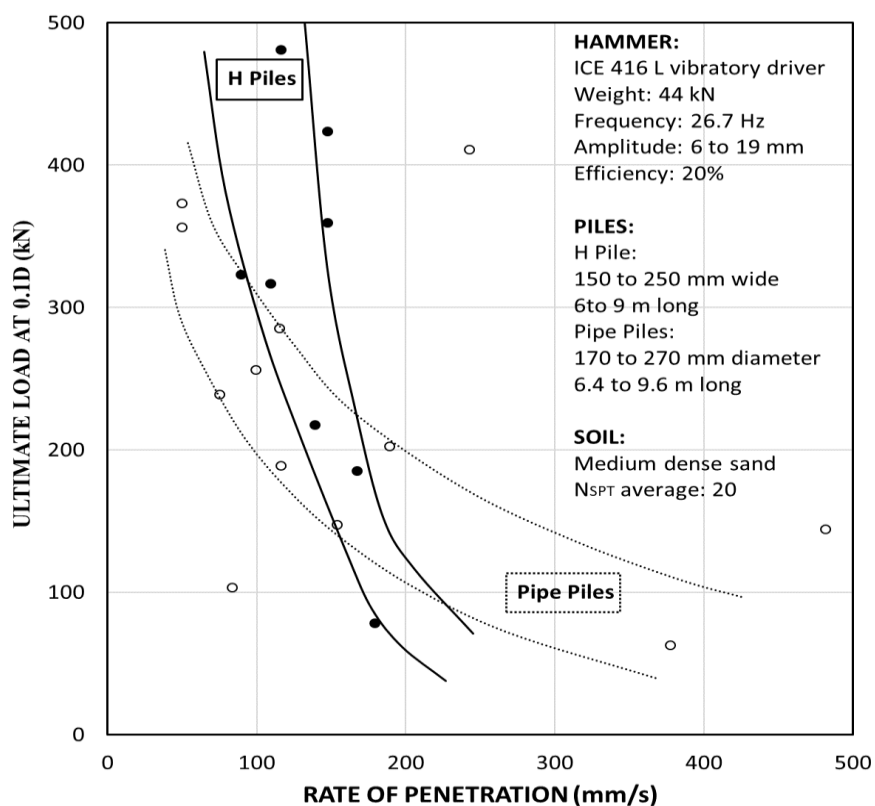
Figure 29. Ultimate pile capacity ($D/10$ criterion) vs. vibration rate of penetration (after Bossher et al., 1998).

Fig. 29 shows the rate within the last 0.5 m of penetration vs. the ultimate capacity of the pile defined as the load reached at a displacement equal to $1/10^{\text{th}}$ of the pile diameter in the static load test. Note that the penetration rate profile was sometimes erratic at the end of vibrating; this makes the case for using the end of re-vibrating to improve upon the predictions. Nonetheless, the trend is as expected with a decrease in capacity as the penetration rate increases, but the plot exhibits quite a bit of scatter. The Briaud Tucker method, meant to calculate the ultimate capacity of impact driven piles in sand on the basis of SPT blow count (Briaud, 2013), was used and compared well with the measured data after applying a 0.75 reduction factor for vibro-driven piles. Thus, it seems reasonable to propose that:
