40 Years of Full-Scale Infrastructure Testing at a National Geotechnical Experimentation Site: Sand Site.

ABSTRACT: A site at the Texas A&M University RELLIS campus near College Station, Texas, was dedicated to full-scale infrastructure testing in 1978. It was designated as a National Geotechnical Experimentation Site by NSF and FHWA in 1992. The site is made of 15 m of medium dense silty sand, within which most experiments took place, underlain by a deep layer of clay shale. The water table is approximately 7.5 m deep. Over the last 40 years, many full-scale instrumented experiments on infrastructure elements have been conducted at that site. The main projects include a box culvert within an embankment, spread footings of various sizes, drilled shafts with intentional construction defects, an anchored top down retaining wall, a top down deep-soil-mixing retaining wall, post grouted drilled shafts, vibro-driven steel piles, a drilled shaft embedded in an MSE wall and pushing on it, a tractor trailer truck crashing against a barrier on top of an MSE wall, a single unit truck crashing against a row of in line piles, and erosion in-situ tests. This paper describes each one of those p

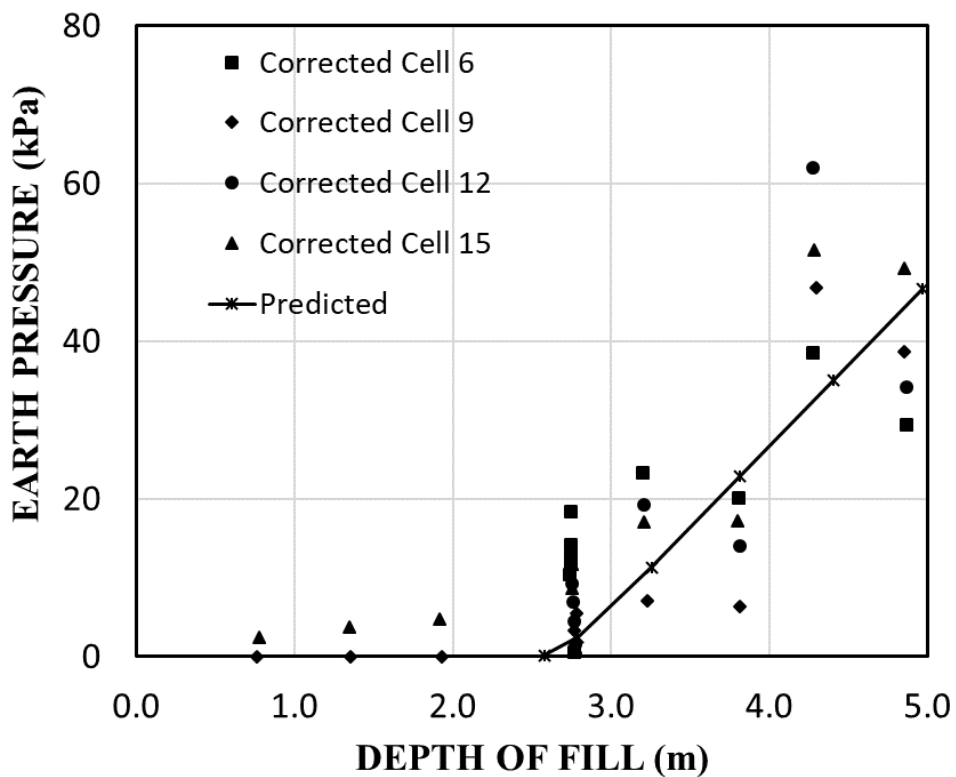
Figure 6. Pressure cell readings as a function of the fill height (after James et al., 1986).

The pressure on the top of the culvert, given by the pressure cells, increased as the fill increased in height (Fig. 6). As can be seen, the scatter is not negligible but the trend matches the total vertical stress σ expressed as γz where γ is the soil total unit weight of 20 kN/m³ and z is the depth of fill. This depth of fill refers to the thickness of the fill; it was zero when the fill level is near the bottom of the culvert, thus the pressure cells on top of the culvert only started to record pressure when the fill reached the top of the culvert. The pressure cell readings as the rear axle of the truck passed on top of the cells and for different depth of cover are shown in Fig. 7. Remember that the tire pressure was of the order of 550 kPa, yet the pressures on the cells placed on the roof of the culvert were much smaller than 550 kPa. In fact, they seemed to obey the stress distribution that one would have obtained from a bulb of pressure elastic approach (Briaud, 2013).
