40 Years of Full-Scale Infrastructure Testing at a National Geotechnical Experimentation Site: Sand Site.

Jean-Louis Briaud, Distinguished Professor, Zachry Dpt. of Civil Engineering, Texas A&M University, College Station, Texas, 77834-3136, U.S.A.; email: briaud@tamu.edu

ABSTRACT: A site at the Texas A&M University RELLIS campus near College Station, Texas, was dedicated to full-scale infrastructure testing in 1978. It was designated as a National Geotechnical Experimentation Site by NSF and FHWA in 1992. The site is made of 15 m of medium dense silty sand, within which most experiments took place, underlain by a deep layer of clay shale. The water table is approximately 7.5 m deep. Over the last 40 years, many full-scale instrumented experiments on infrastructure elements have been conducted at that site. The main projects include a box culvert within an embankment, spread footings of various sizes, drilled shafts with intentional construction defects, an anchored top down retaining wall, a top down deep-soil-mixing retaining wall, post grouted drilled shafts, vibro-driven steel piles, a drilled shaft embedded in an MSE wall and pushing on it, a tractor trailer truck crashing a

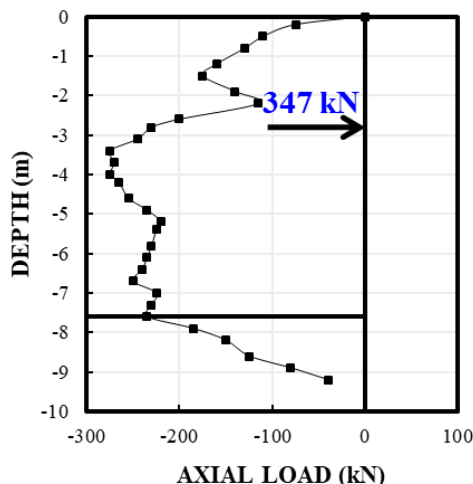
Figure 23. Wall vertical load at end of construction for one row of anchors (after Chung, Briaud, 1992).
