Asynchronous Mobilization of Shear Resistance in Slope Failures

ABSTRACT: *This paper focuses on the case study of the 2014 embankment failure at the Mount Polley TSF in Canada to study deformation-controlled mechanisms of instability leading to the asynchronous mobilization of shear strength and causing progressive failure. Three such mechanisms were identified in this failure: strain-weakening, the delayed mobilization of shear strength in the shell owing to stiffness incompatibility, and a reduction of mobilized shear resistance in the extending regions of the slide due to loss of confinement. Changes associated with these mechanisms were identified in the numerical analysis to help diagnose the impending collapse. These are: the emergence in the strain-weakening unit of a substantive area on the brink of strain-weakening, the depletion of reserve strengths in the foundation materials, and the extension of the unit above the strain-weakening zone owing to differential shear displacements within and outside the failure zone. Safety factor calculations do not adequately capture the stability of the Mount Polley embankment in the year preceding its collapse, and limit equilibrium

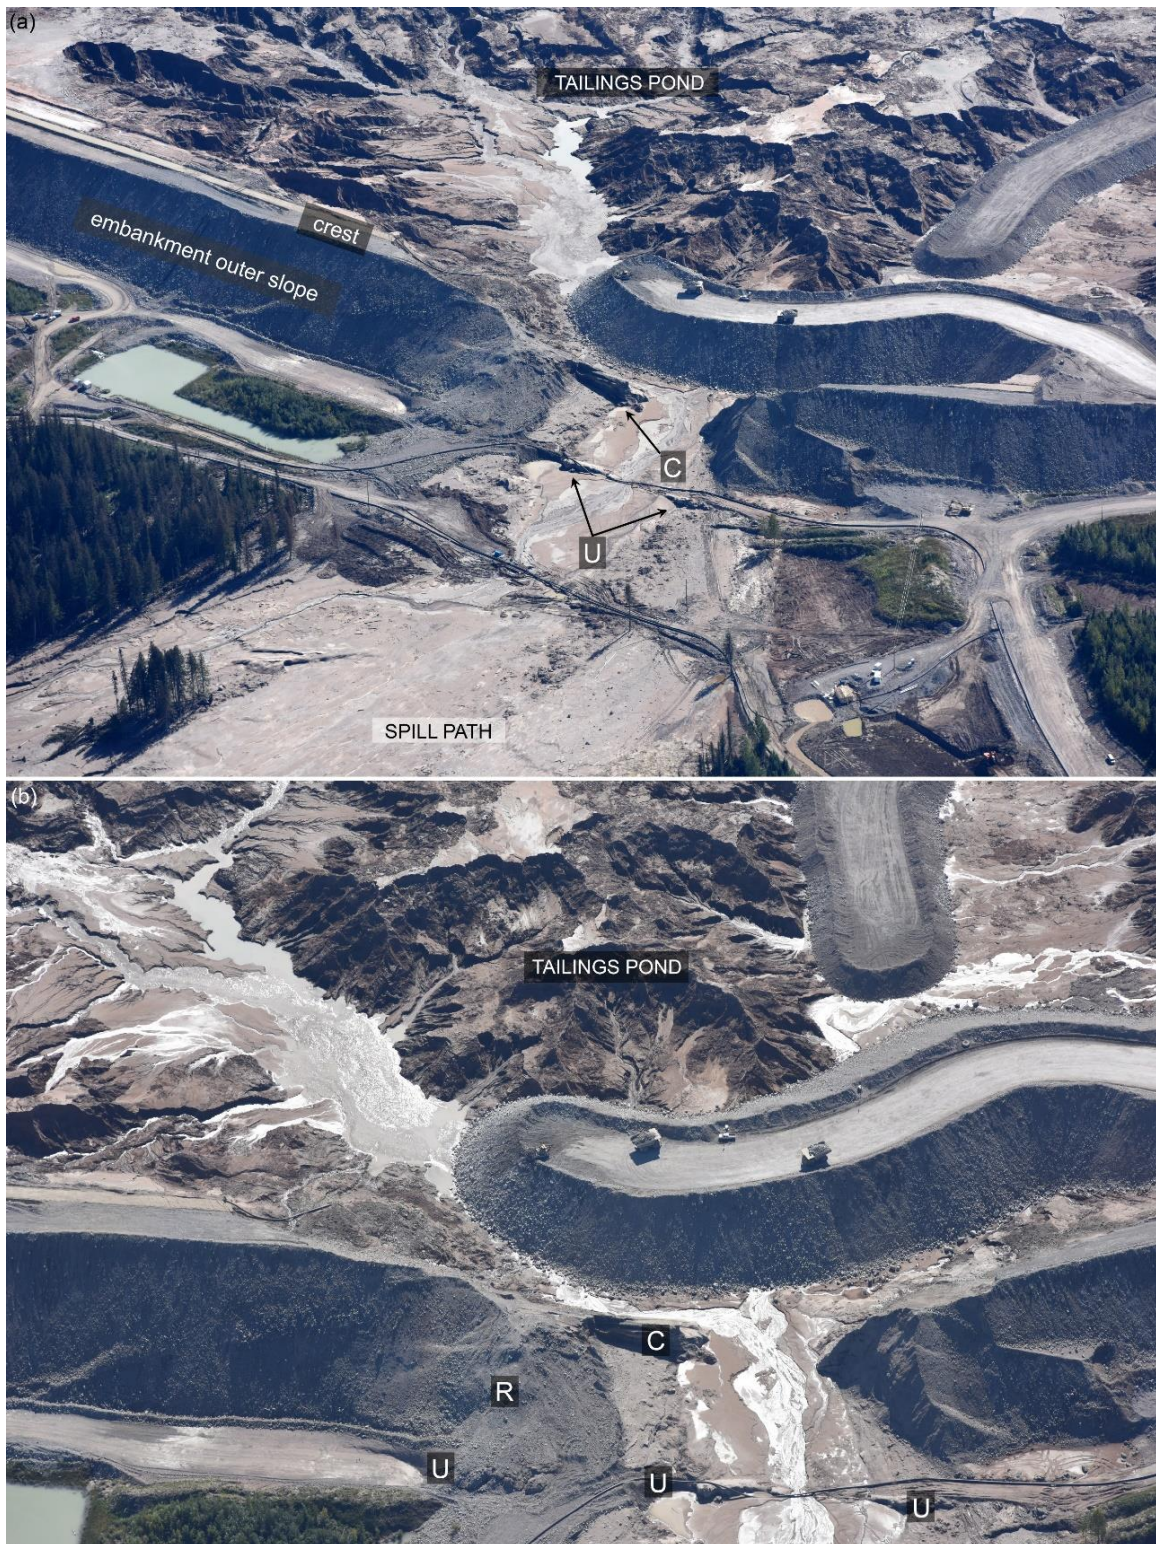
Figure 4. (a) Aerial diagonal view of the breach and spill path areas; (b) Aerial diagonal close-up of the breach location. Labels: C – core remnant, R – rockfill at the east boundary of the slide, U – uplift at the toe of the slide. Photography courtesy of Jamie Heath of terrasaurus.ca, taken 09/05/2014, reproduced with permission, altered to add labels.

Above the slide base, the geometry of the slip was irregular. Extensive ground cracking, shear zones (IRP 2015, Fig. 5.1.7), and sheared remnants of core (Fig. 4, feature C) delineated the extent of the slide in the upstream region roughly along the dam centerline and just few meters upstream of the Upper GLU's upstream edge. The failure zone was restricted to a width $\sim 100\text{m}$ at ground level, widening to $\leq 150\text{m}$ at crest level. The broad (200-250m) slip surface in the Upper GLU did not clearly propagate into the embankment; however, the rockfill in the shell zone flanking the breach is seen to have undergone significant deformation (Fig. 4, feature R). This material's lower deformation modulus and resulting stress-strain incompatibility with the rest of the structure was inferred both from the large deformations at failure but also from a documented history of poor compaction and low confinement stresses.
