Appendix A.13:

Bower Ave – CPT 3937

Liquefaction Ejecta Case Histories for 2010-11 Canterbury Earthquakes

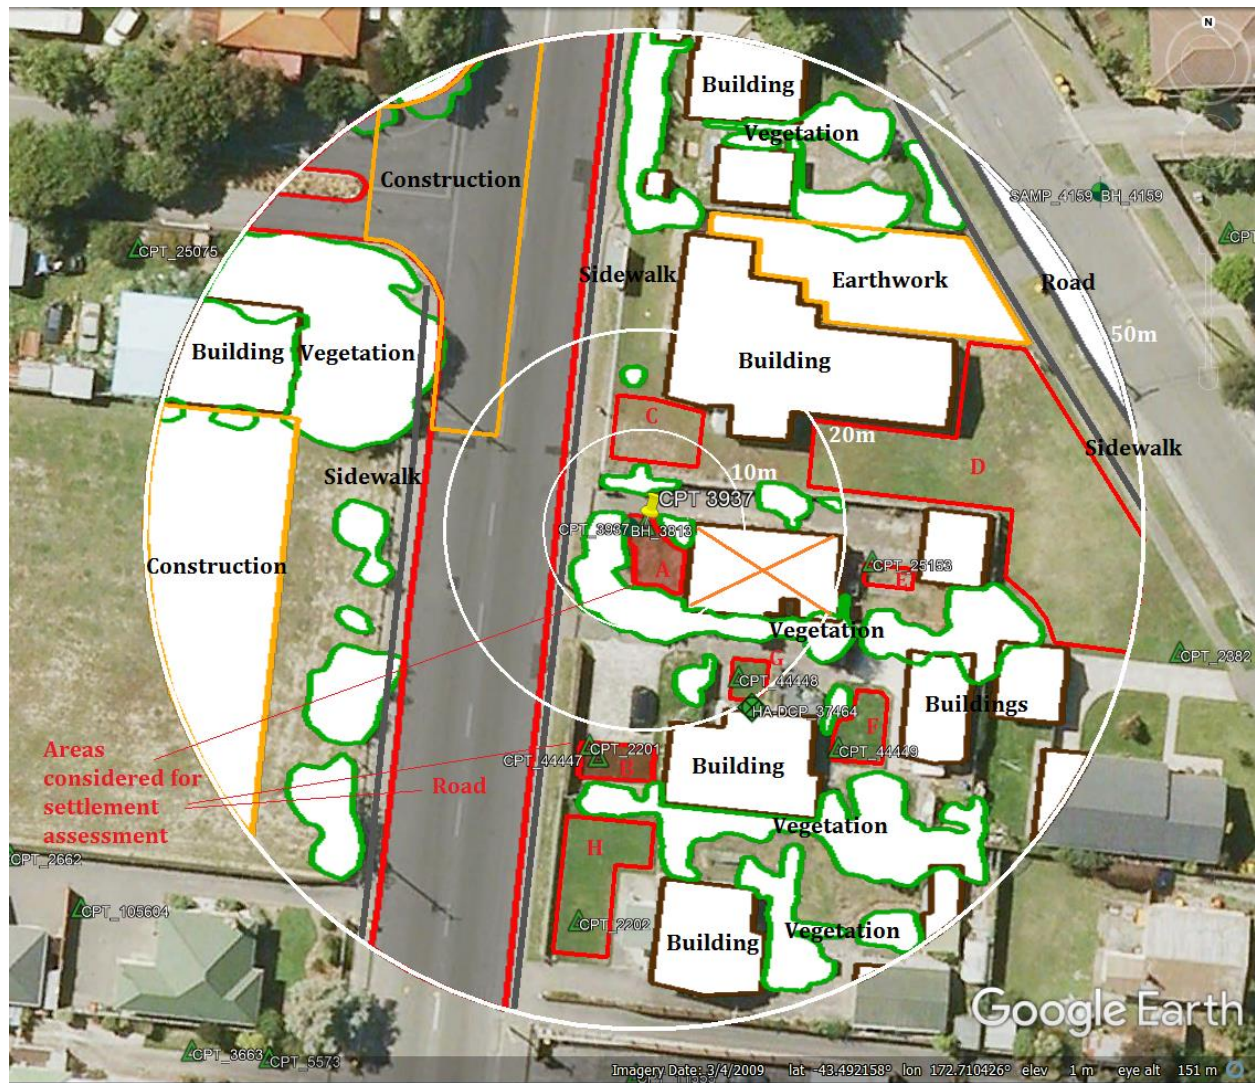
Figure 1: Site plan with areas where LiDAR survey data is considered.

Note 1: Eight patches (outlined in red) in free field were initially selected for settlement assessment as areas free of vegetation and structures. Further analyses such as proximity of a patch to a CPT, proximity of a patch to a property subjected to addition and/or demolition of a structure, front yard/backyard alterations (e.g., ploughing, rubble, scrap), aerial distribution of sediment ejecta, and density of LiDAR points for 2003 resulted in Patches A and B being selected for detailed settlement assessment and other patches being discarded in detailed settlement assessment. In addition, since significant amounts of ejecta were observed on roads in the CES, the entire portion of the road within the 50-m buffer was considered for settlement assessment. Roads as hard, relatively flat surfaces provide many ground-classified points.

- A_T is the total assessment area for a buffer being considered (Figure 1).

Note 7: The selection of CPTs for the area considered for settlement assessment (Figure 1) is based on the proximity of the CPTs to the considered areas. In accordance with that, the following table shows CPTs that were used for the volumetric settlement analysis in *Cliq v.3.0.3.2*, a CPT soil liquefaction software developed by GeoLogismiki. (The average volumetric settlements were reported in Table 8.)

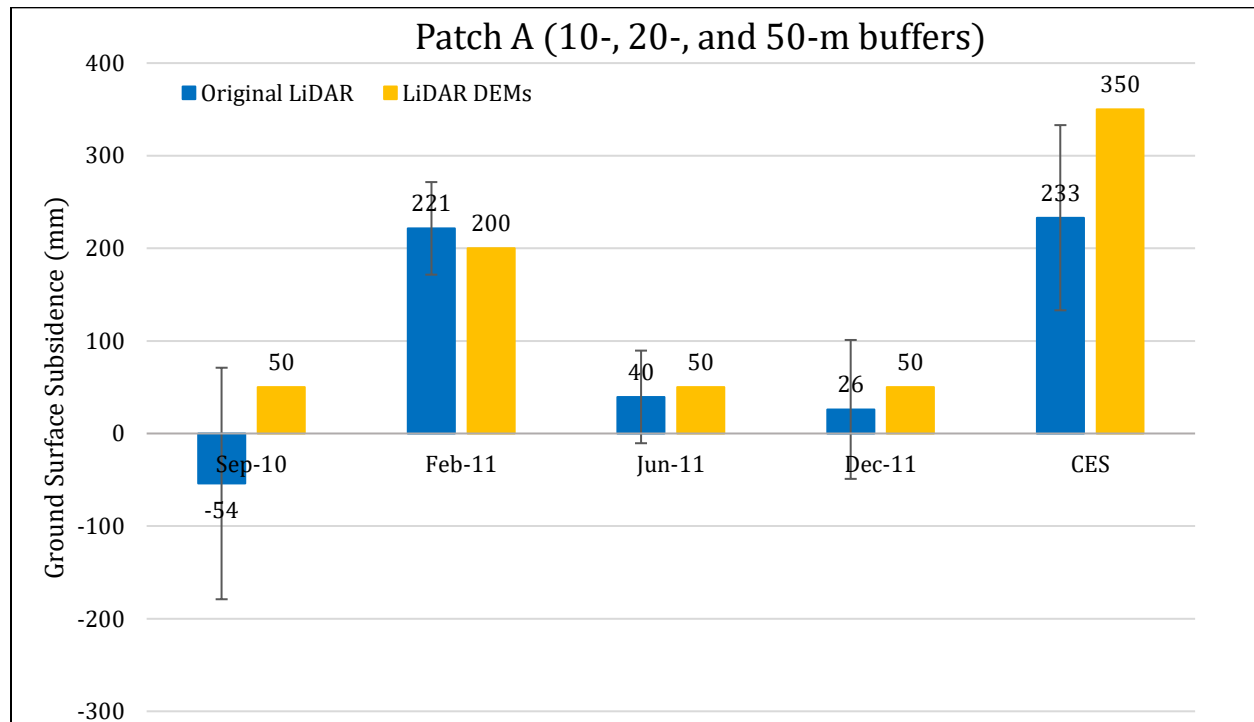
Figure 2: Comparison between ground surface subsidence determined from original LiDAR survey points and ground surface subsidence (50th %ile) estimated using LiDAR DEMs for Patch A.

Note 2: The ground surface subsidence values determined from original LiDAR survey points are in agreement with the ground surface subsidence values estimated using LiDAR DEMs for all earthquake events.

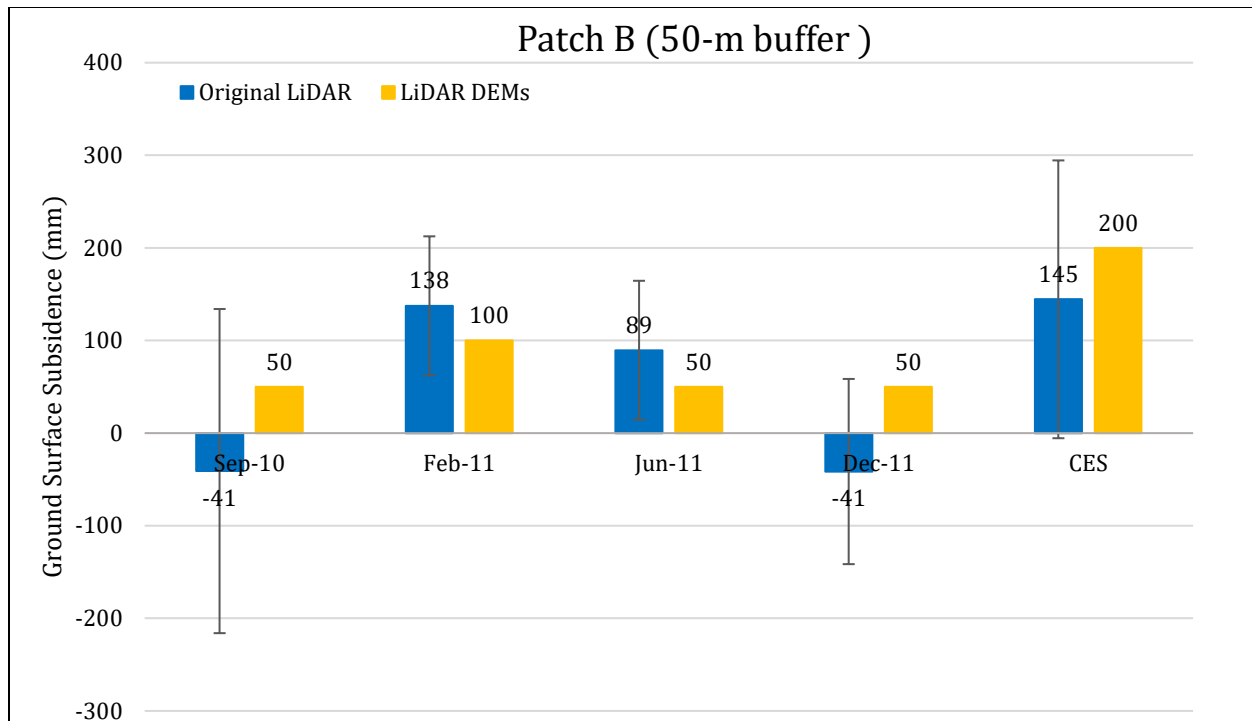
Figure 3: Comparison between ground surface subsidence determined from original LiDAR survey points and ground surface subsidence (50th %ile) estimated using LiDAR DEMs for Patch B for the 50-m buffer.

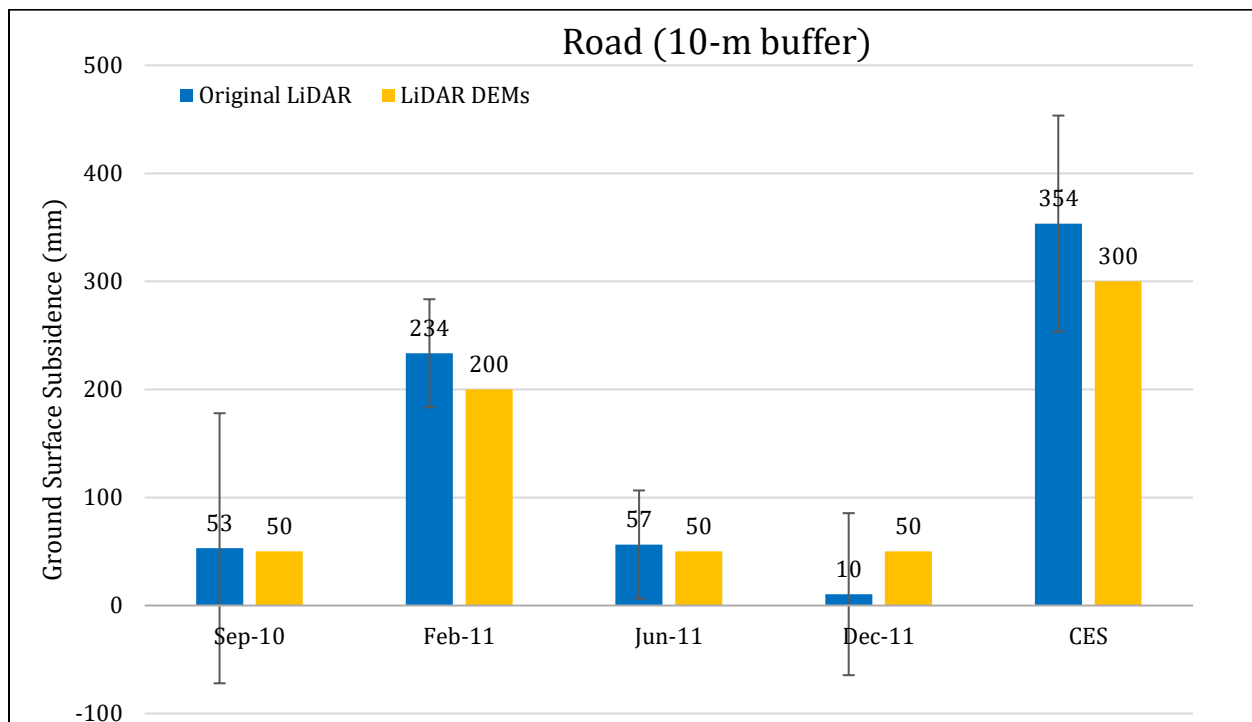
Figure 4: Comparison between ground surface subsidence determined from original LiDAR survey points and ground surface subsidence (50th %ile) estimated using LiDAR DEMs for Road for the 10-m buffer.

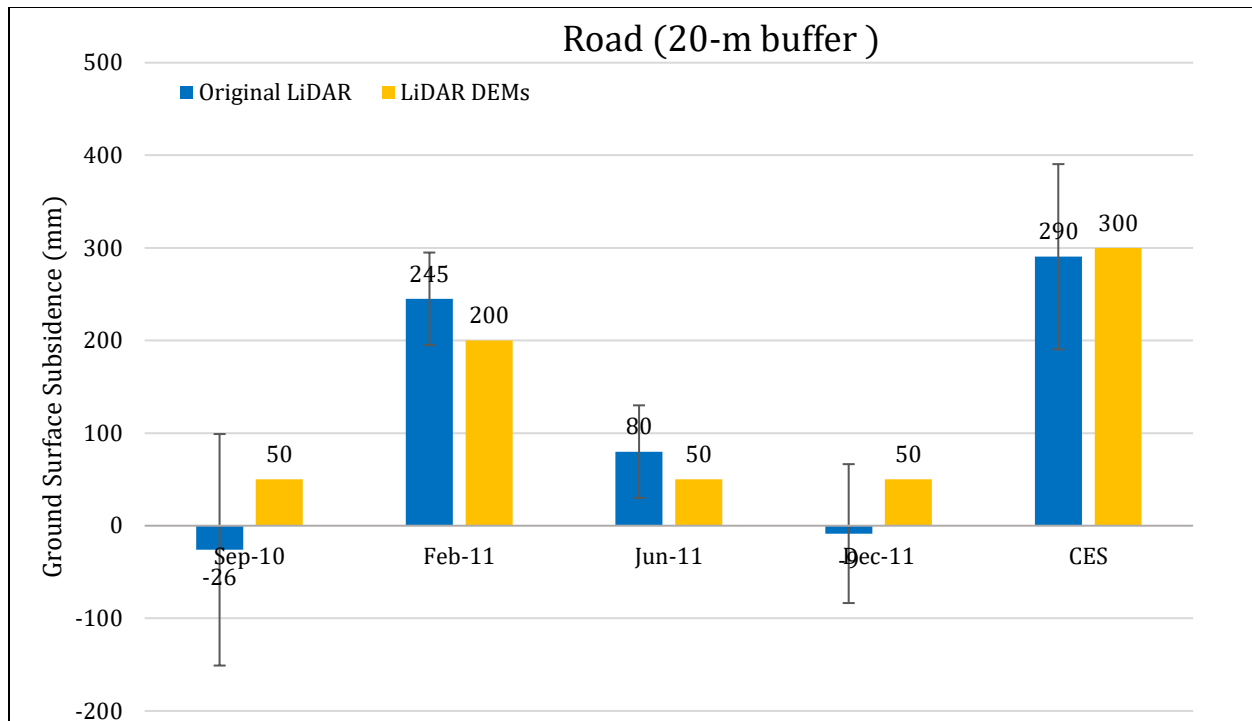
Figure 5: Comparison between ground surface subsidence determined from original LiDAR survey points and ground surface subsidence (50th %ile) estimated using LiDAR DEMs for Road for the 20-m buffer.

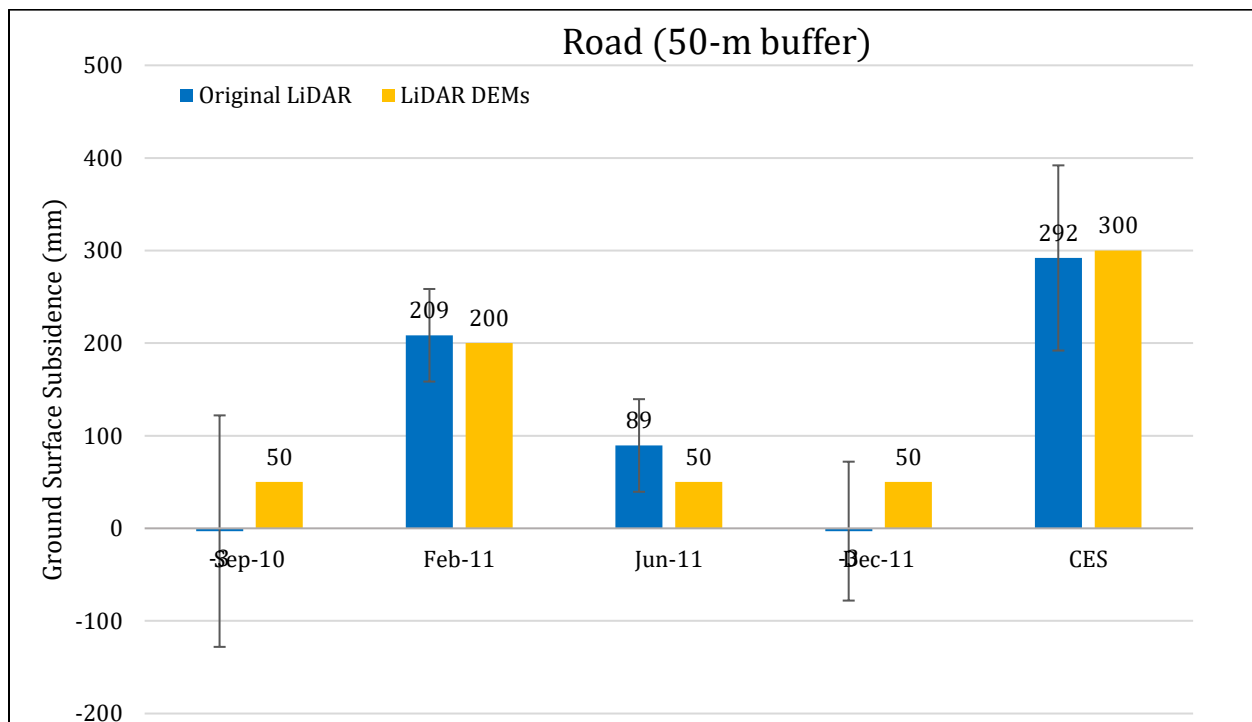
Figure 6: Comparison between ground surface subsidence determined from original LiDAR survey points and ground surface subsidence (50th %ile) estimated using LiDAR DEMs for Road for the 50-m buffer.

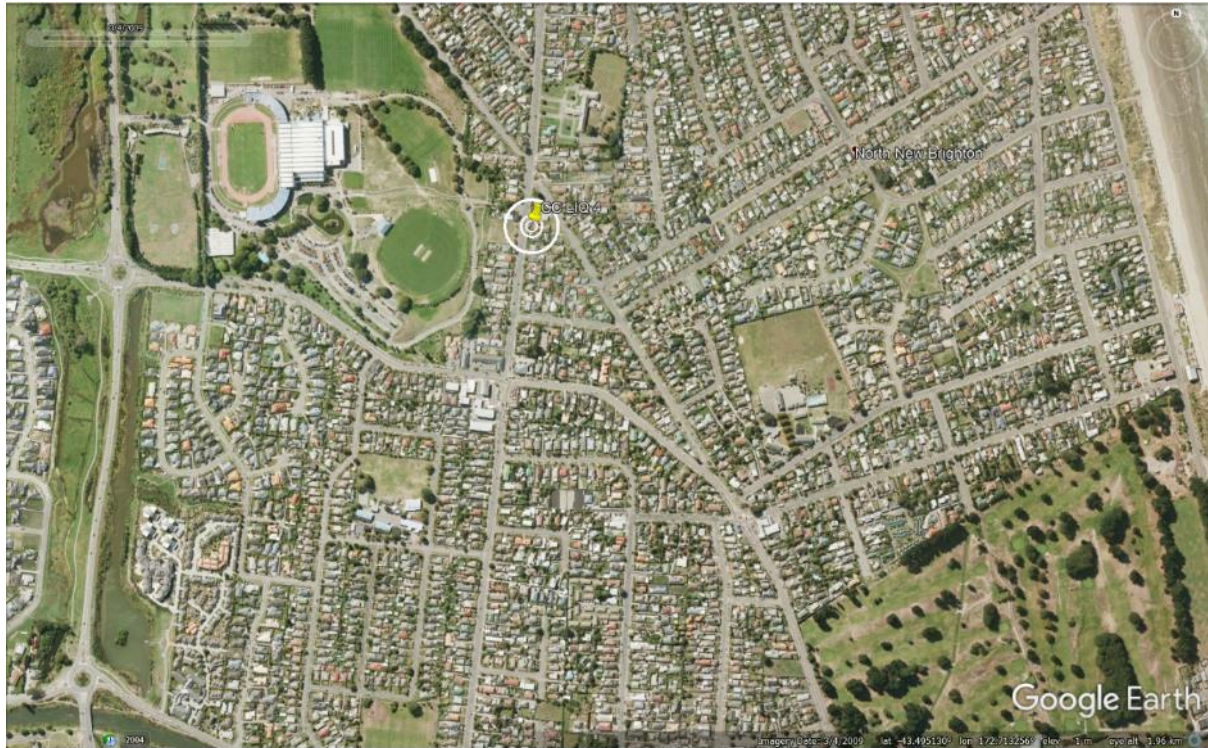
Figure 8: Position of the site relative to nearby buildings, vegetation, and free-face features.

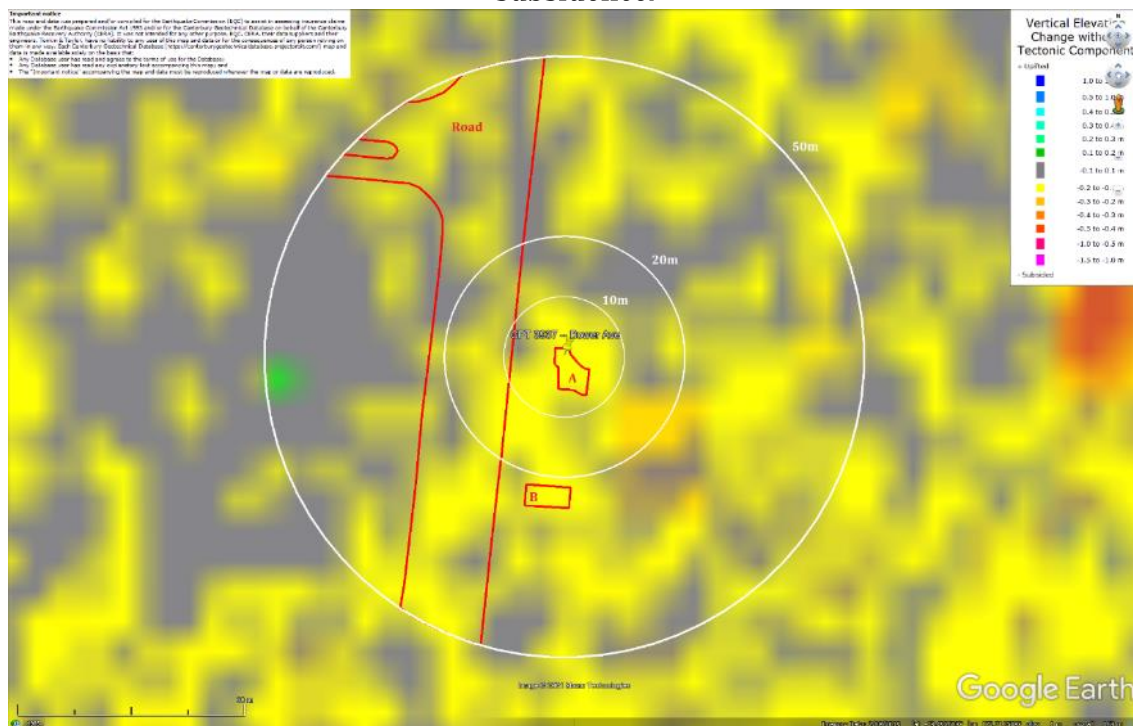
Figure 29: Ground surface subsidence without tectonic component for Sep 2010 Earthquake according to the LiDAR DEM.

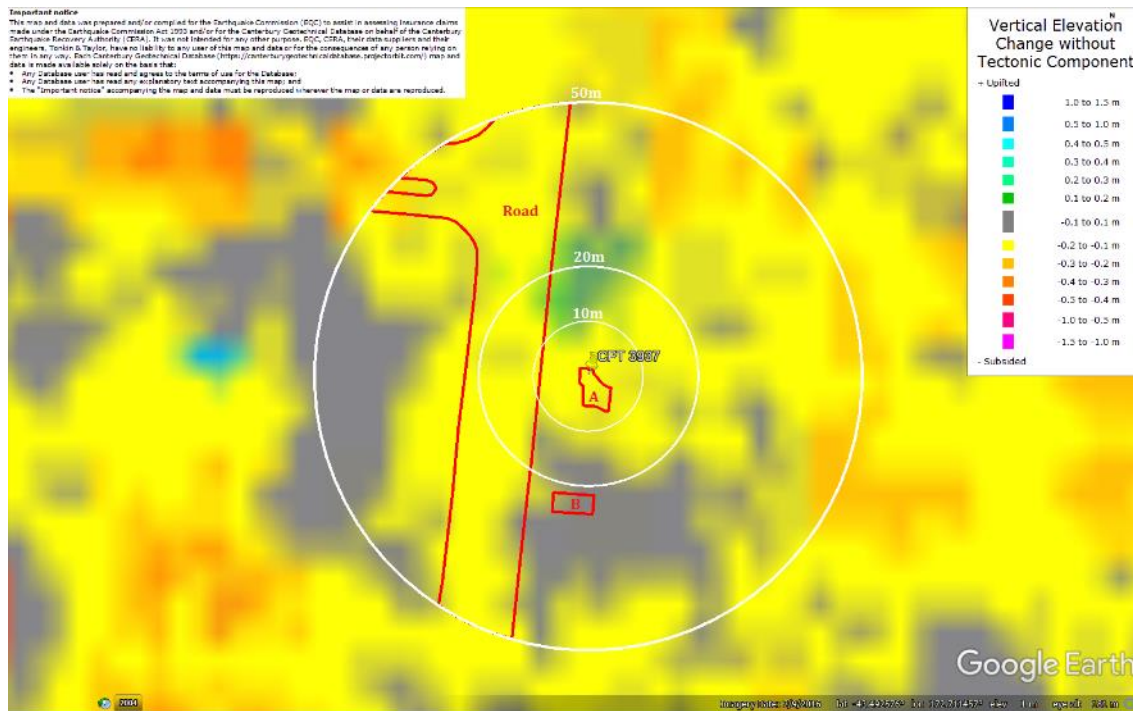
Figure 30: Ground surface subsidence without tectonic component for Feb 2011 Earthquake according to the LiDAR DEM.

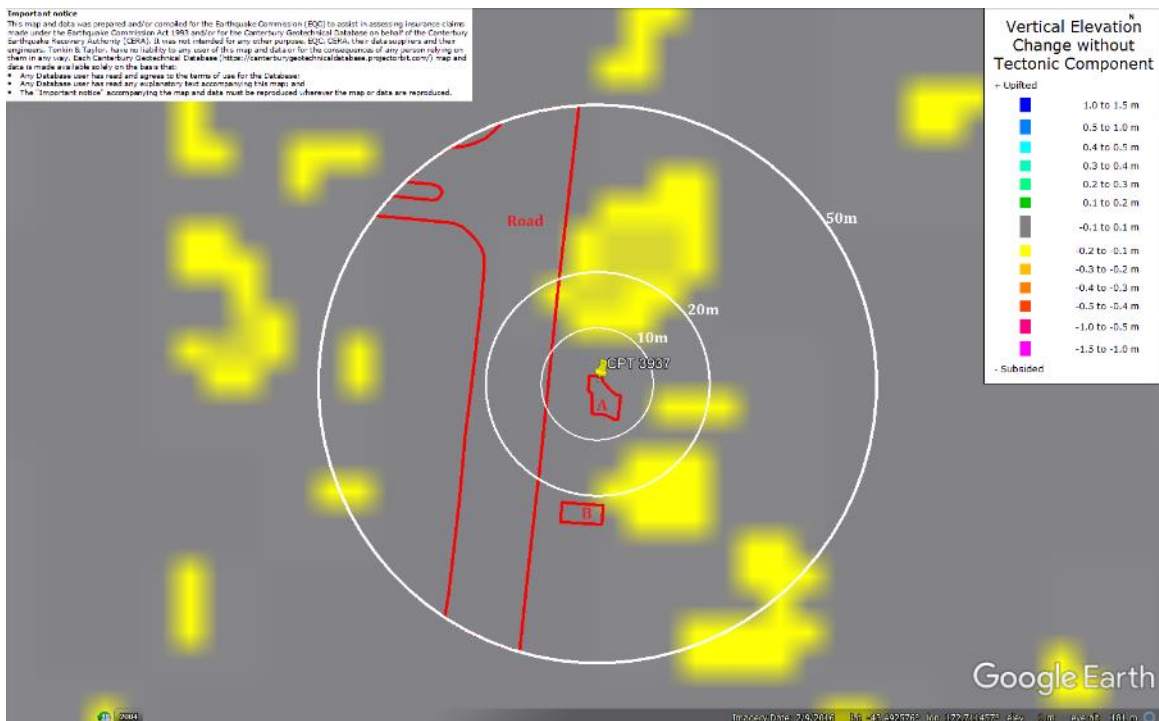
Figure 31: Ground surface subsidence without tectonic component for June 2011 Earthquake according to the LiDAR DEM.

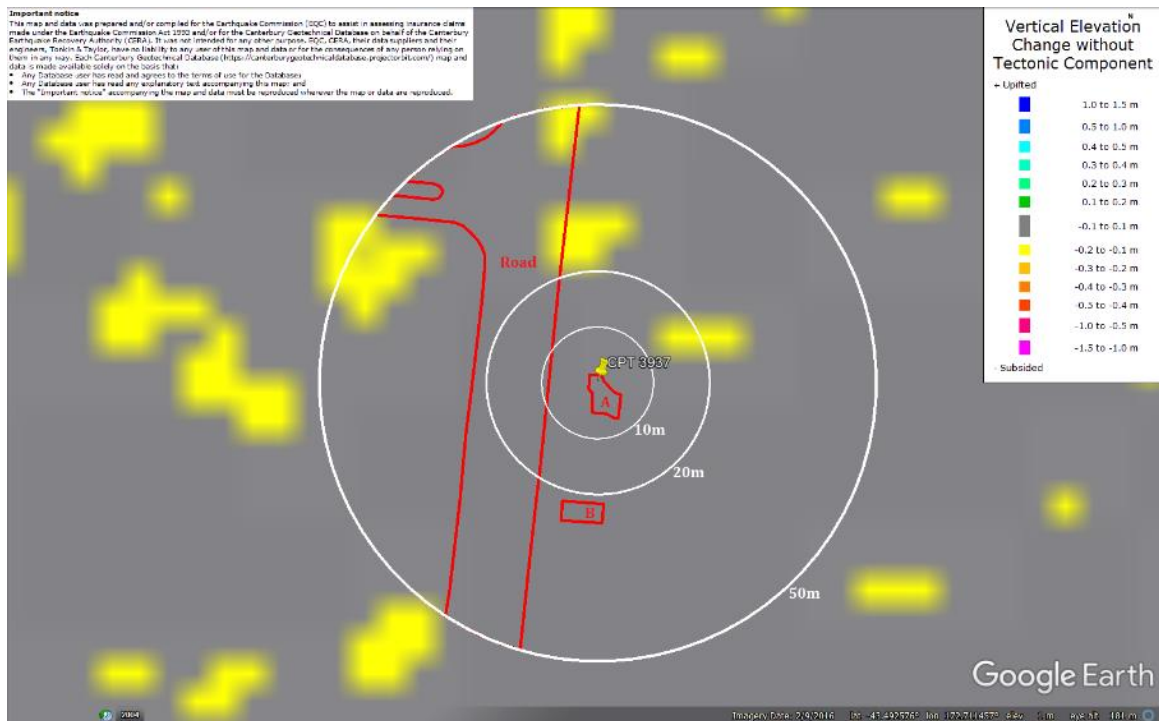
Figure 32: Ground surface subsidence without tectonic component for Dec 2011 Earthquake according to the LiDAR DEM.

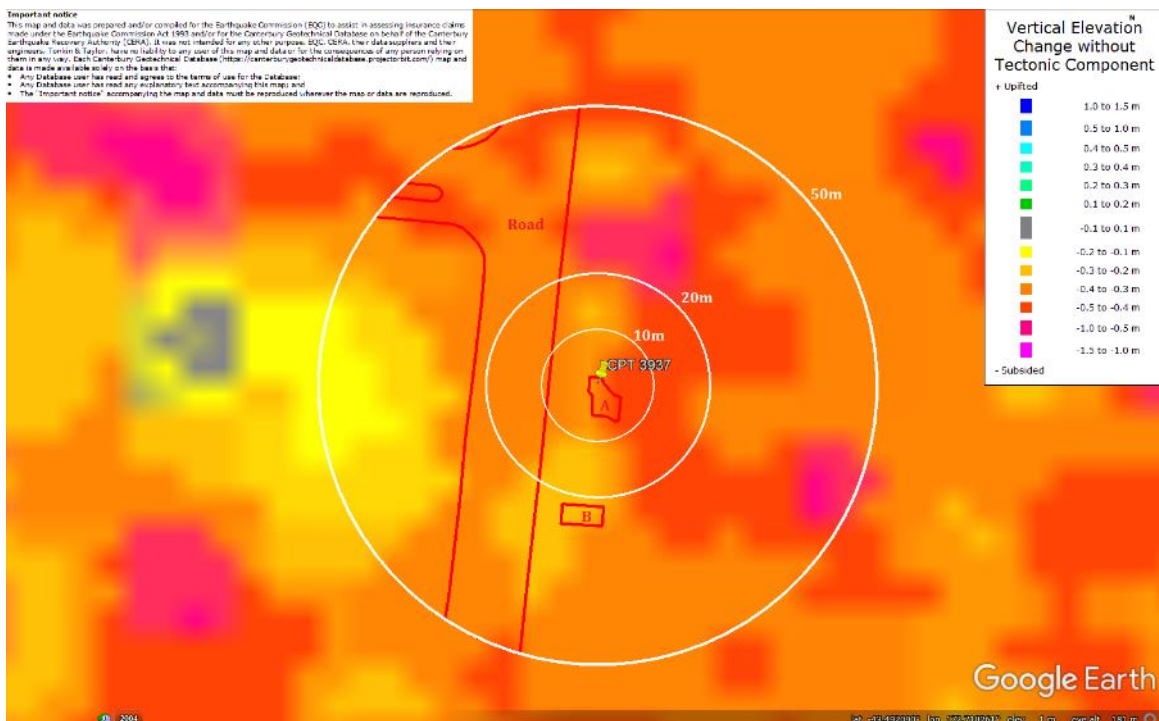
Figure 33: Ground surface subsidence without tectonic component for Canterbury Earthquake Sequence according to the LiDAR DEM.

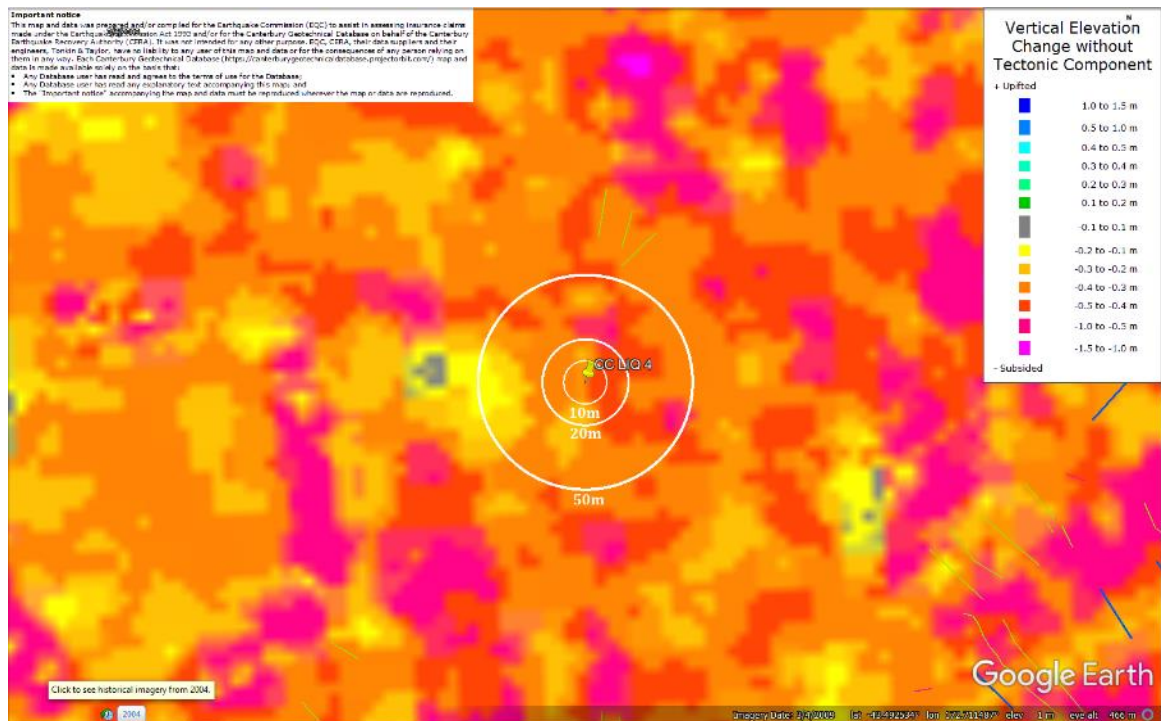
Figure 34: Absence of ground cracks indicating no lateral spreading for Canterbury Earthquake Sequence.

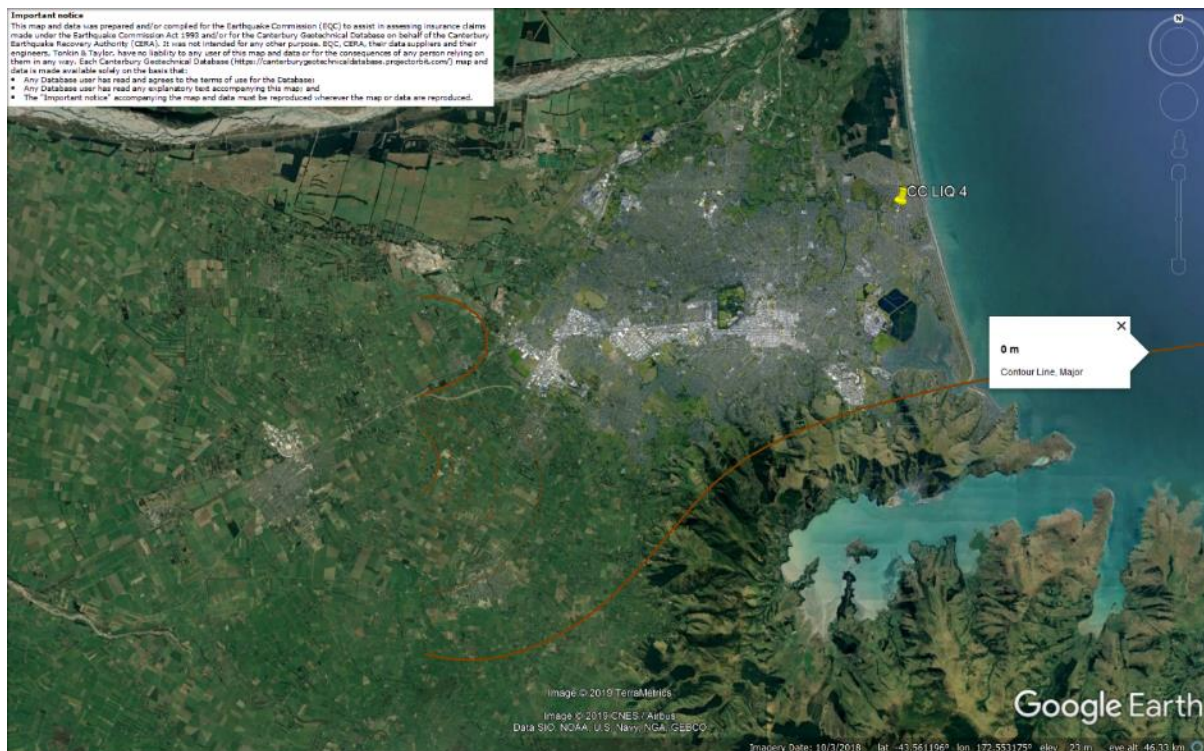
Figure 35: Vertical tectonic movements for Sep 2010 Earthquake.

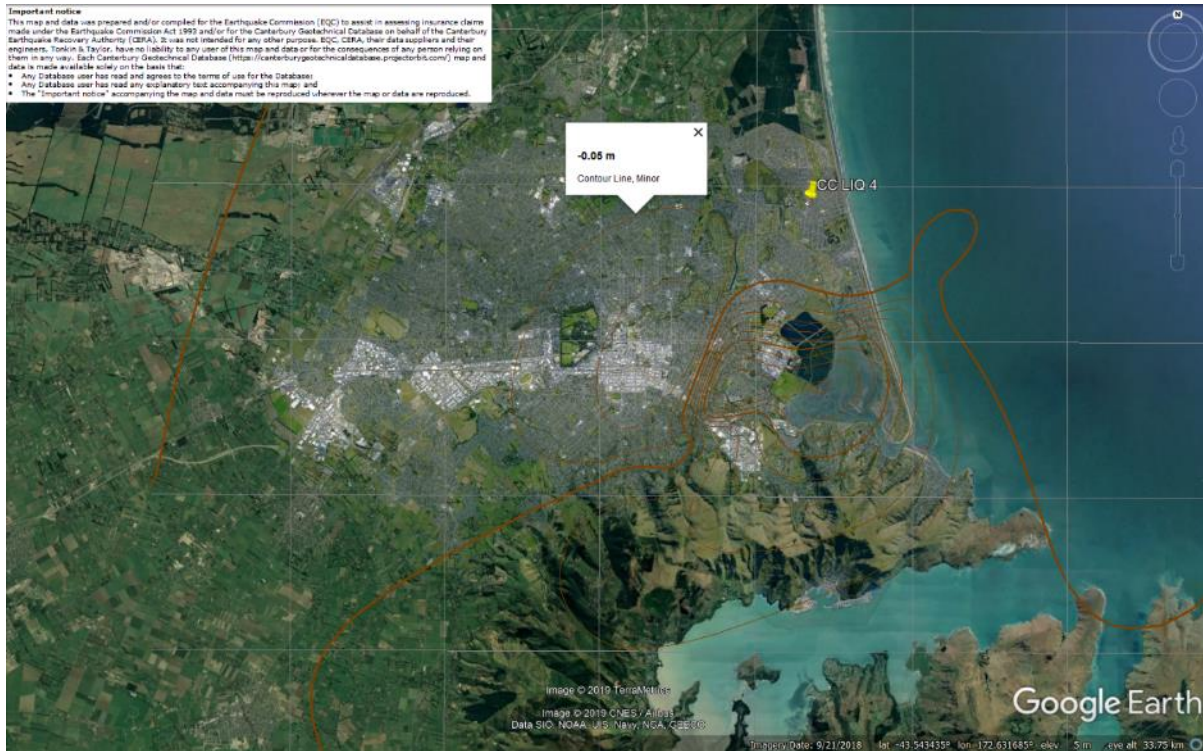
Figure 36: Vertical tectonic movements for Feb 2011 Earthquake.

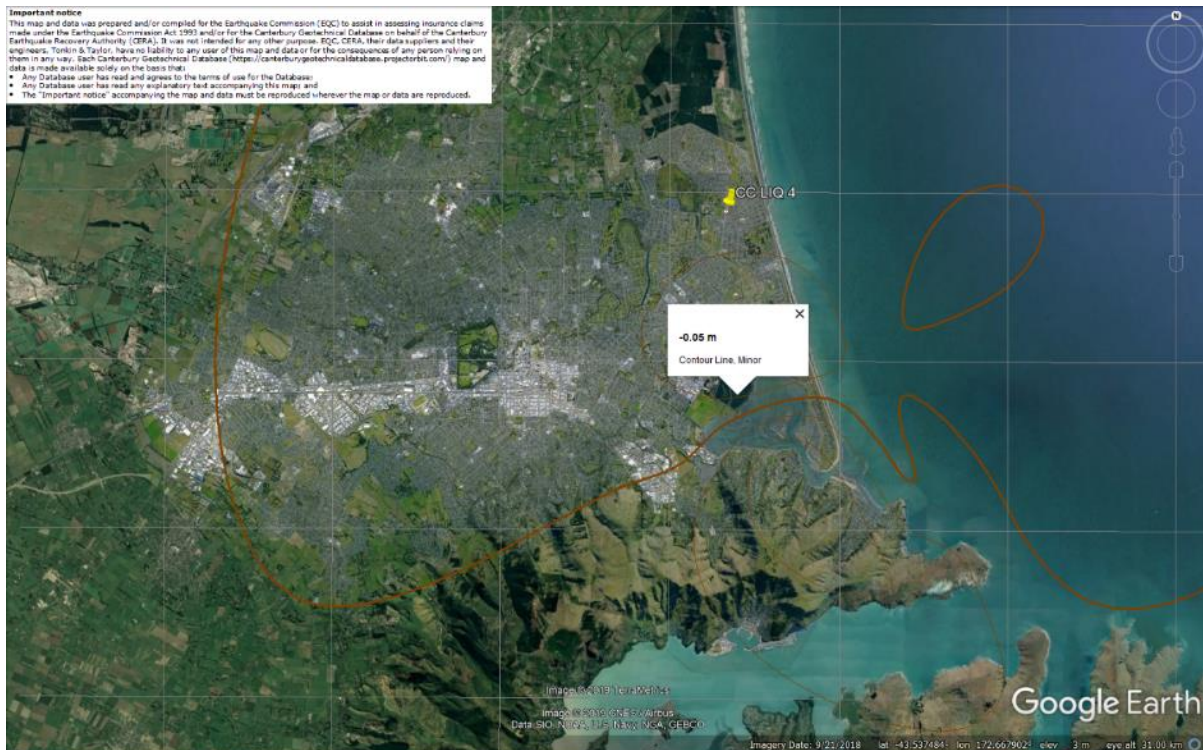
Figure 37: Vertical tectonic movements for June 2011 Earthquake.

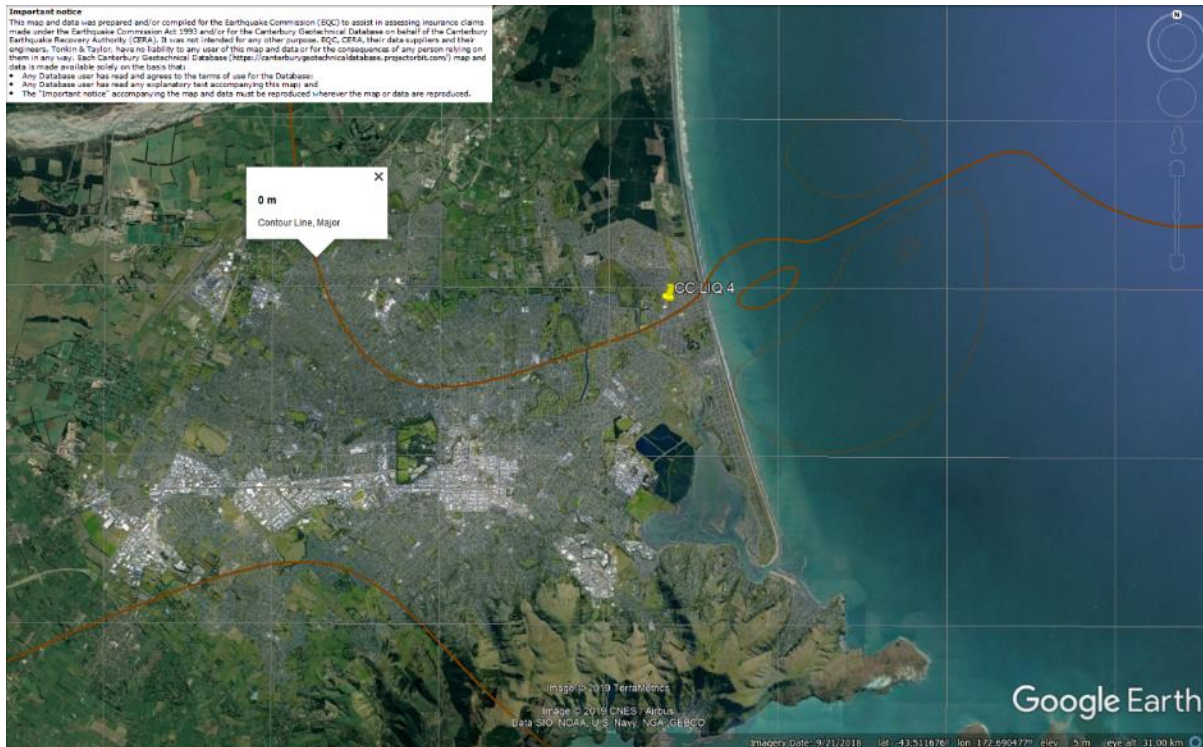
Figure 38: Vertical tectonic movements for Dec 2011 Earthquake.

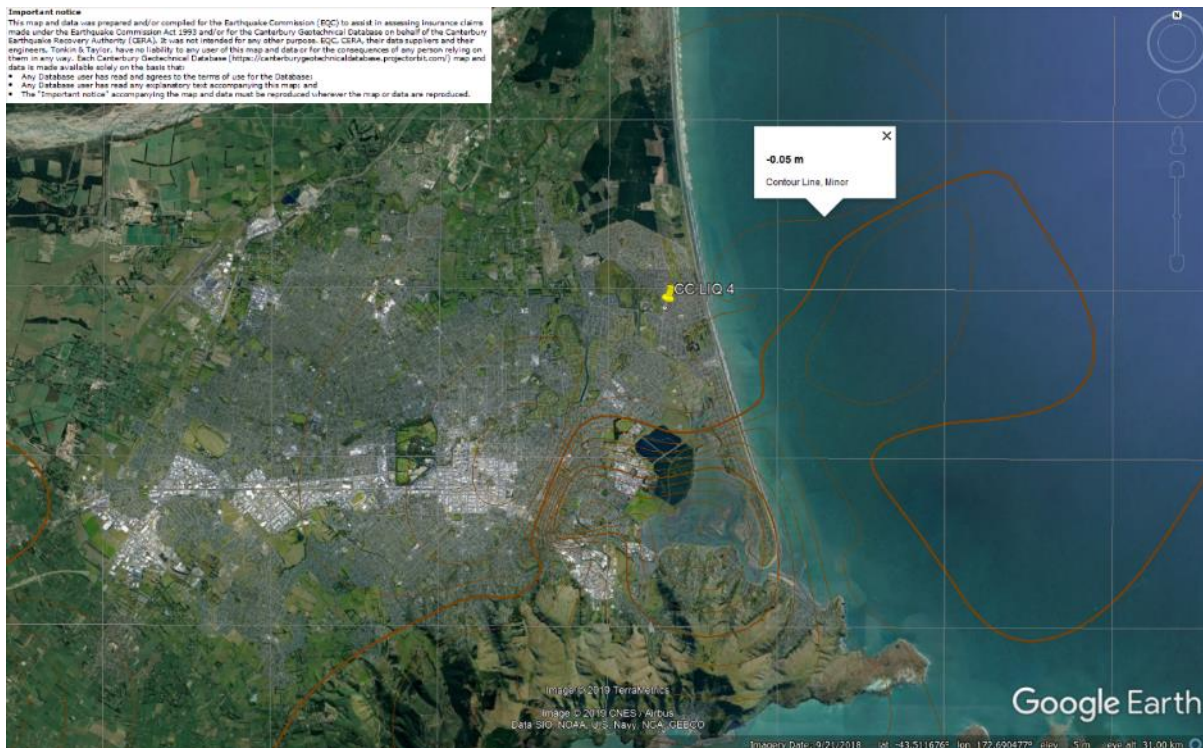
Figure 39: Vertical tectonic movements for Canterbury Earthquake Sequence.

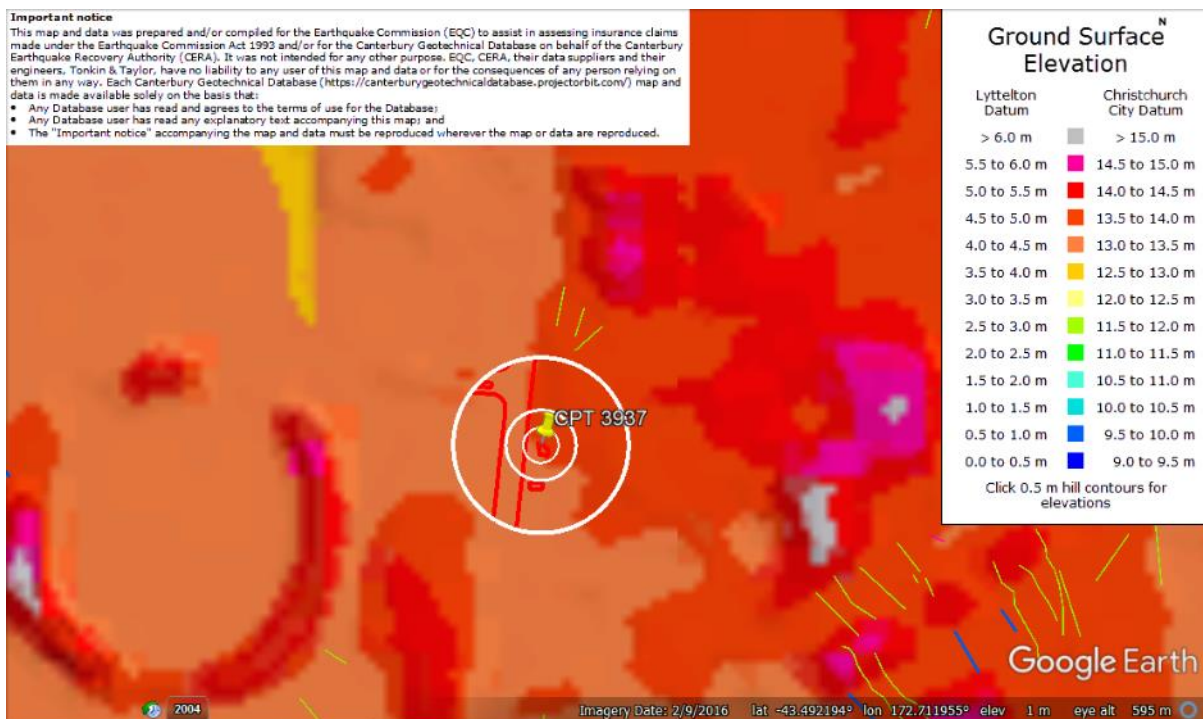
Figure 81: Ground surface elevation difference between the road and properties (LiDAR DEM for Sept 2010).

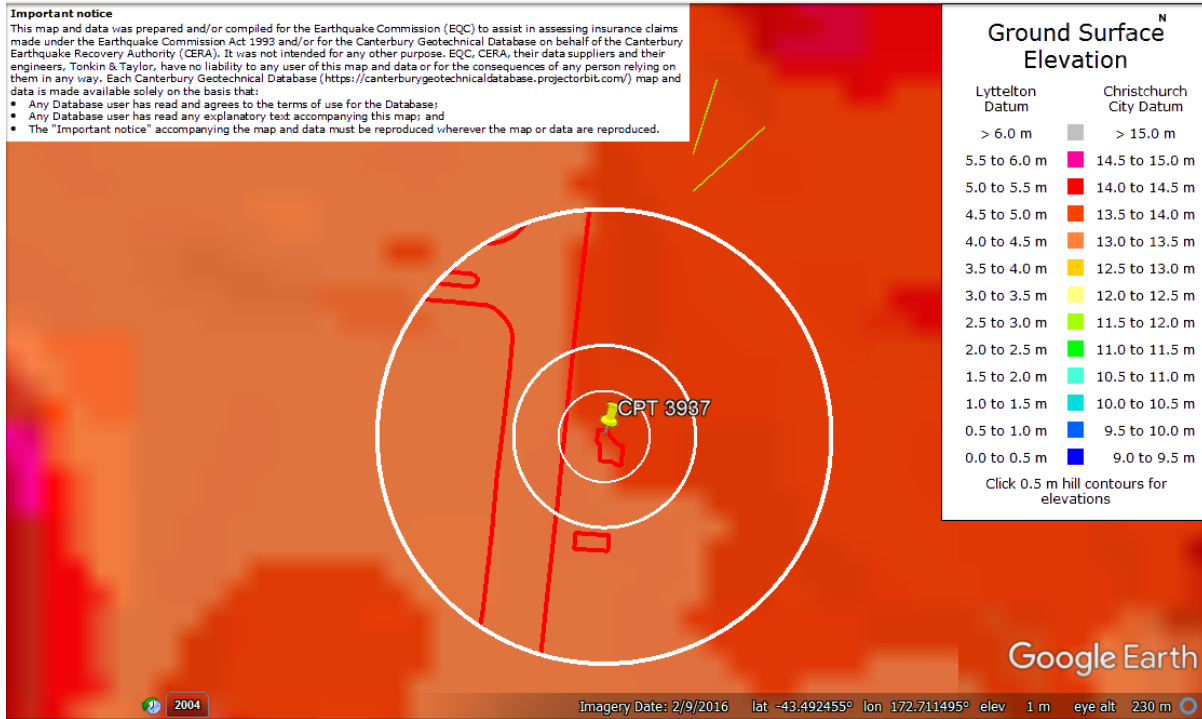
Figure 82: Enlarged view of ground surface elevation difference between the road and properties (LiDAR DEM for Sept 2010).

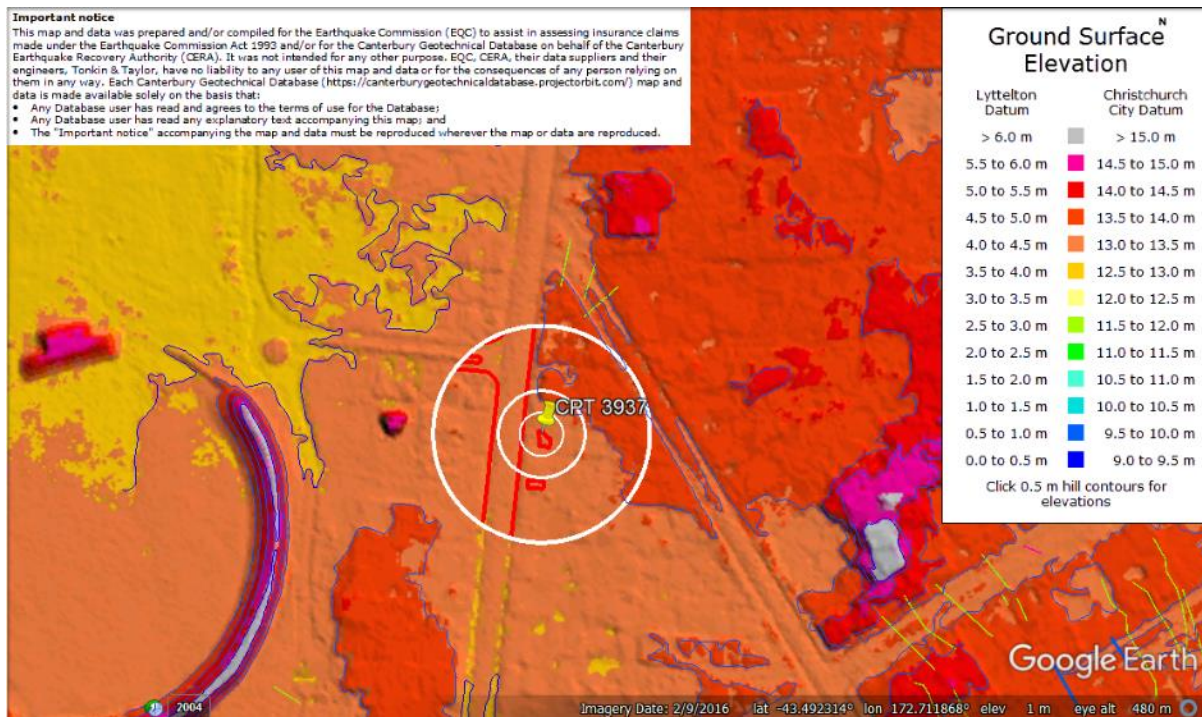
Figure 83: Ground surface elevation difference between the road and properties (LiDAR DEM for Sept 2011).

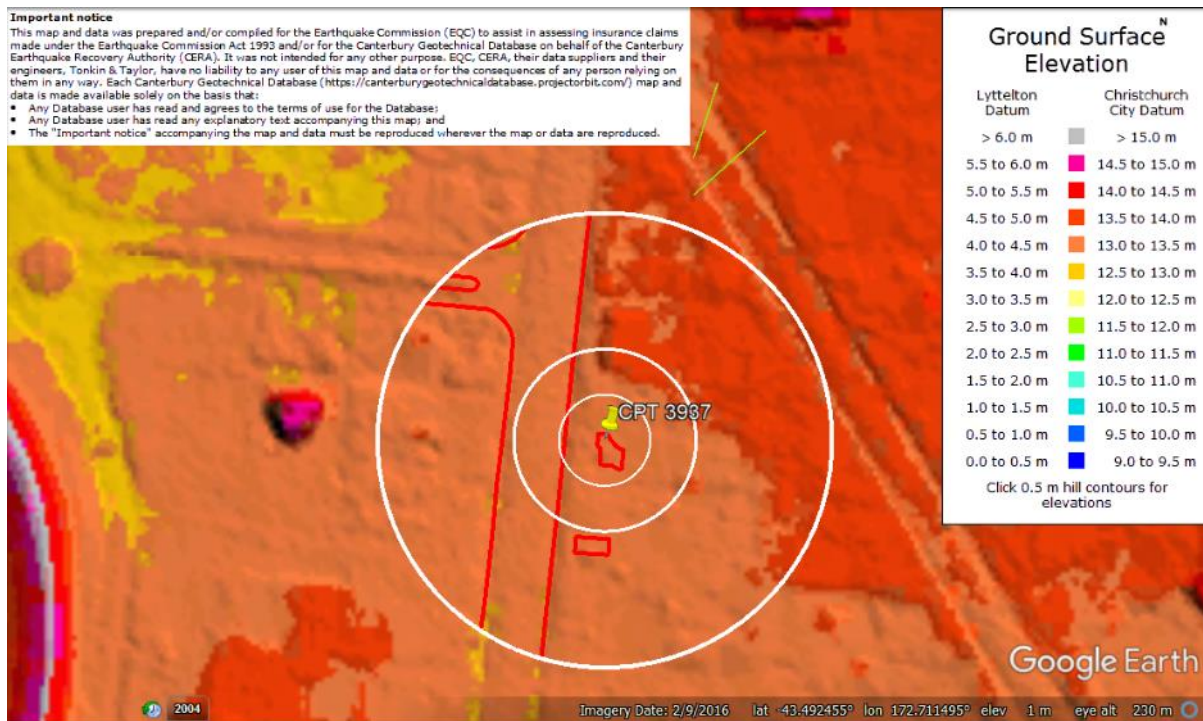
Figure 84: Enlarged view of ground surface elevation difference between the road and properties (LiDAR DEM for Sept 2011).

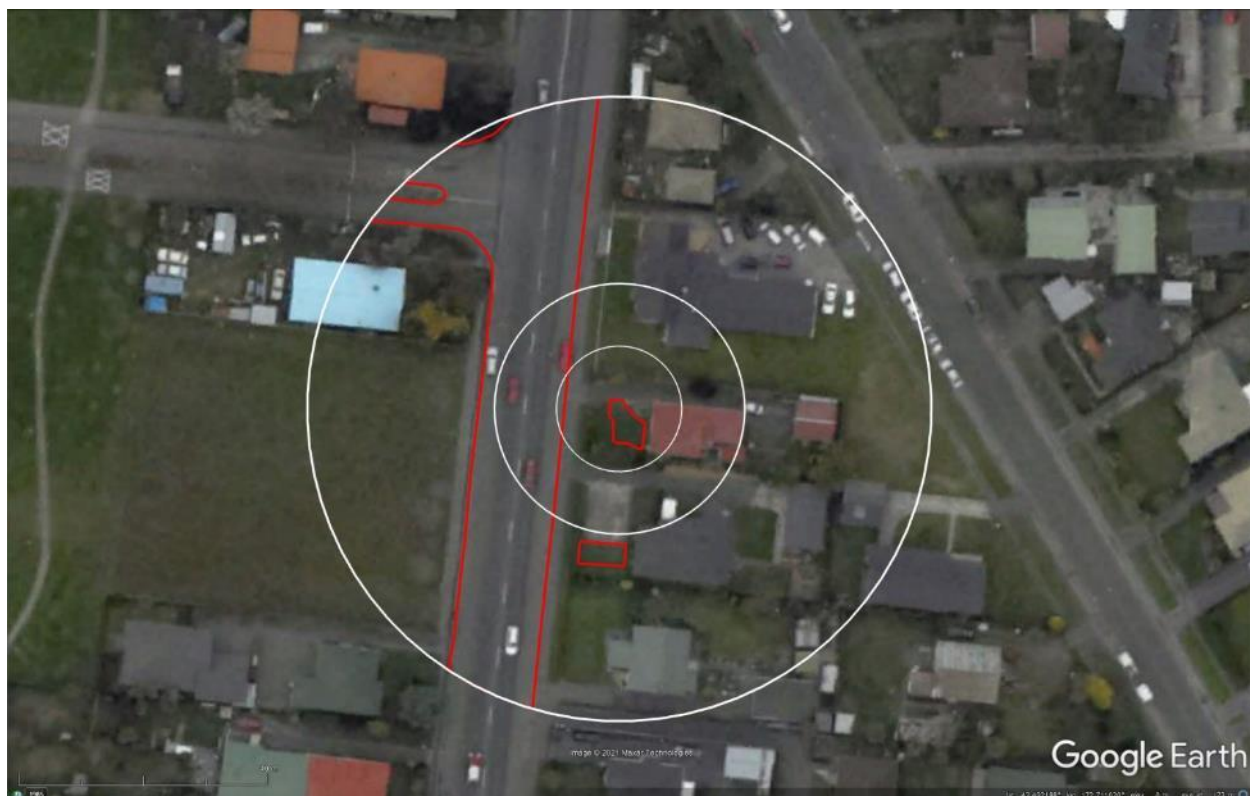
Figure 85: No ejecta for Sep-10 EQ.

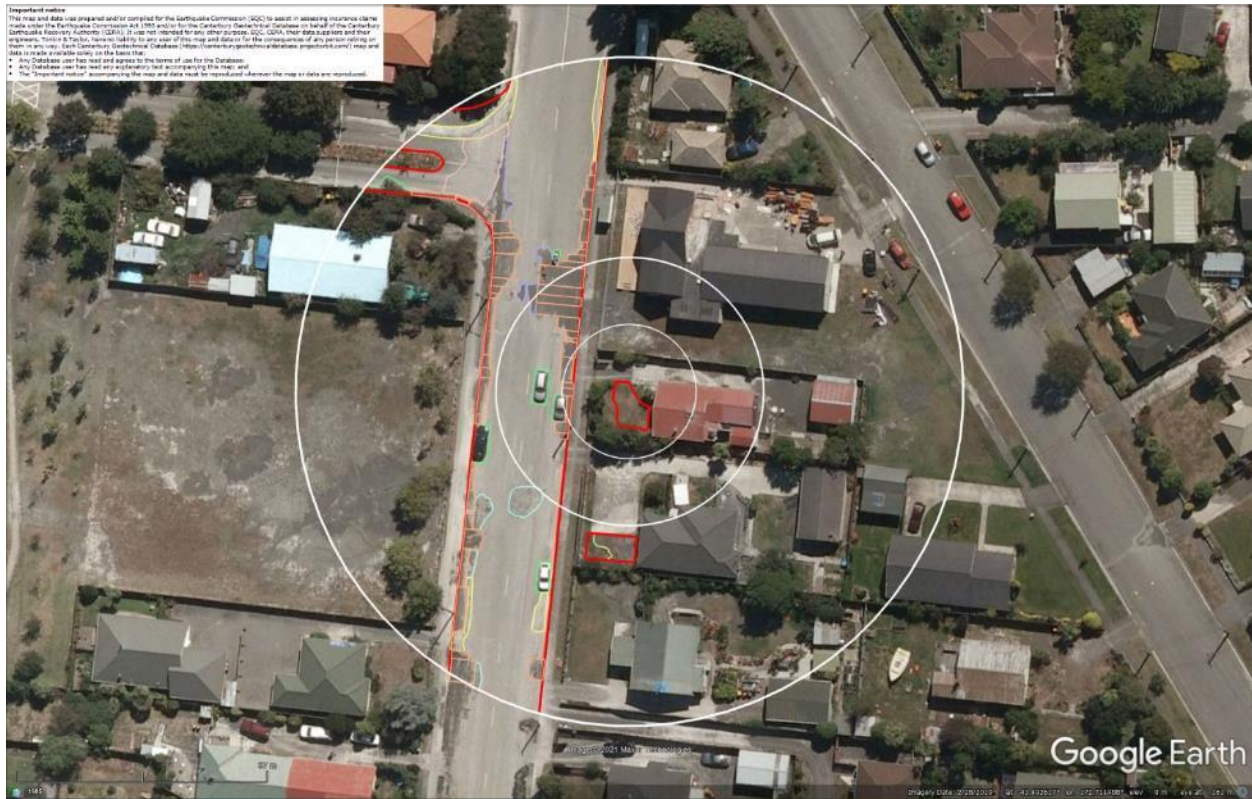
Figure 86: Ejecta outline for Feb-11 EQ.
