Appendix A.13:

Bower Ave – CPT 3937

Liquefaction Ejecta Case Histories for 2010-11 Canterbury Earthquakes

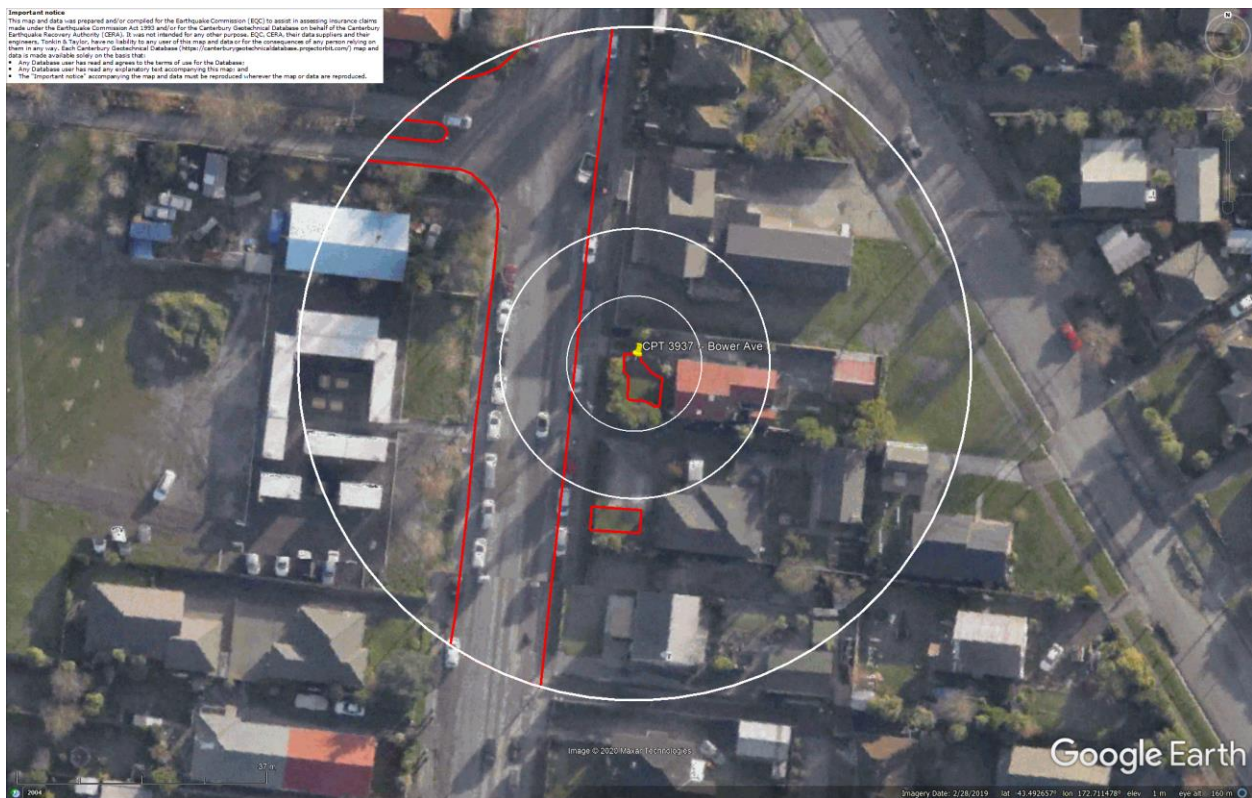
Figure 87: Presence of ejecta as seen in aerial photograph from 14-15 June 2011.

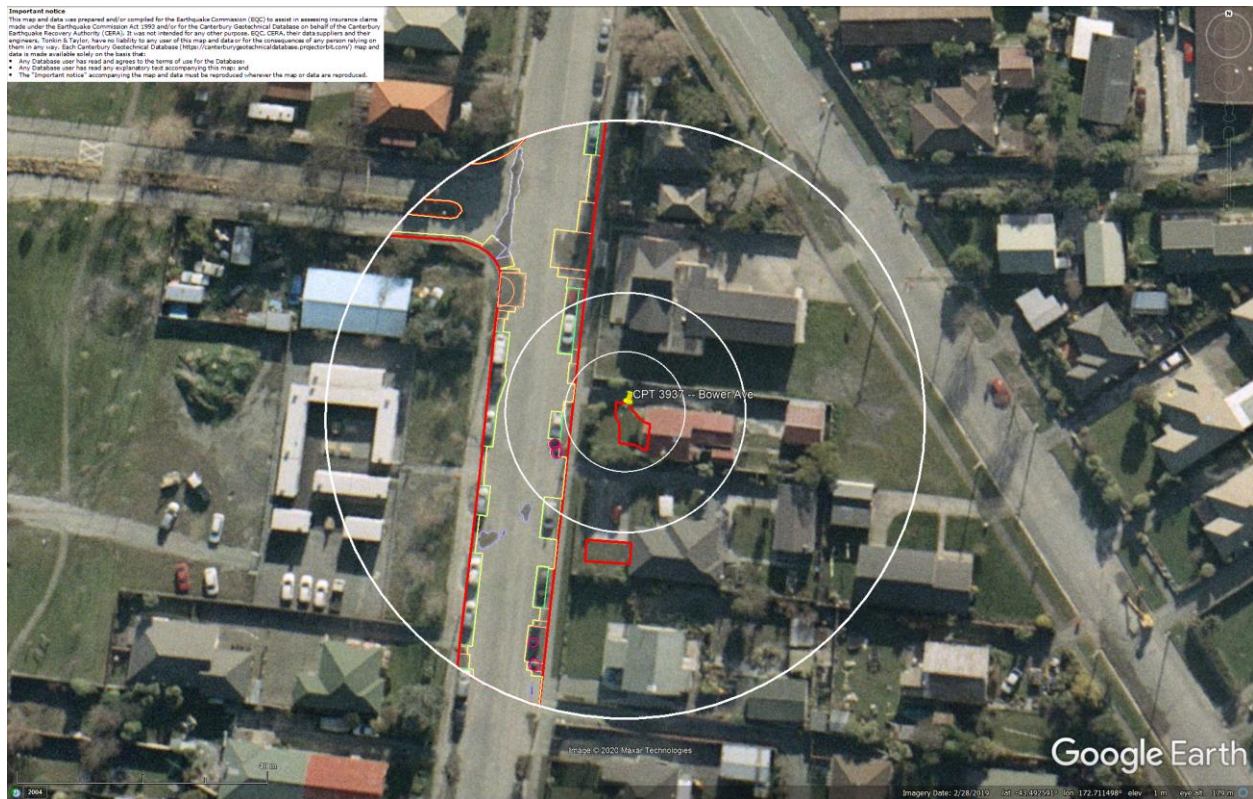
Figure 88: Ejecta outline for Jun-11 EQ.

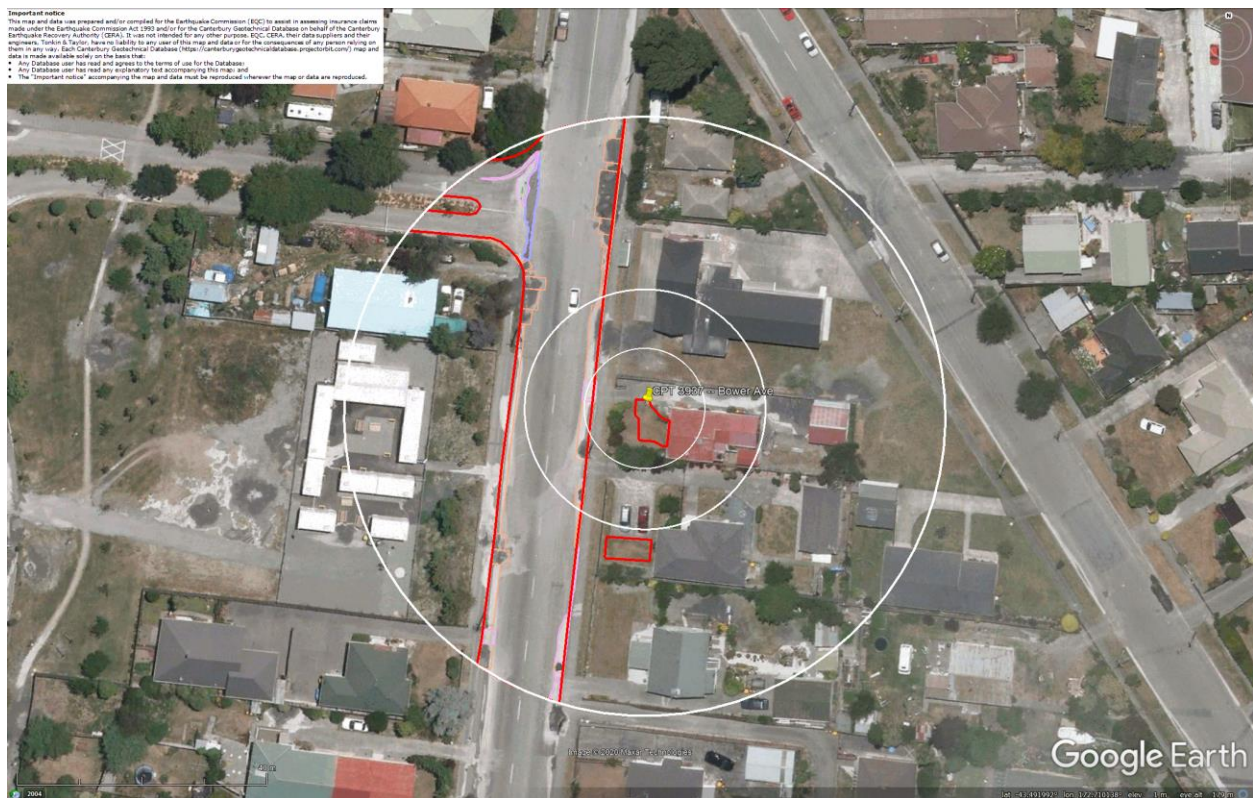
Figure 89: Ejecta outline for Dec-11 EQ.

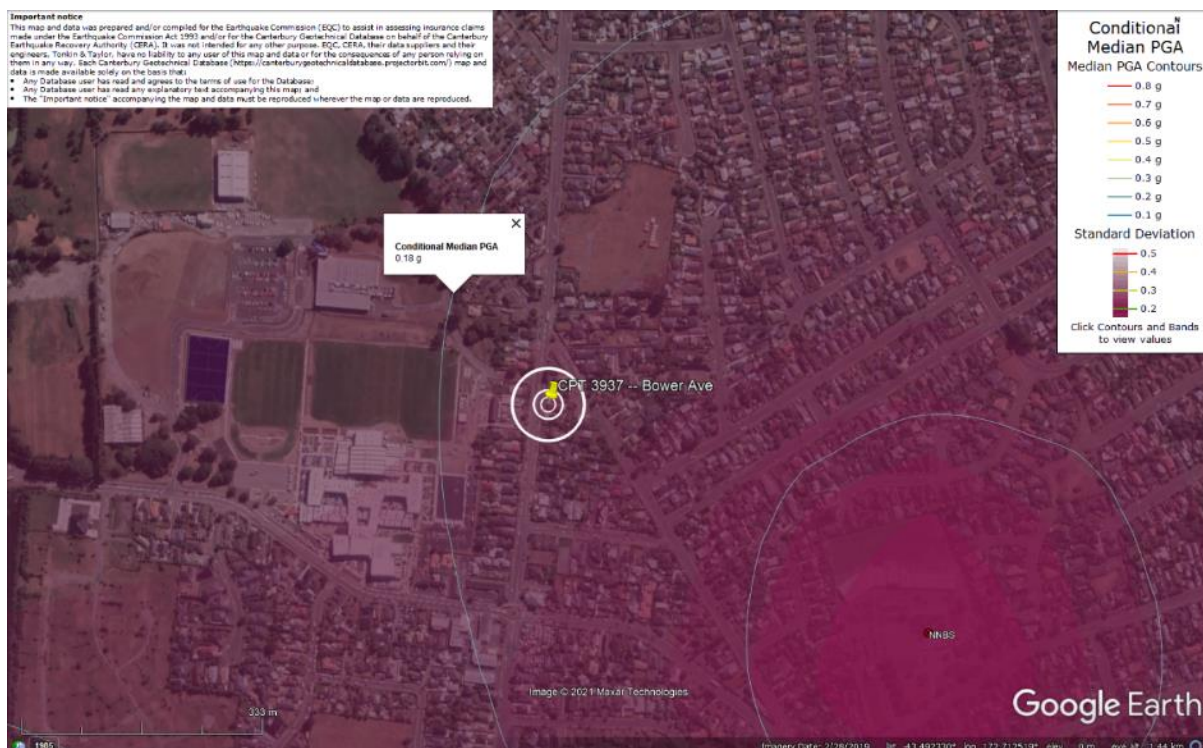
Figure 93: PGA for Sep-10 EQ (st. dev. = 0.250-0.275 ln units).

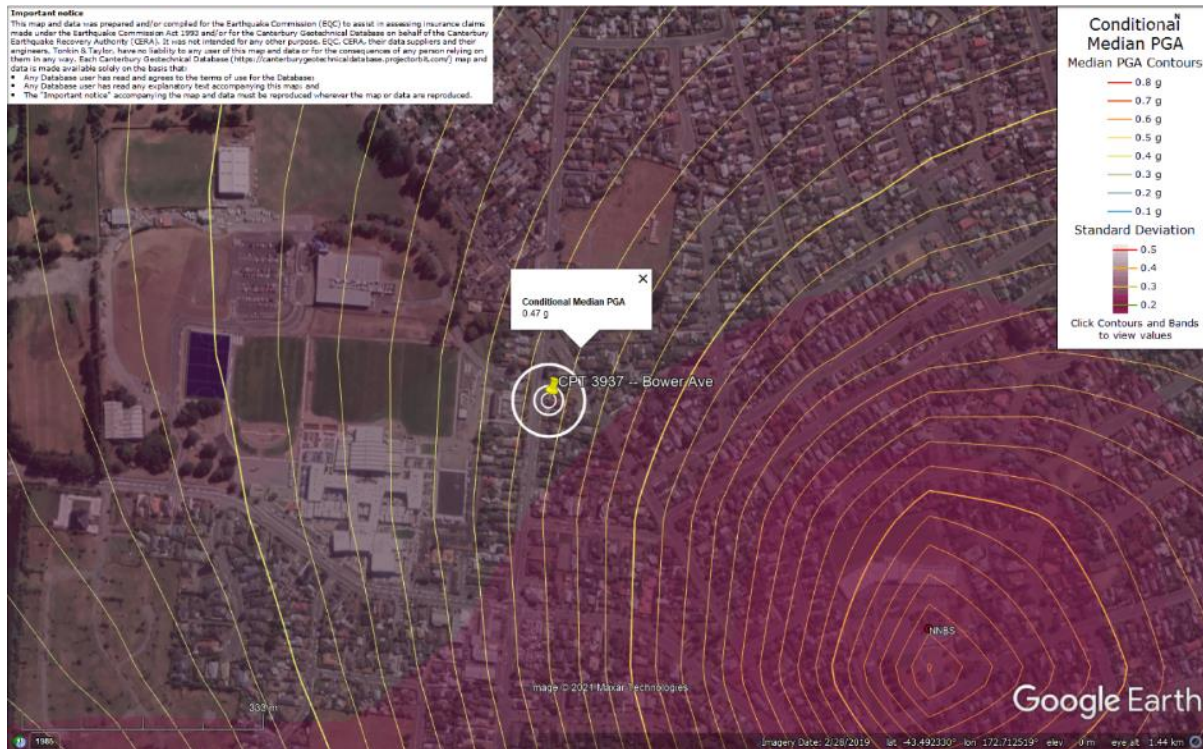
Figure 94: PGA for Feb-11 EQ (st. dev. = 0.275-0.300 ln units).

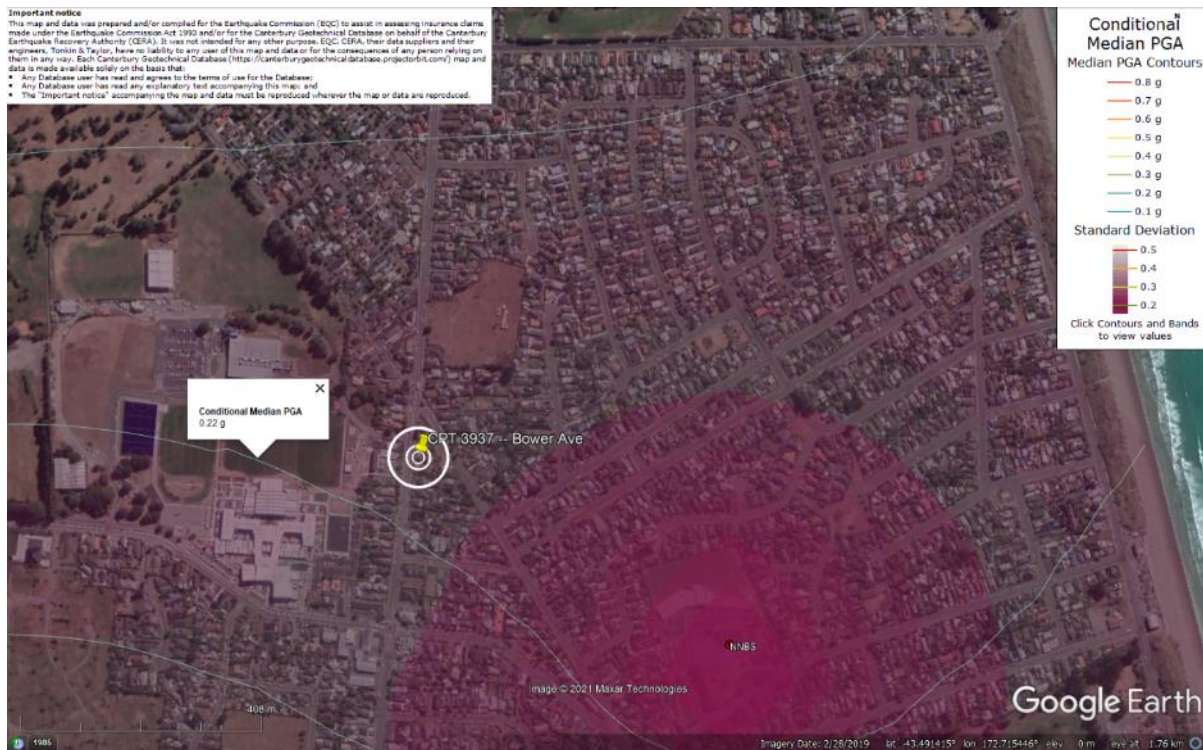
Figure 95: PGA for Jun-11 EQ (st. dev. = 0.275-0.325 ln units).

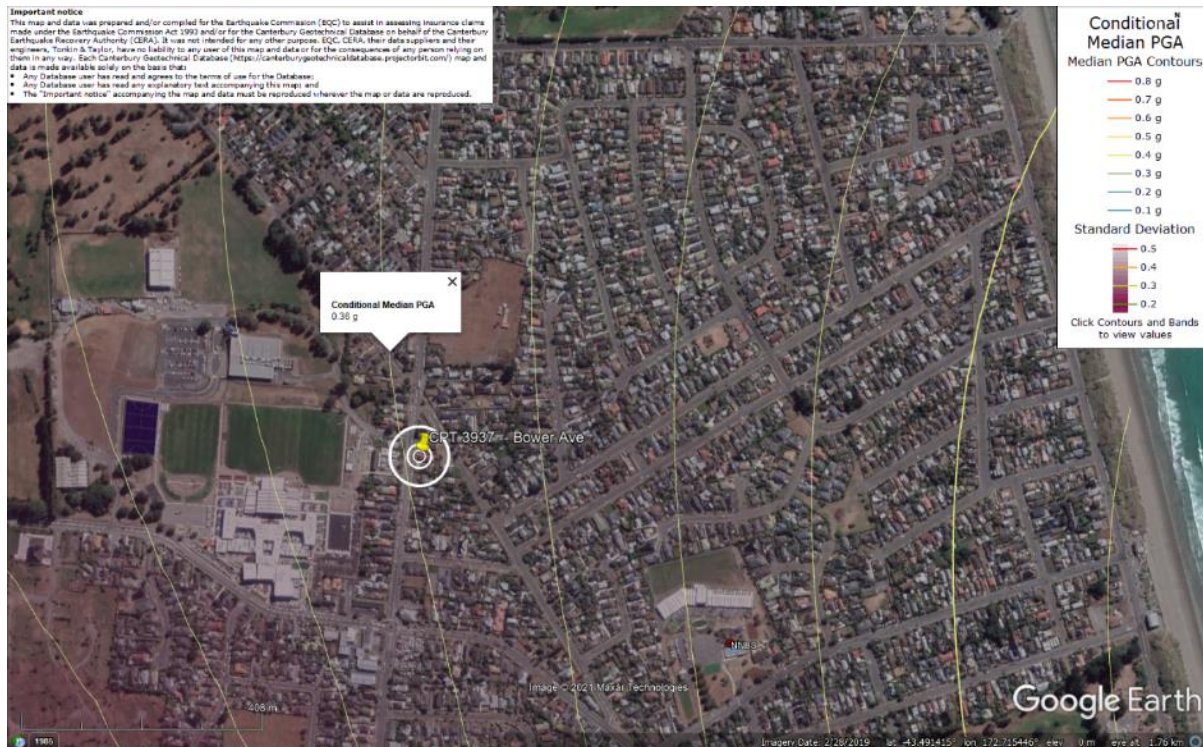
Figure 96: PGA for Dec-11 EQ (st. dev. = 0.375-0.400 ln units).

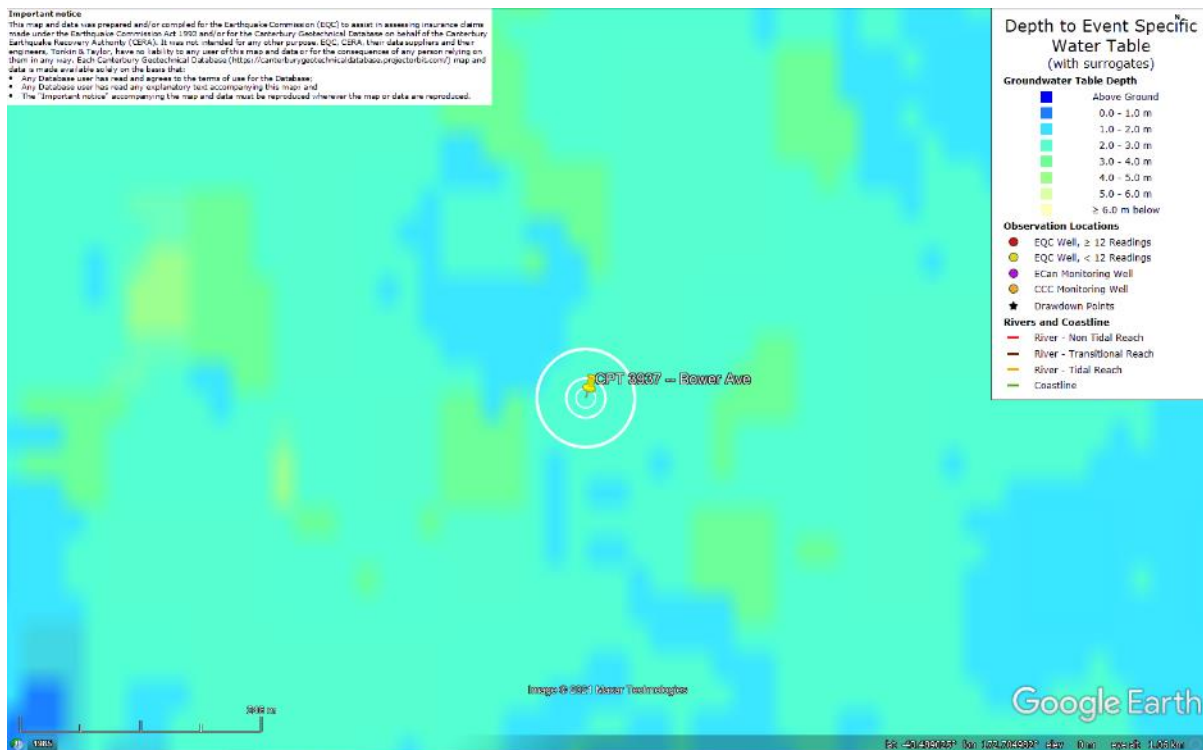
Figure 97: Depth to groundwater table for Sep-10 EQ.

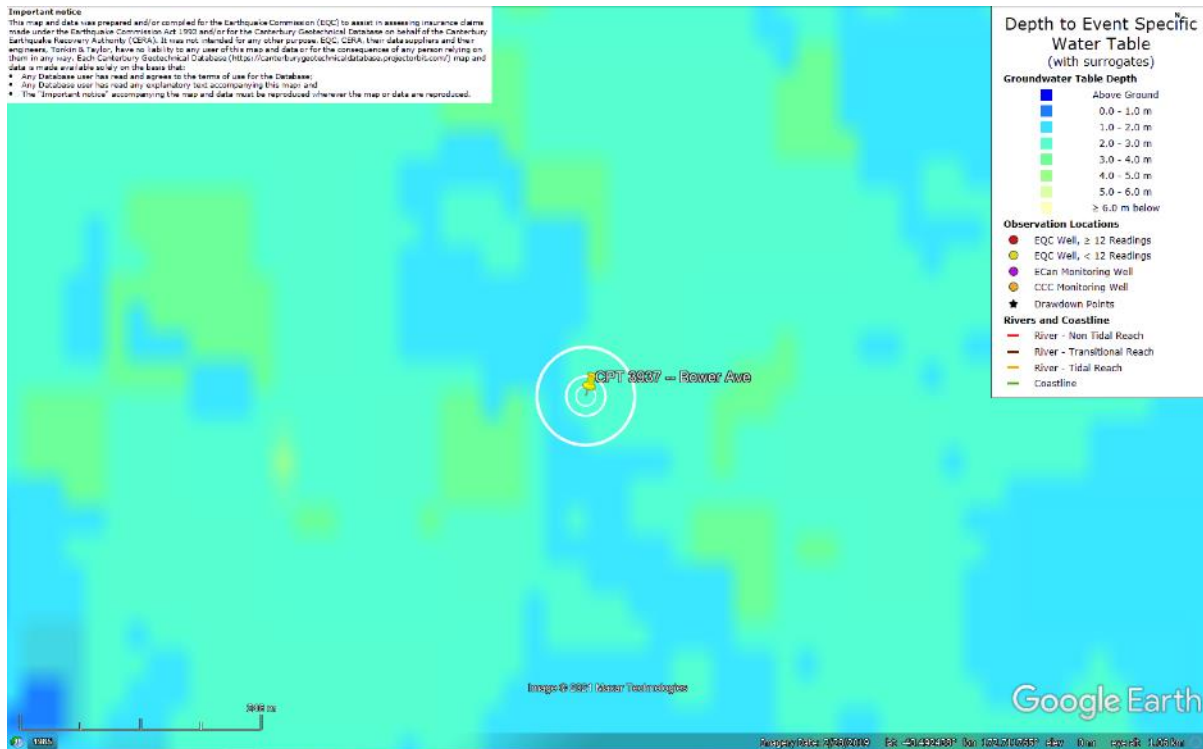
Figure 98: Depth to groundwater table for Feb-11 EQ.

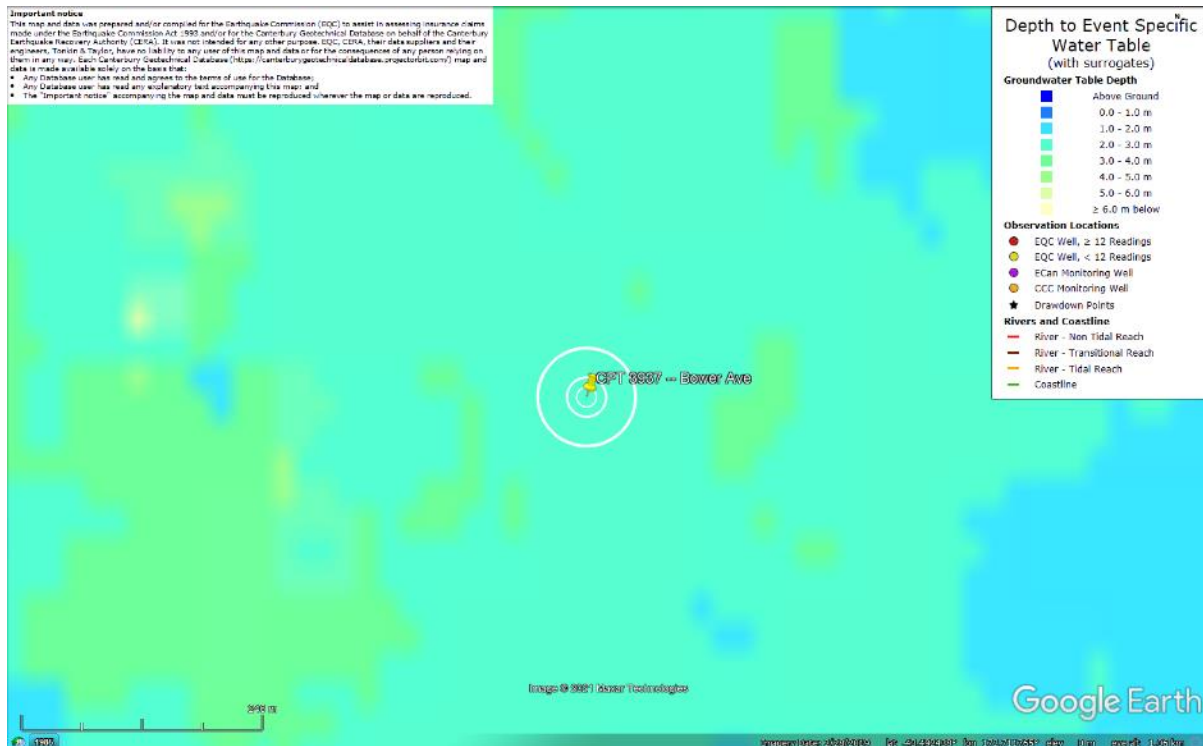
Figure 99: Depth to groundwater table for Jun-11 EQ.

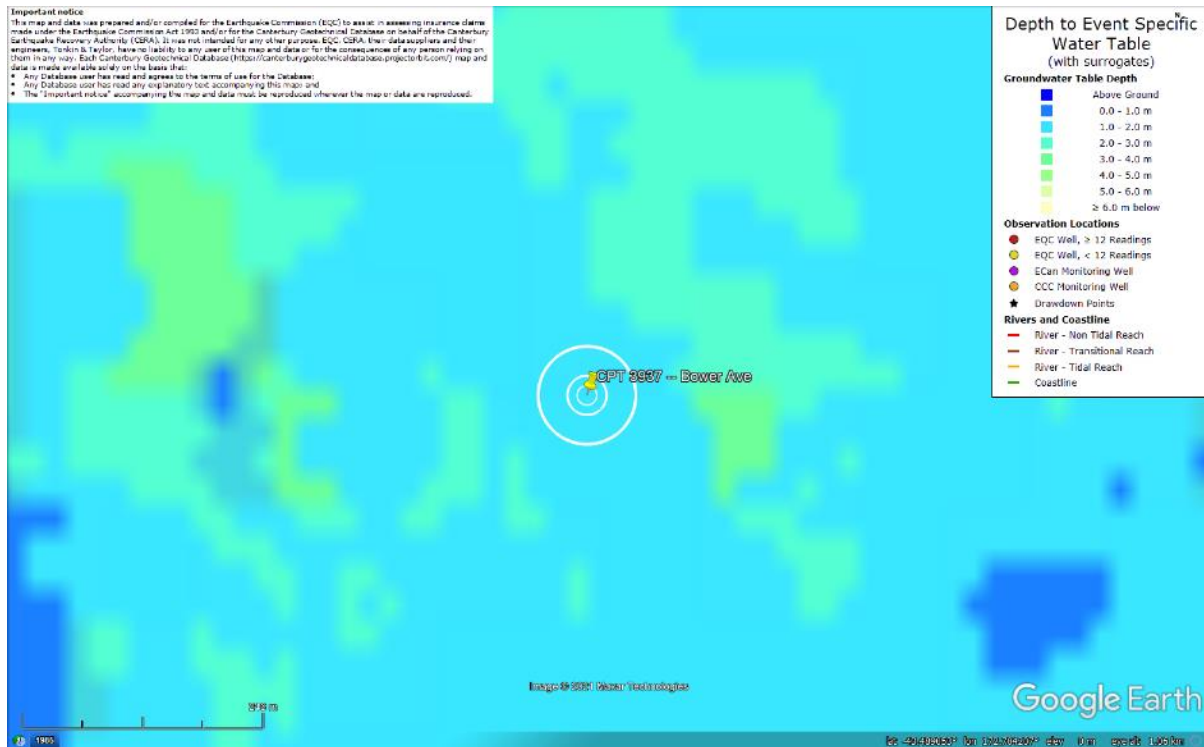
Figure 100: Depth to groundwater table for Dec-11 EQ.

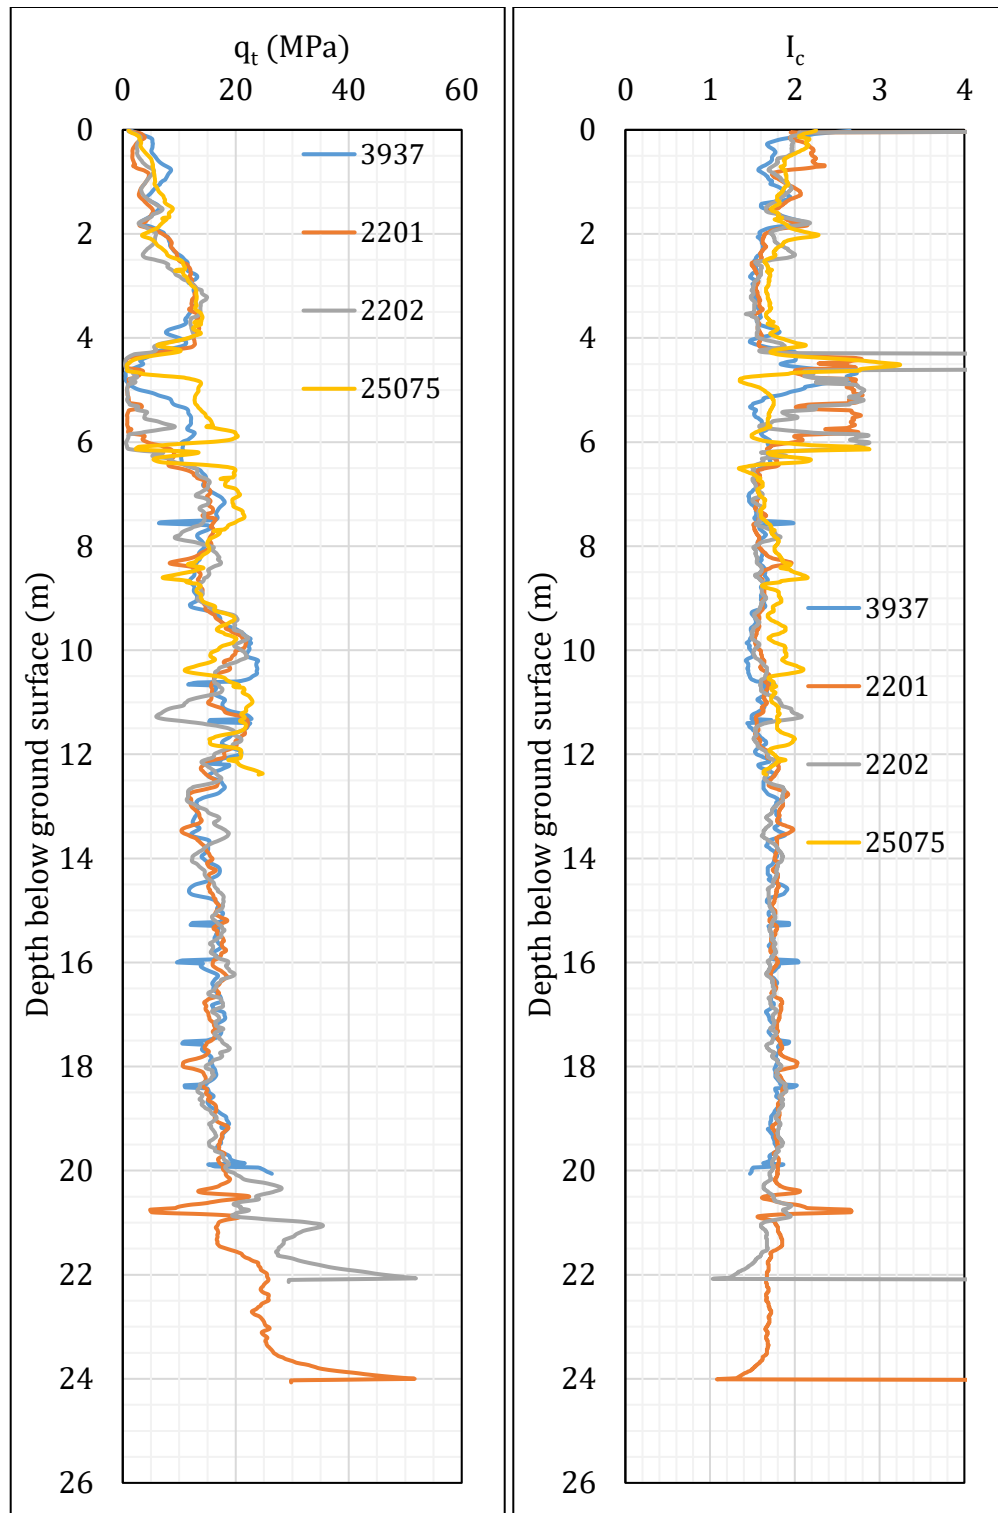
Figure 101: q_t and I_c profiles.

Note 7: The selection of CPTs for the area considered for settlement assessment (Figure 1) is based on the proximity of the CPTs to the considered areas. In accordance with that, the following table shows CPTs that were used for the volumetric settlement analysis in *Cliq v.3.0.3.2*, a CPT soil liquefaction software developed by GeoLogismiki. (The average volumetric settlements were reported in Table 8.)
