Appendix A.18:

Travis Country Dr – CPT 29778

Liquefaction Ejecta Case Histories for 2010-11 Canterbury Earthquakes

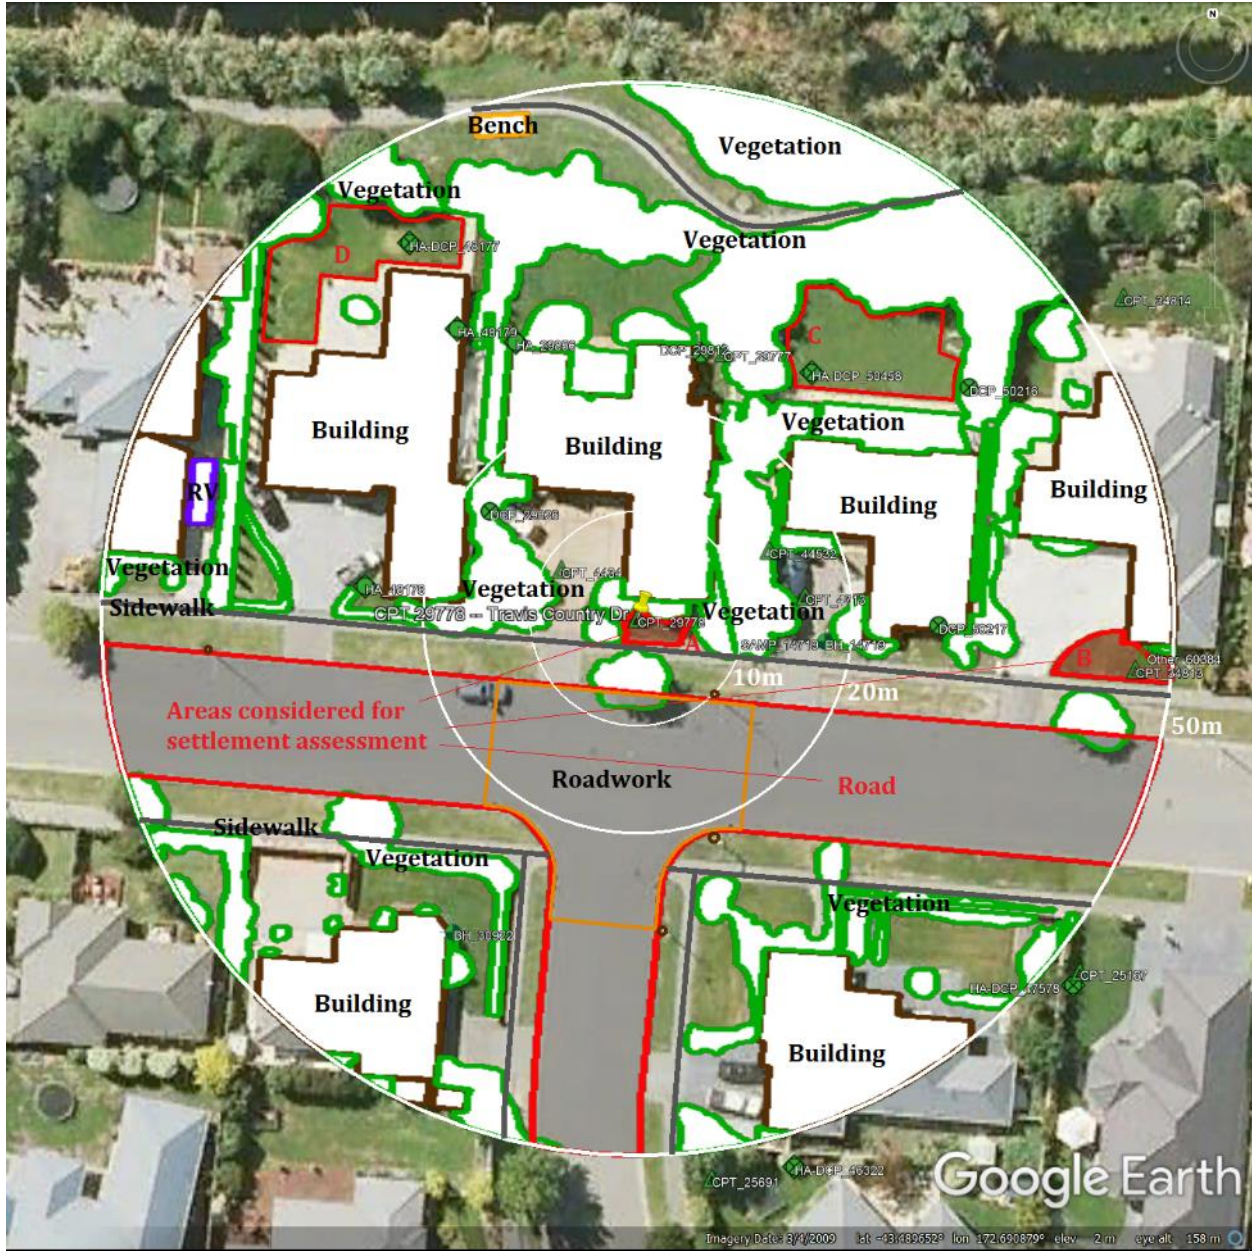
Figure 1: Site plan with areas where LiDAR survey data is considered.

Note 1: Four patches (outlined in red) in free field were initially selected for settlement assessment as areas free of vegetation and structures. Further analyses such as proximity of a patch to a CPT, proximity of a patch to a property subjected to addition and/or demolition of a structure, front yard/backyard alterations (e.g., ploughing, rubble, scrap), aerial distribution of sediment ejecta, and density of LiDAR points for 2003 resulted in Patches A and B being selected for detailed settlement assessment and other patches being discarded in detailed settlement assessment. In addition, since significant amounts of ejecta were observed on roads in the CES, the entire portion of the road within the 50-m buffer was considered for settlement assessment. Roads as hard, relatively flat surfaces provide many ground-classified points. Therefore, it is very useful to compare settlement estimates on roads with settlement estimates in free field.

Note 9: The selection of CPTs for the area considered for settlement assessment (Figure 1) is based on the proximity of the CPTs to the considered areas. In accordance with that, the following table shows CPTs that were used for the volumetric settlement analysis in *Cliq v.3.0.3.2*, a CPT soil liquefaction software developed by GeoLogismiki. (The average volumetric settlements were reported in Table 8.)

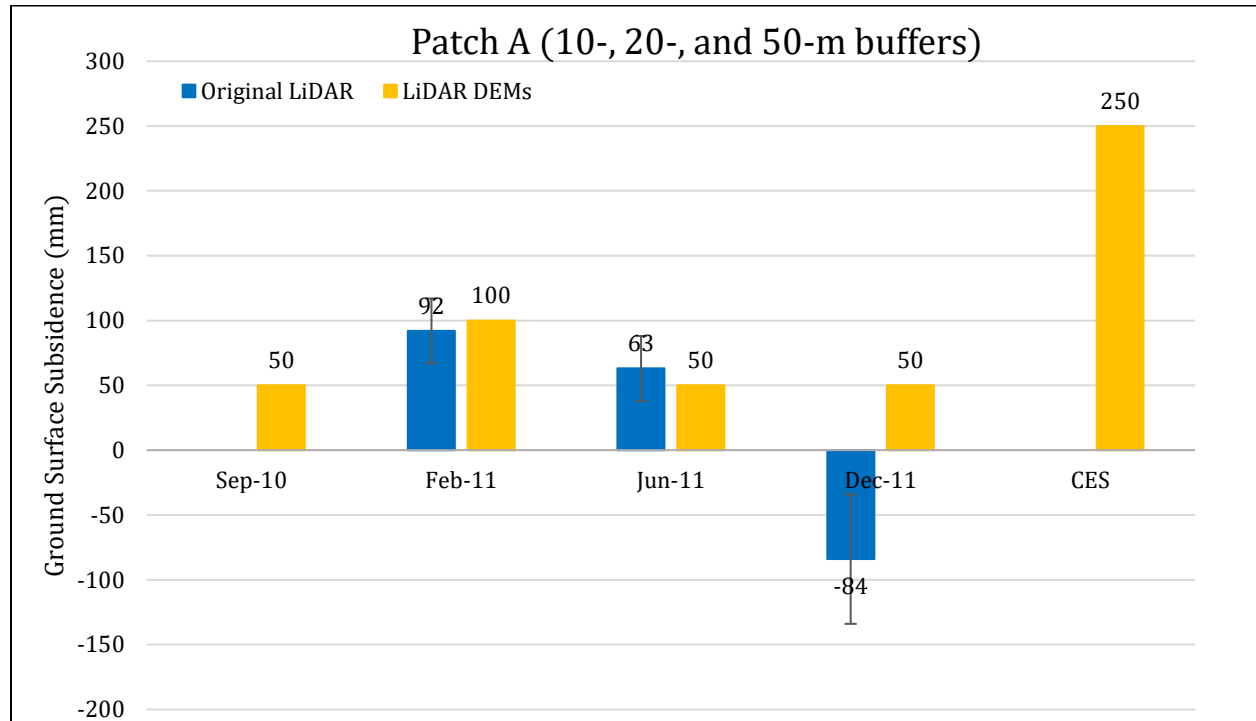
Figure 2: Comparison between ground surface subsidence determined from original LiDAR survey points and ground surface subsidence (50th %ile) estimated using LiDAR DEMs for Patch A.

Note 2: The ground surface subsidence values determined from original LiDAR survey points are generally similar to the ground surface subsidence values estimated using LiDAR DEMs for all earthquake events. Discrepancy is evident for Patch B for the Feb-11 EQ – the ground surface subsidence based on LiDAR DEMs is two times smaller than that estimated using the original LiDAR points (50 mm versus 110 mm, respectively).

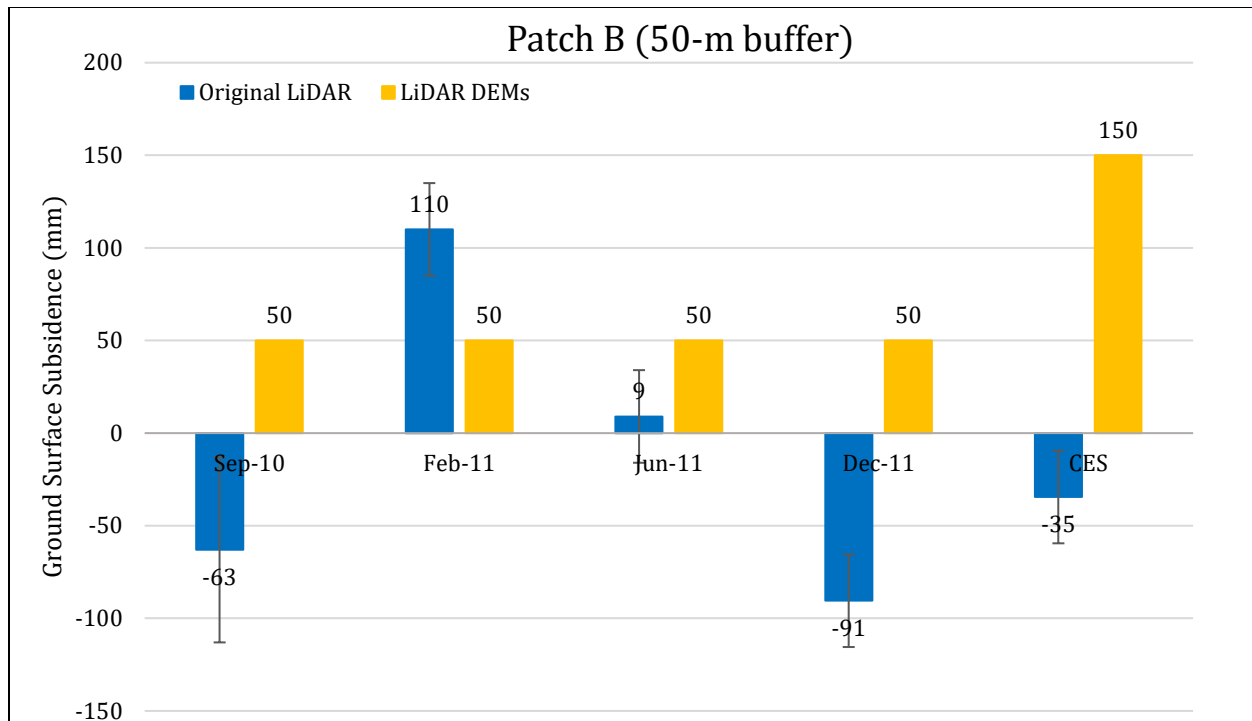
Figure 3: Comparison between ground surface subsidence determined from original LiDAR survey points and ground surface subsidence (50th %ile) estimated using LiDAR DEMs for Patch B.

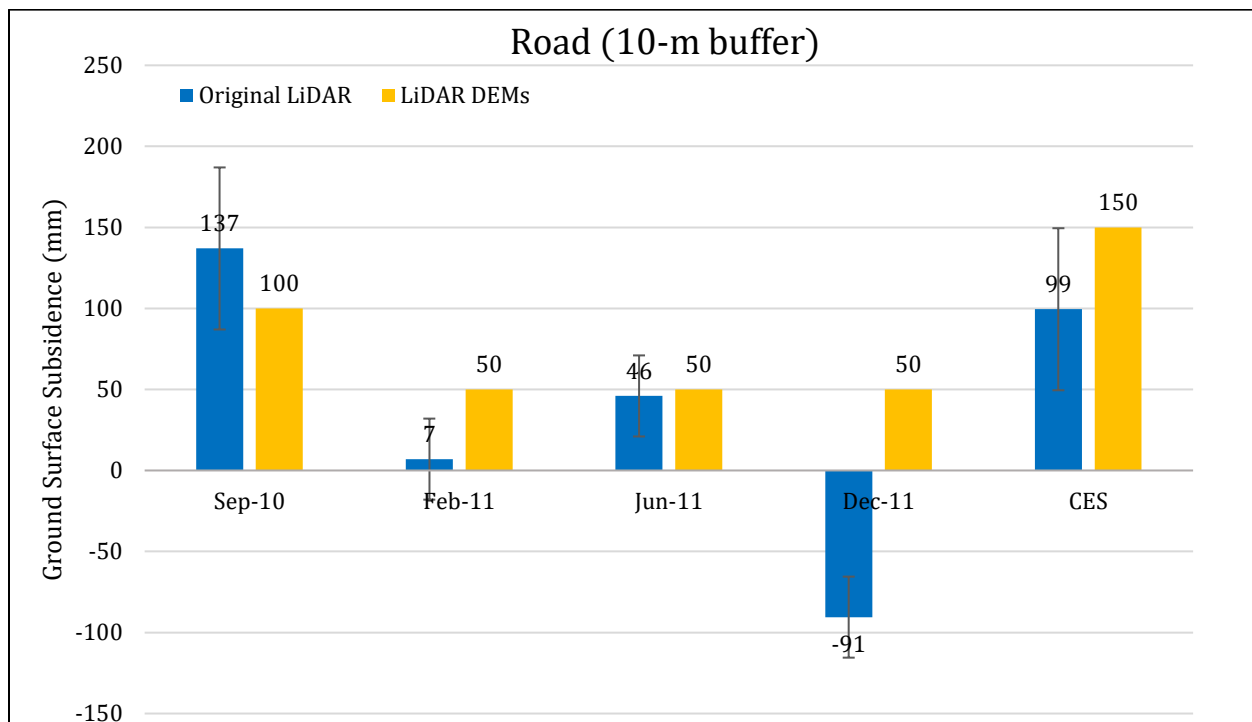
Figure 4: Comparison between ground surface subsidence determined from original LiDAR survey points and ground surface subsidence (50th %ile) estimated using LiDAR DEMs for Road for the 10-m buffer.

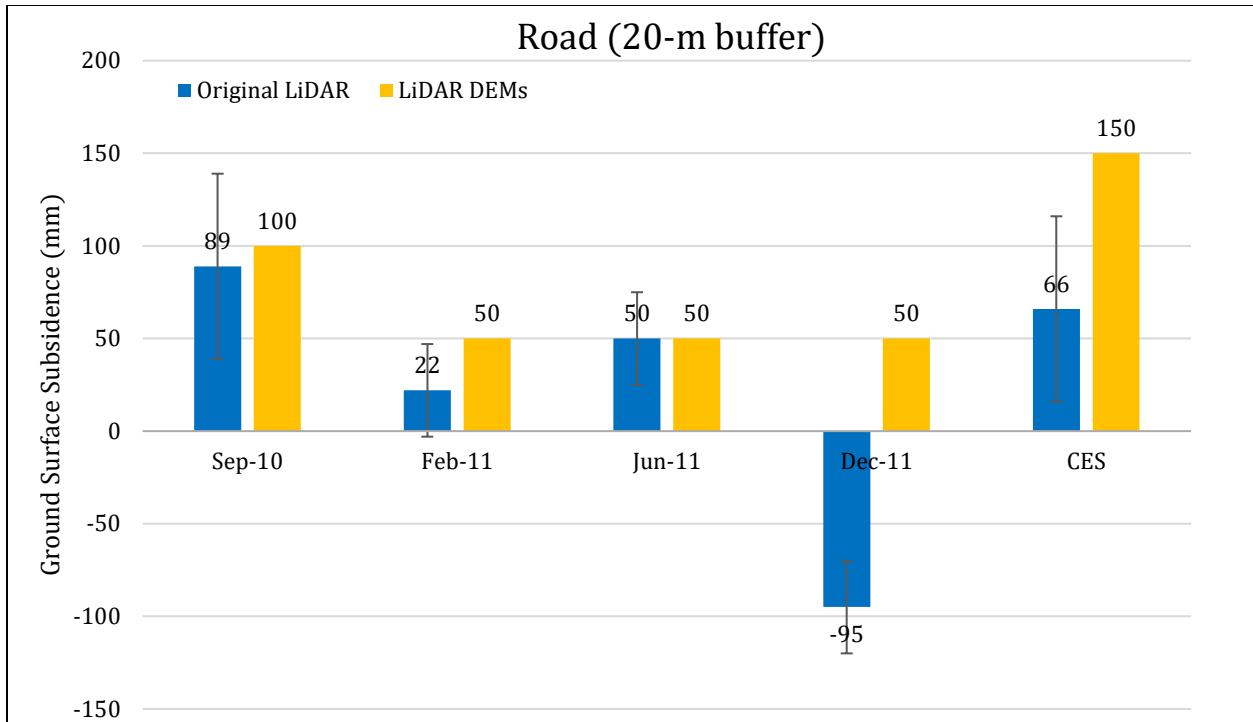
Figure 5: Comparison between ground surface subsidence determined from original LiDAR survey points and ground surface subsidence (50th %ile) estimated using LiDAR DEMs for Road for the 20-m buffer.

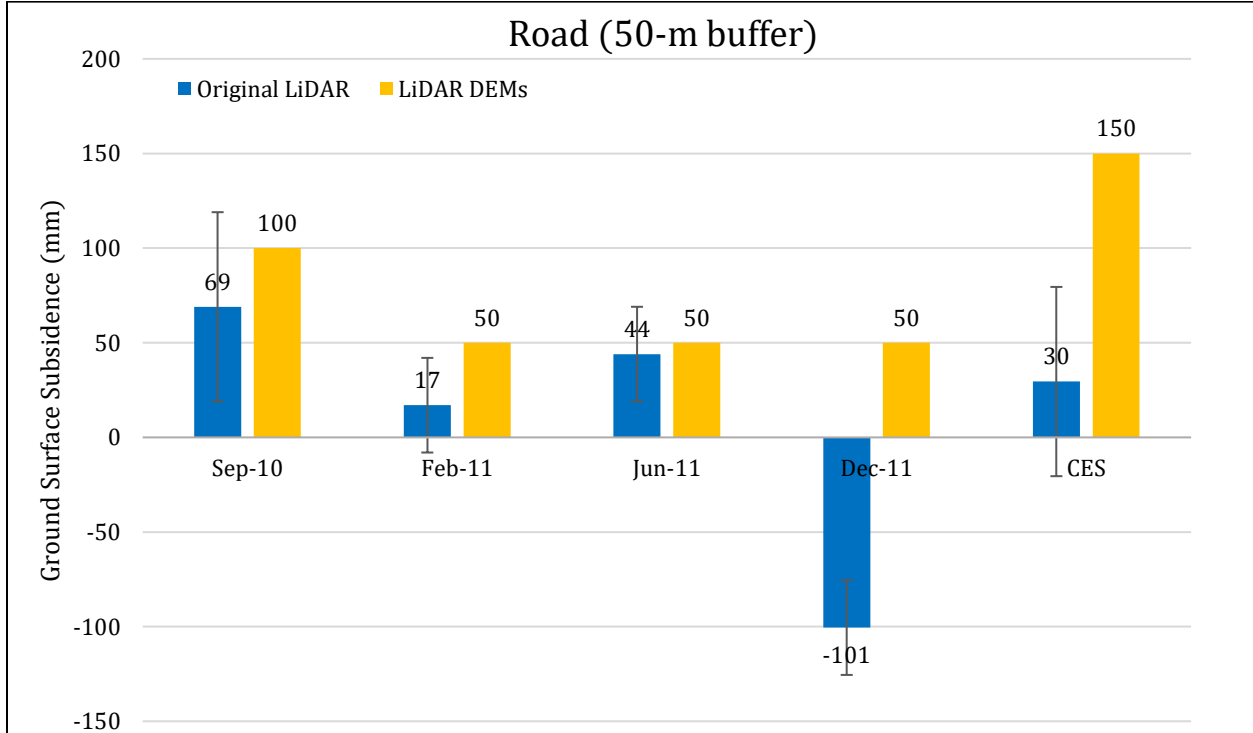
Figure 6: Comparison between ground surface subsidence determined from original LiDAR survey points and ground surface subsidence (50th %ile) estimated using LiDAR DEMs for Road for the 50-m buffer.

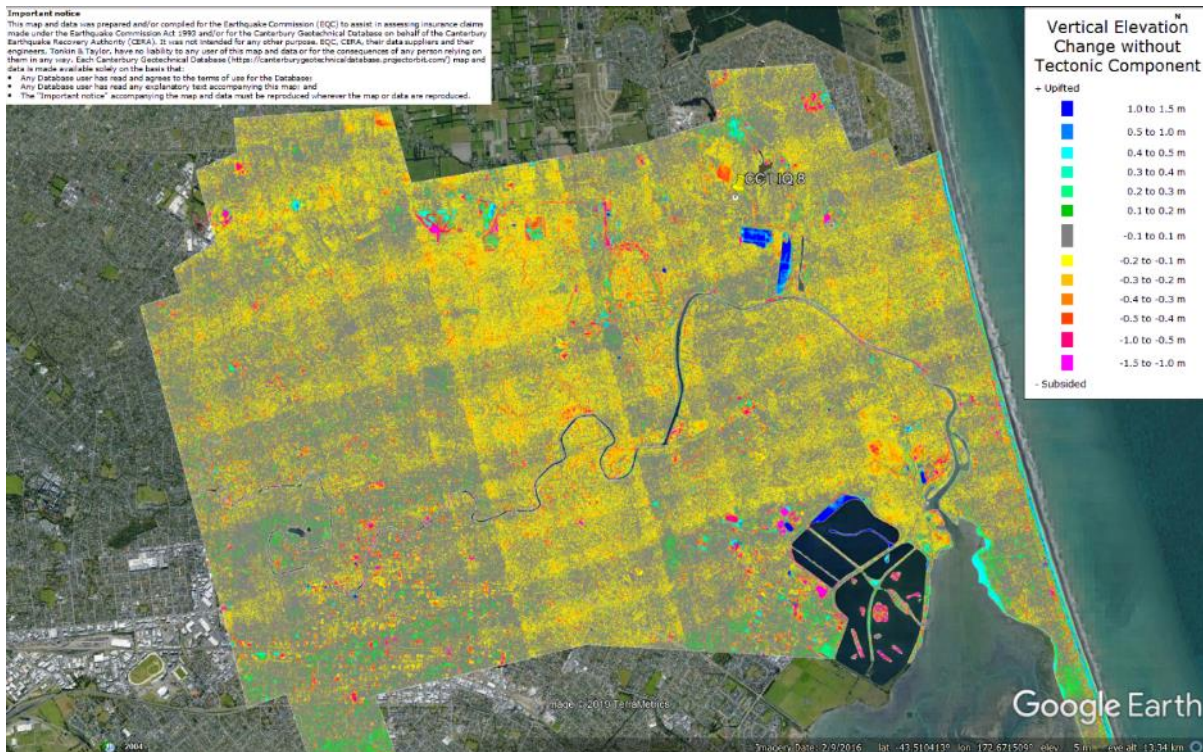
Figure 24: Vertical Ground Movements (Surface – Tectonic) for Sep 2010 Earthquake – the site is not in the apparent zone of overestimated ground surface subsidence.

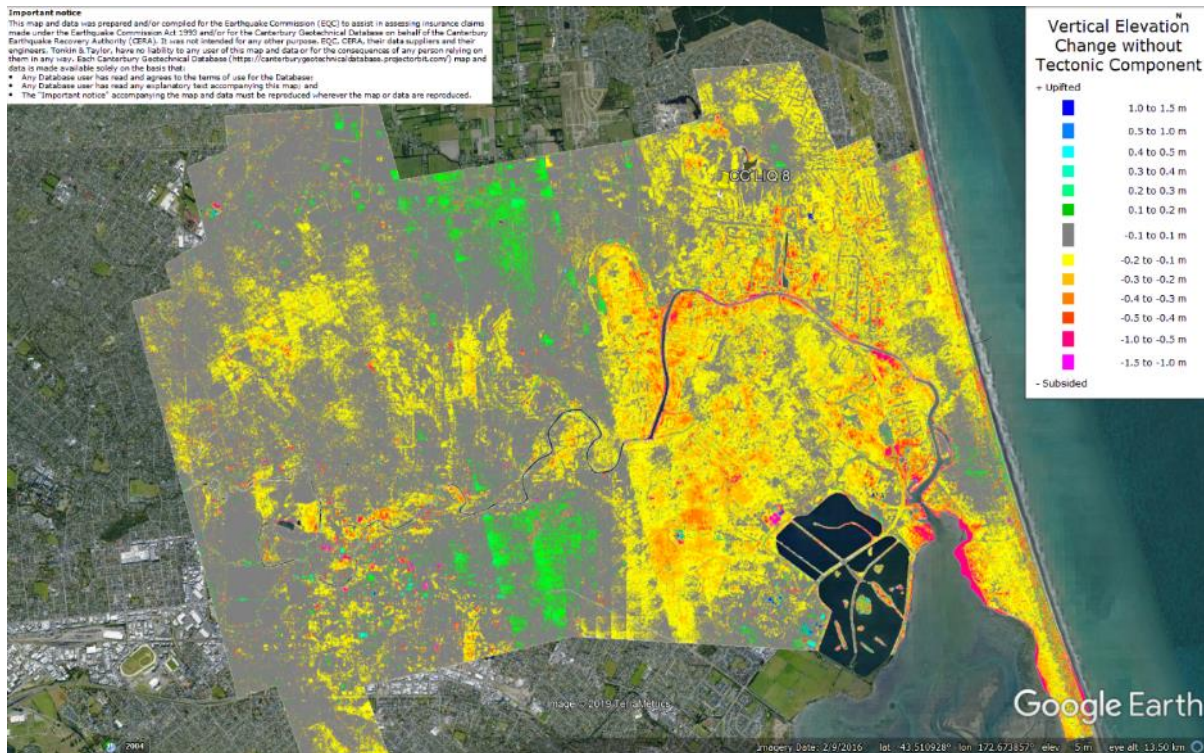
Figure 25: Vertical Ground Movements (Surface – Tectonic) for Feb 2011 Earthquake – the site is not in the apparent zone of underestimated ground surface subsidence.

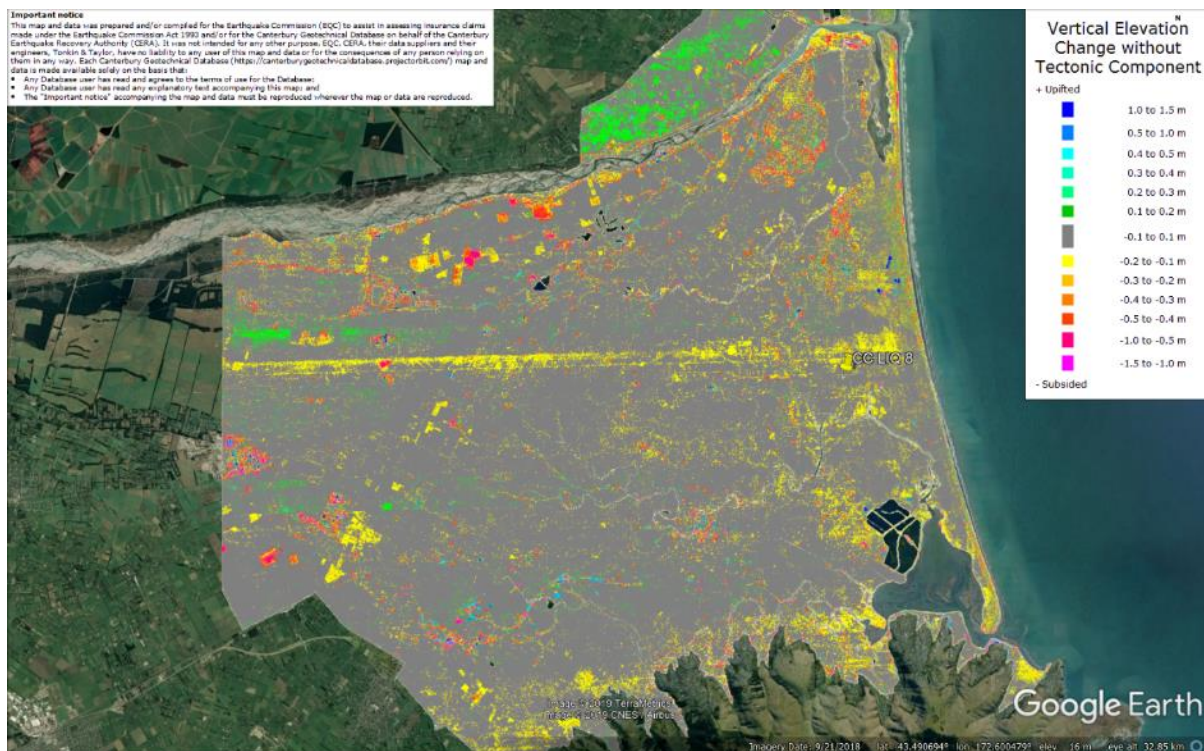
Figure 26: Vertical Ground Movements (Surface – Tectonic) for June 2011 Earthquake – the site is not in the apparent zone of overestimated or underestimated ground surface subsidence.

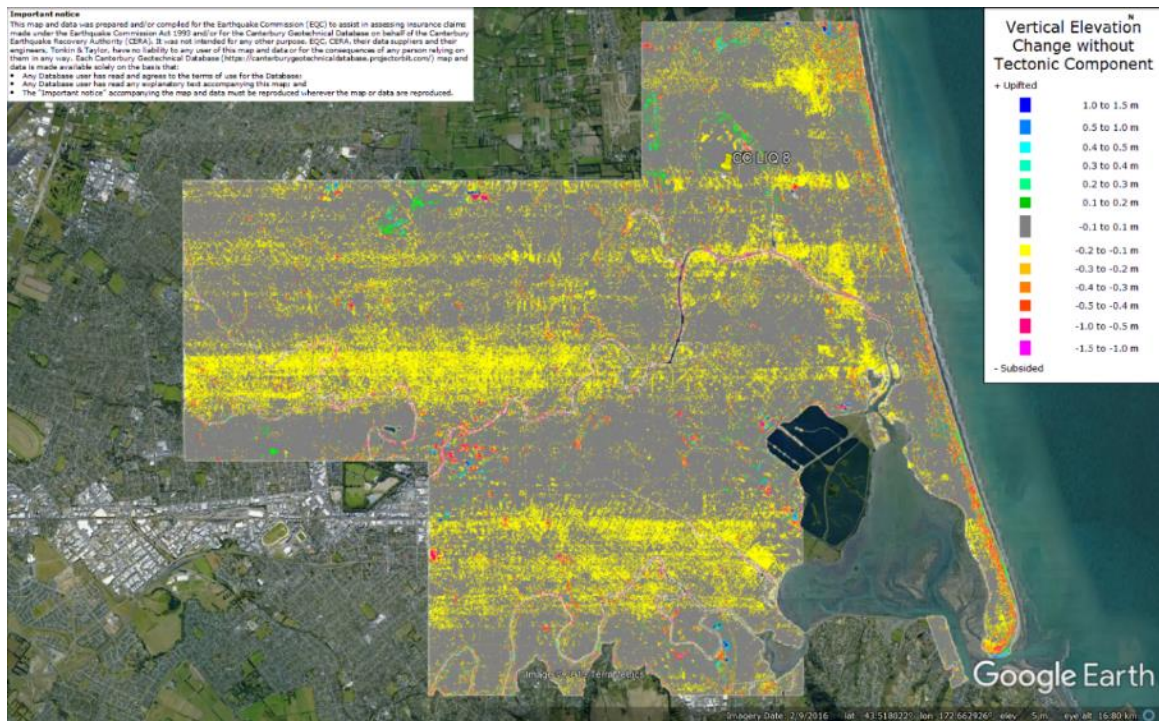
Figure 27: Vertical Ground Movements (Surface – Tectonic) for Dec 2011 Earthquake – the site is in the apparent zone of underestimated ground surface subsidence (i.e., Feb 2012 LiDAR flight error) .

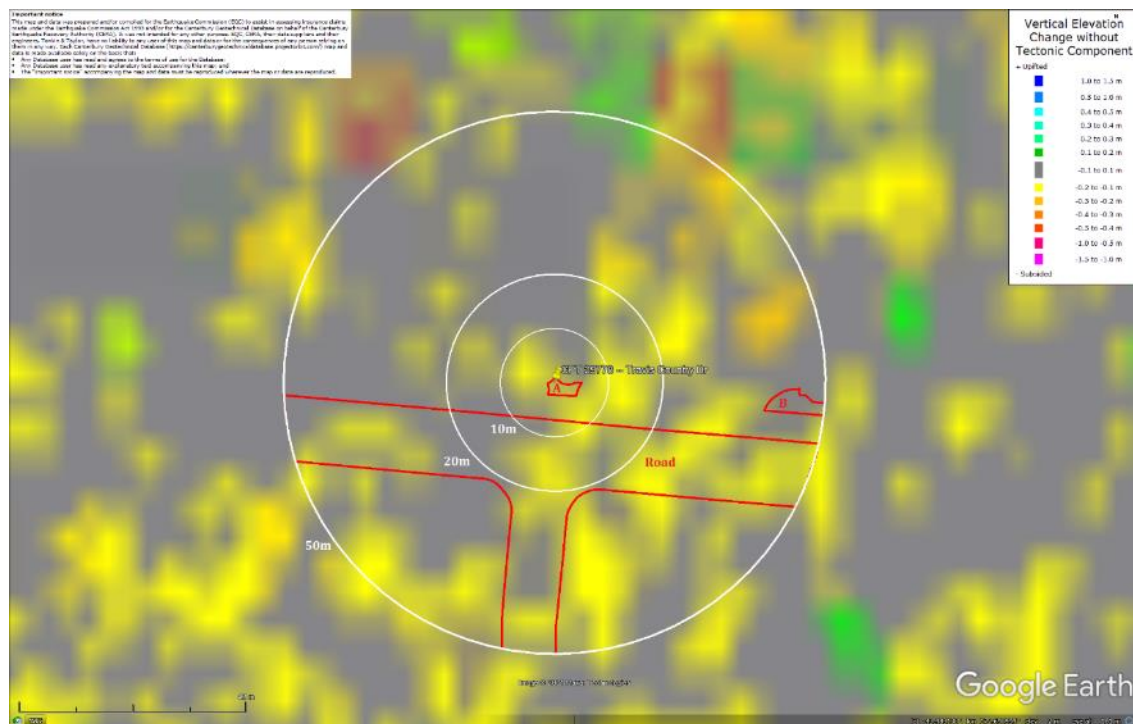
Figure 28: Ground surface subsidence without tectonic component for Sep 2010 Earthquake according to the LiDAR DEM.

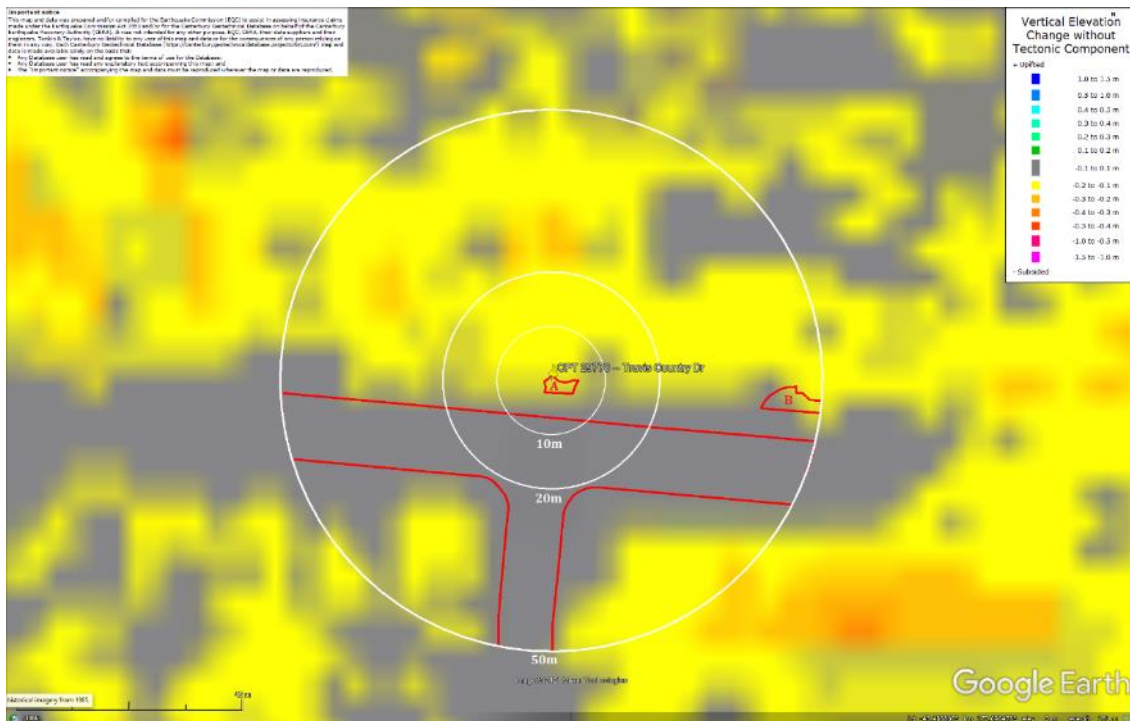
Figure 29: Ground surface subsidence without tectonic component for Feb 2011 Earthquake according to the LiDAR DEM.

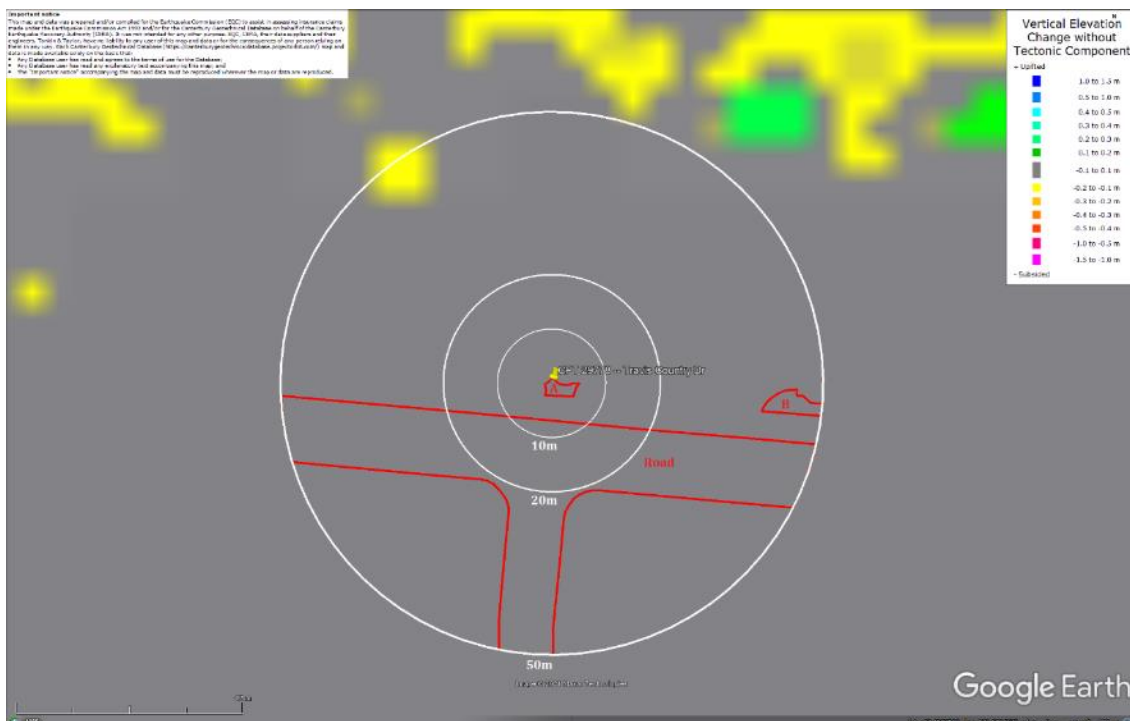
Figure 30: Ground surface subsidence without tectonic component for Jun 2011 Earthquake according to the LiDAR DEM.

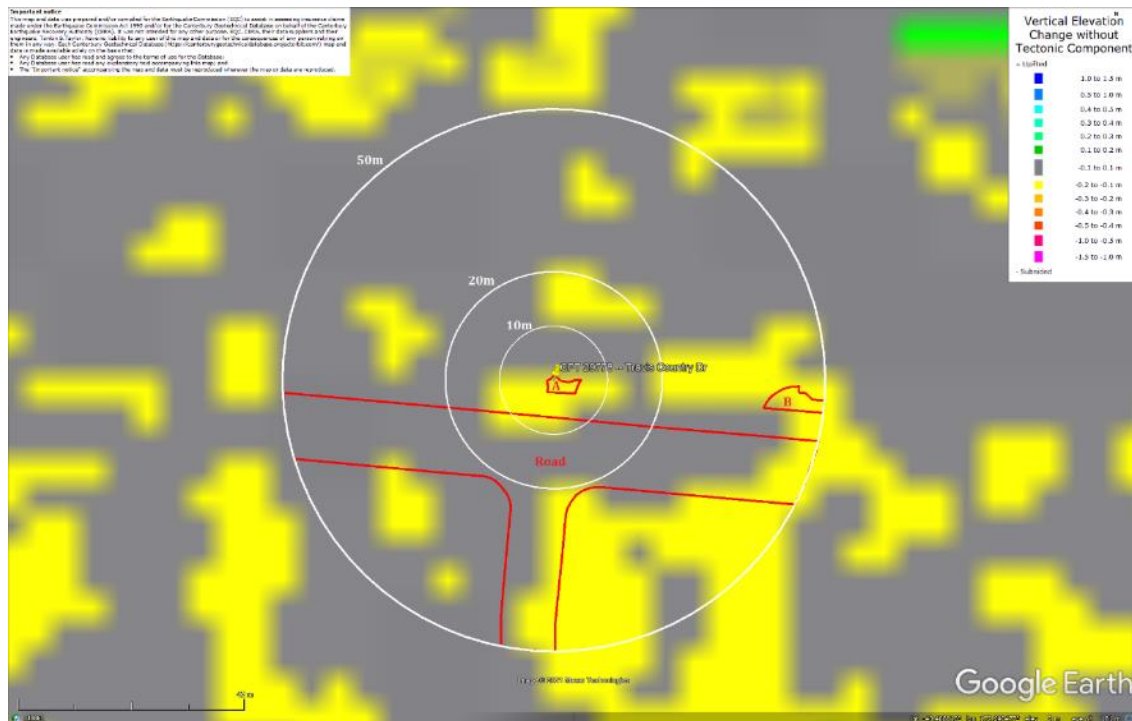
Figure 31: Ground surface subsidence without tectonic component for Dec 2011 Earthquake according to the LiDAR DEM.

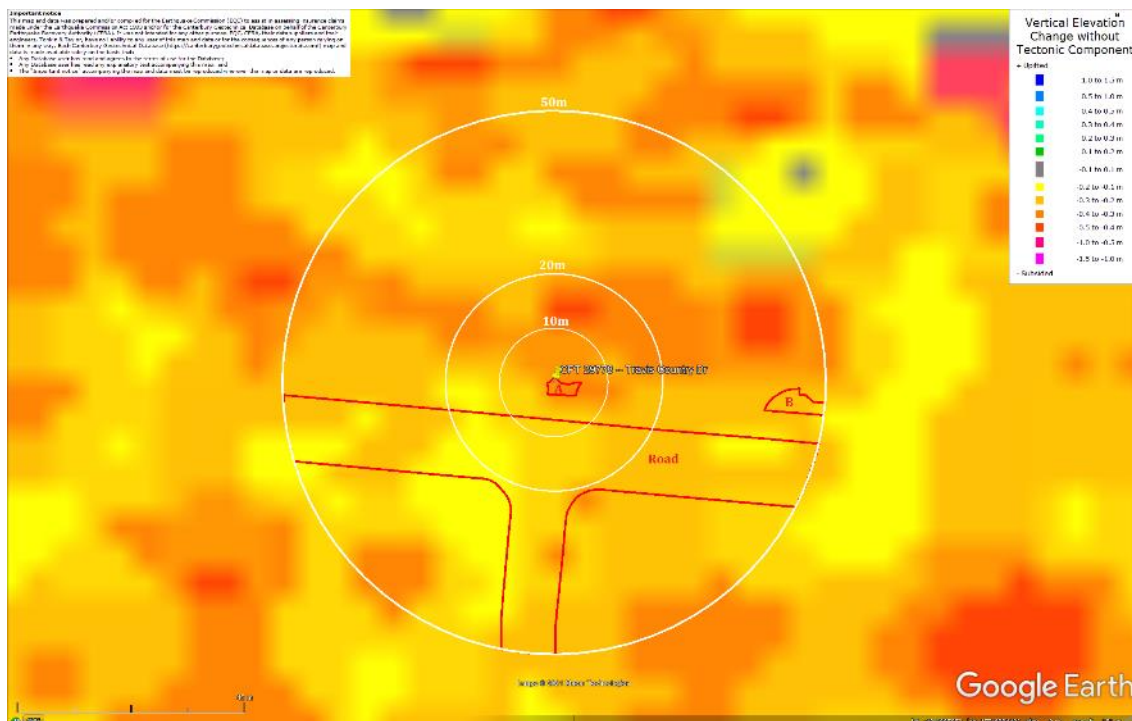
Figure 32: Ground surface subsidence without tectonic component for Canterbury Earthquake Sequence according to the LiDAR DEM.

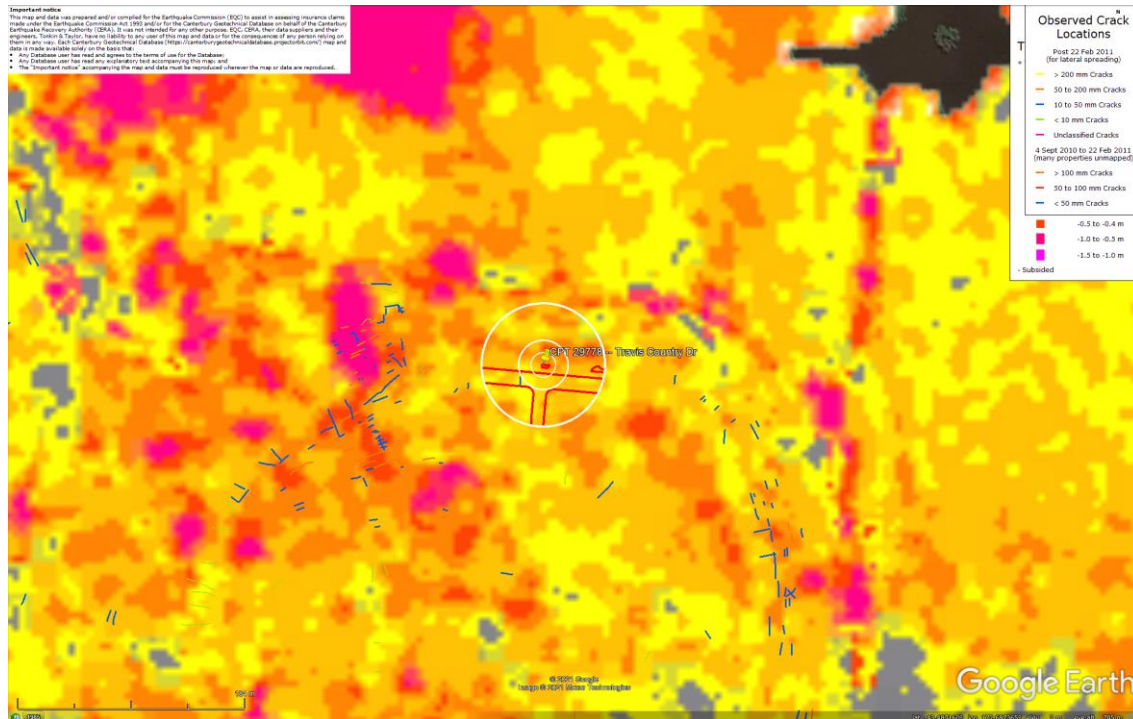
Figure 33: Absence of ground cracks indicates no lateral spreading for Canterbury Earthquake Sequence.

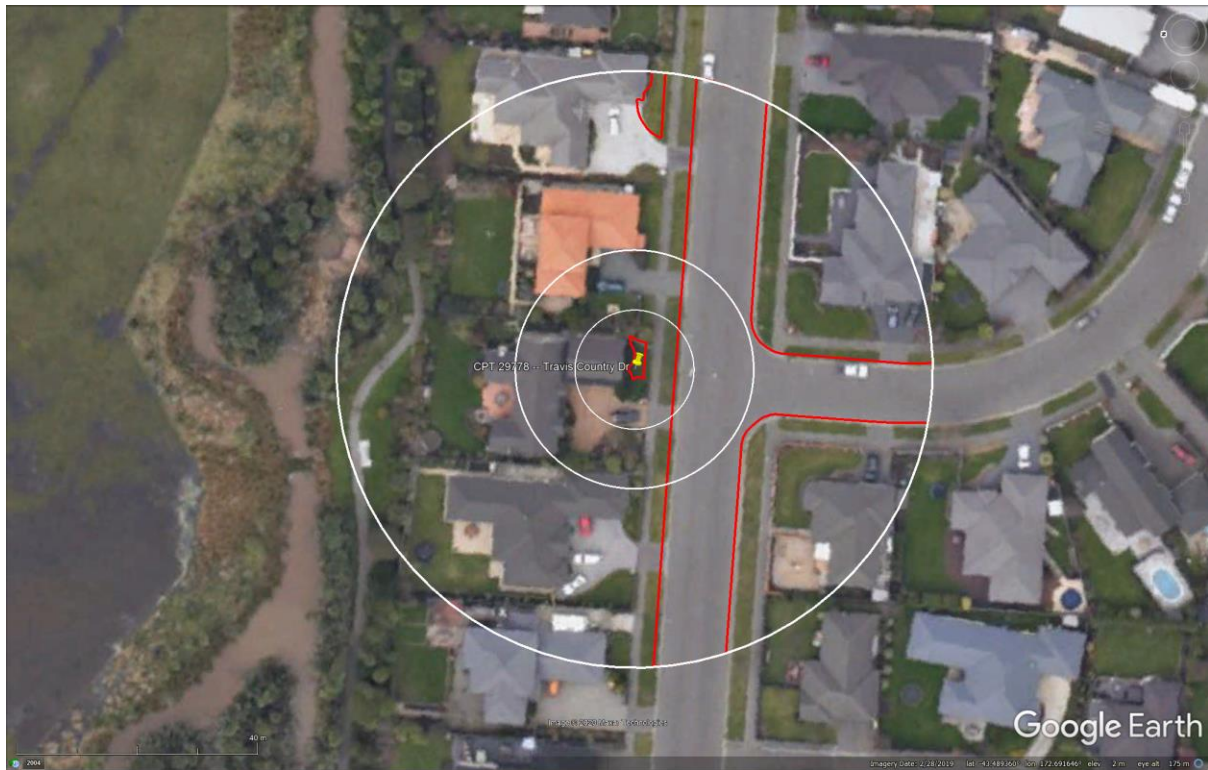
Figure 75: Absence of ejecta at the site for Sep-10 EQ.

Note 4: The values in Table 9 correspond to the coverage area of ejecta outlined in aerial photographs (Figures 75 through 79) and the lower and upper estimates of ejecta height based on geometry and EQC LDAT property inspection notes (Figures 80 and 81) and reports from Aug 2011 (no lateral spreading was observed by the inspection team). The ejecta-induced settlement using photographs and engineering judgment, $S_{E,P}$, is estimated as

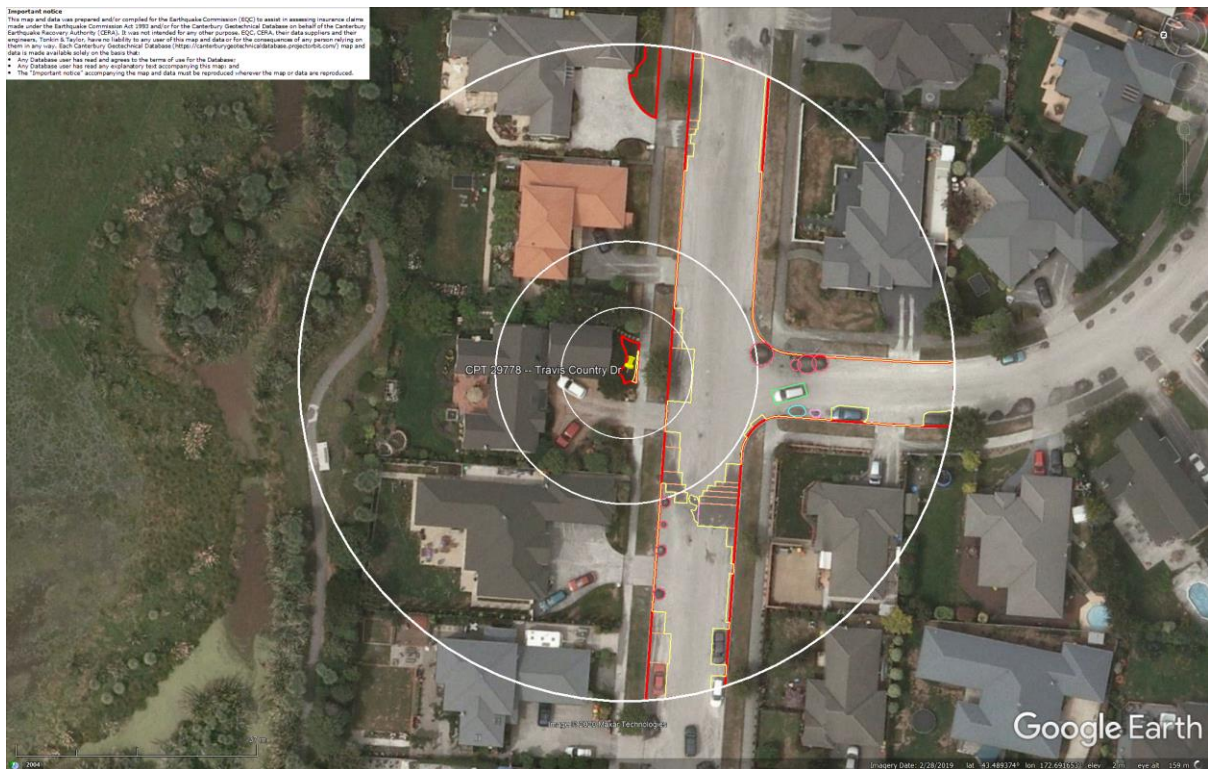
Figure 76: Ejecta outline for Feb-11 EQ.

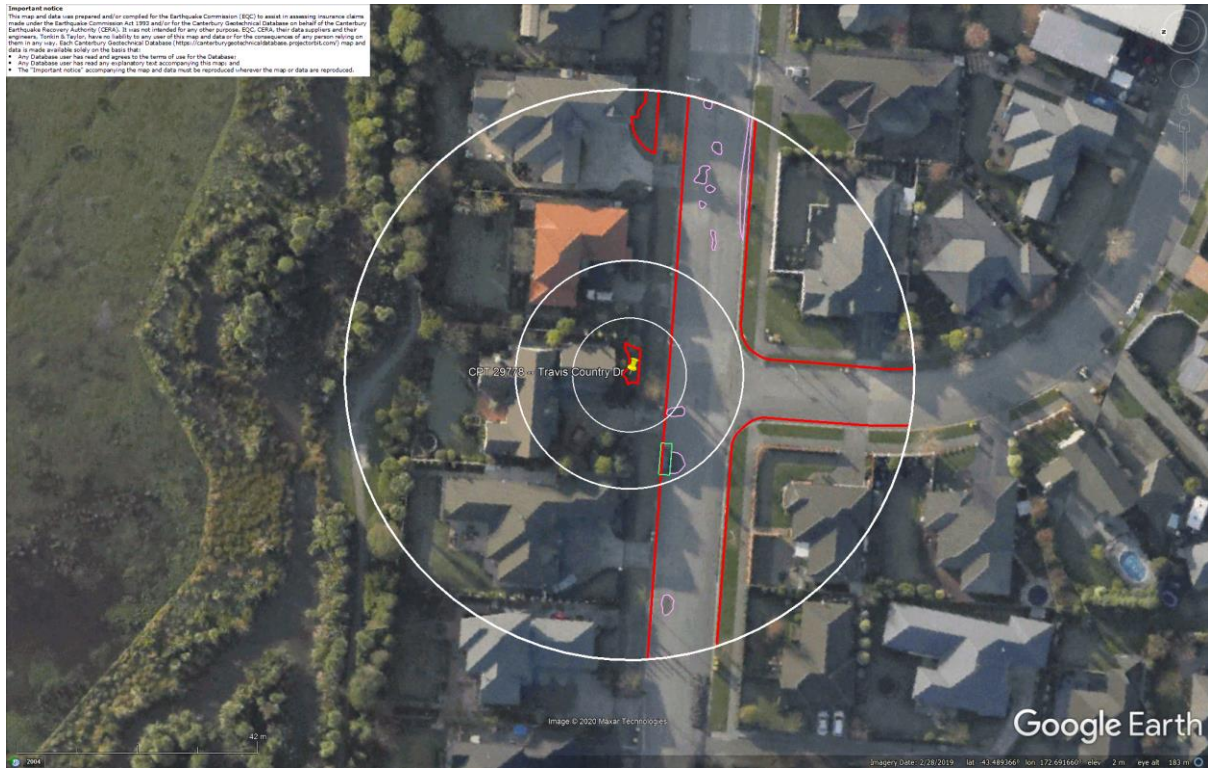
Figure 77: Ejecta outline for Jun-11 EQ in the aerial photograph acquired on Jun 14-15, 2011.

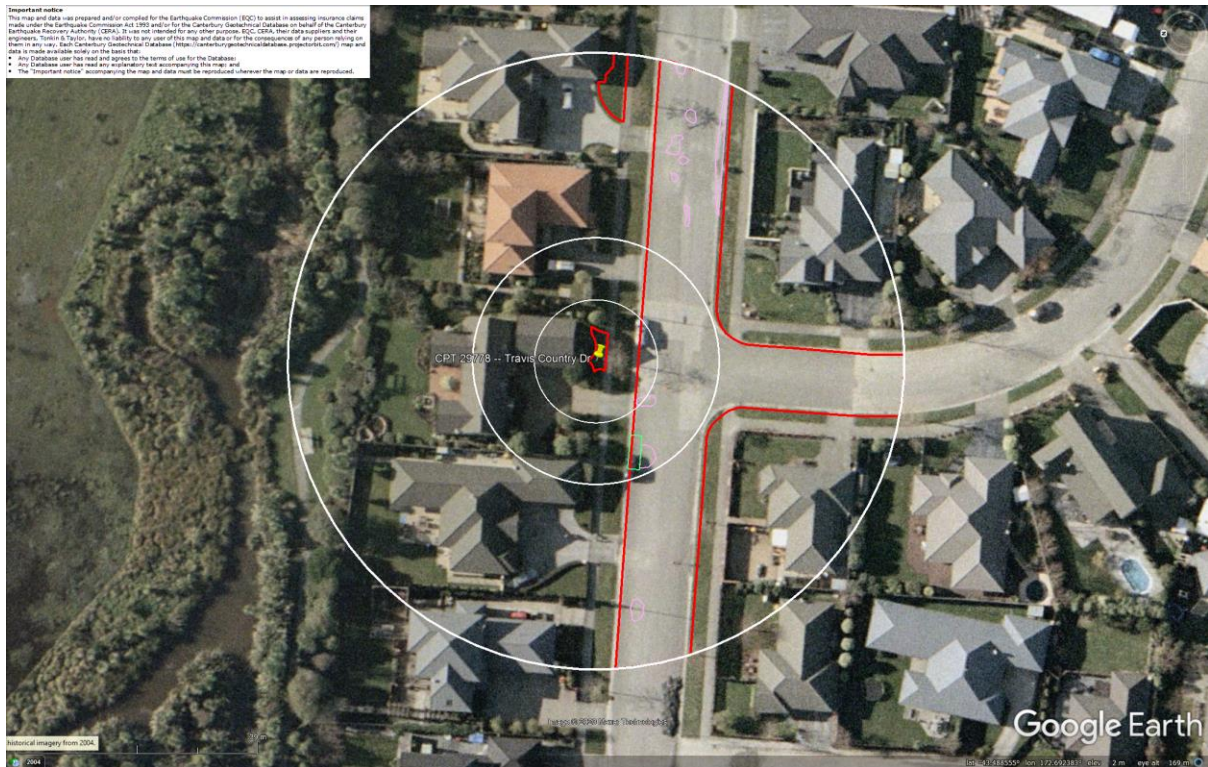
Figure 78: Aerial photograph acquired on Jun 16, 2011, showing ejecta outline for Jun-11 EQ based on the aerial photograph from Jun 14-15, 2011 (Figure 87).

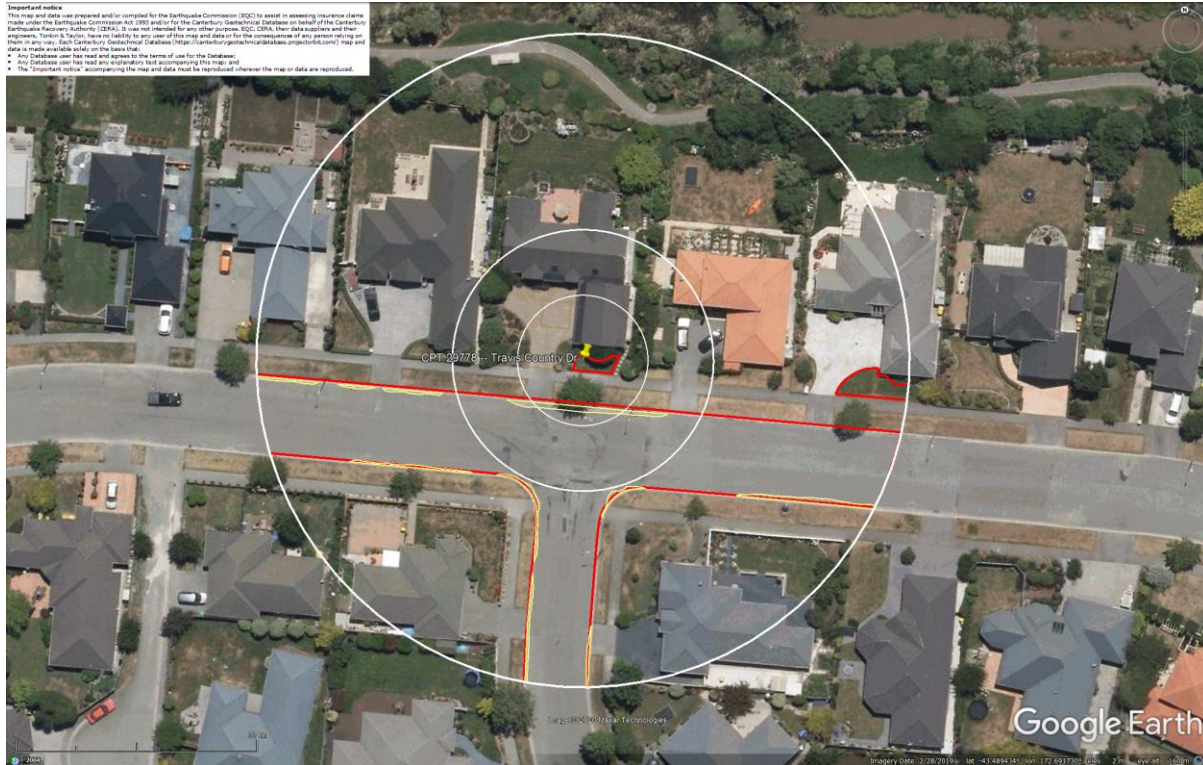
Figure 79: Ejecta outline for Dec-11 EQ.

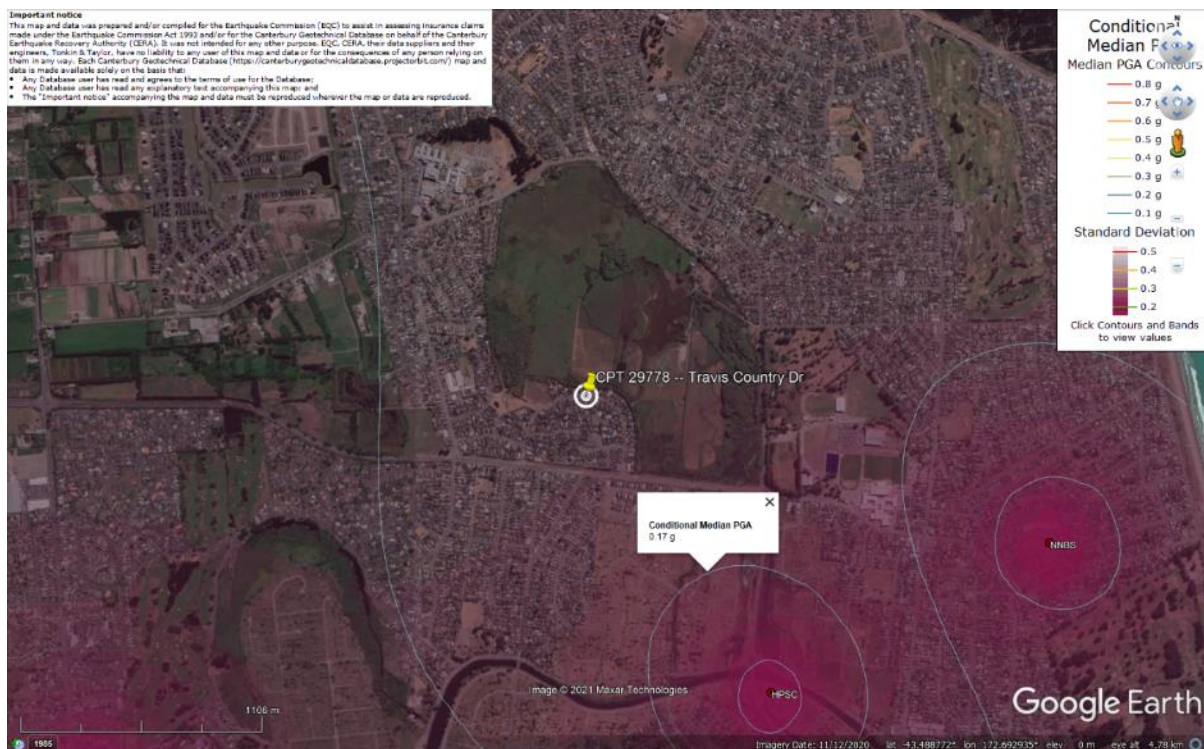
Figure 82: PGA for Sep-10 EQ (st. dev. = 0.325-0.350 ln units).

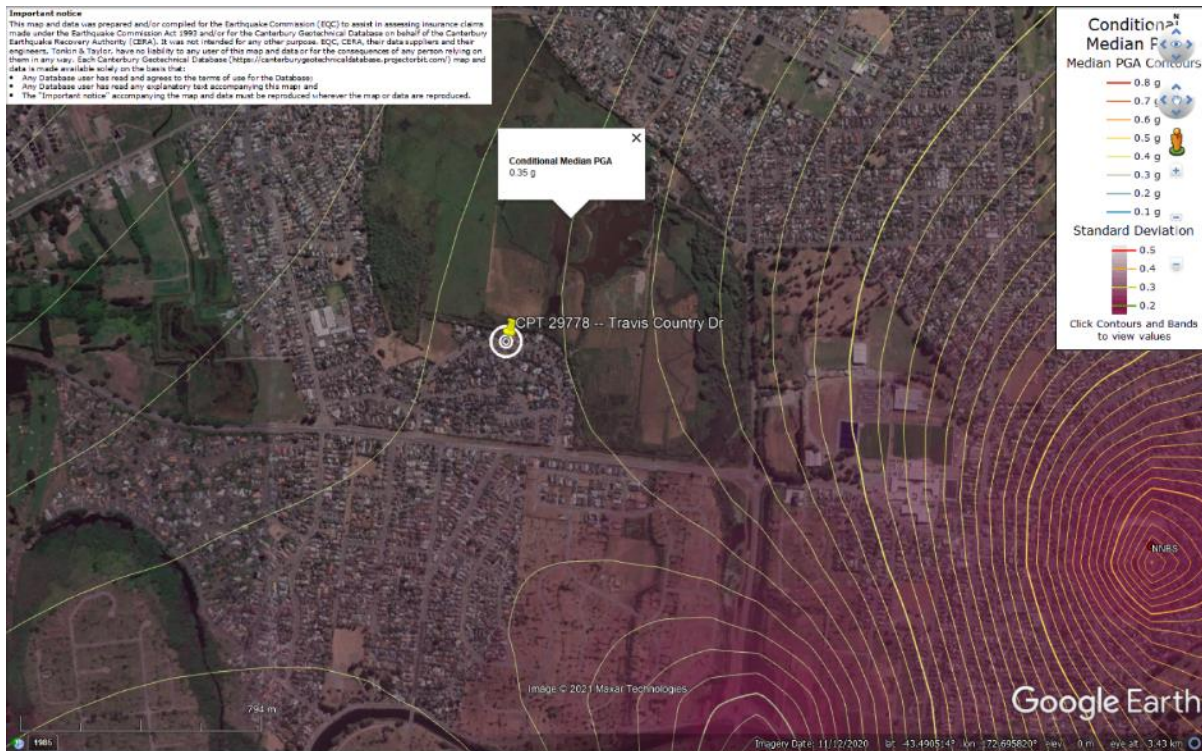
Figure 83: PGA for Feb-11 EQ (st. dev. = 0.350-0.375 ln units).
