Appendix A.18:

Travis Country Dr – CPT 29778

Liquefaction Ejecta Case Histories for 2010-11 Canterbury Earthquakes

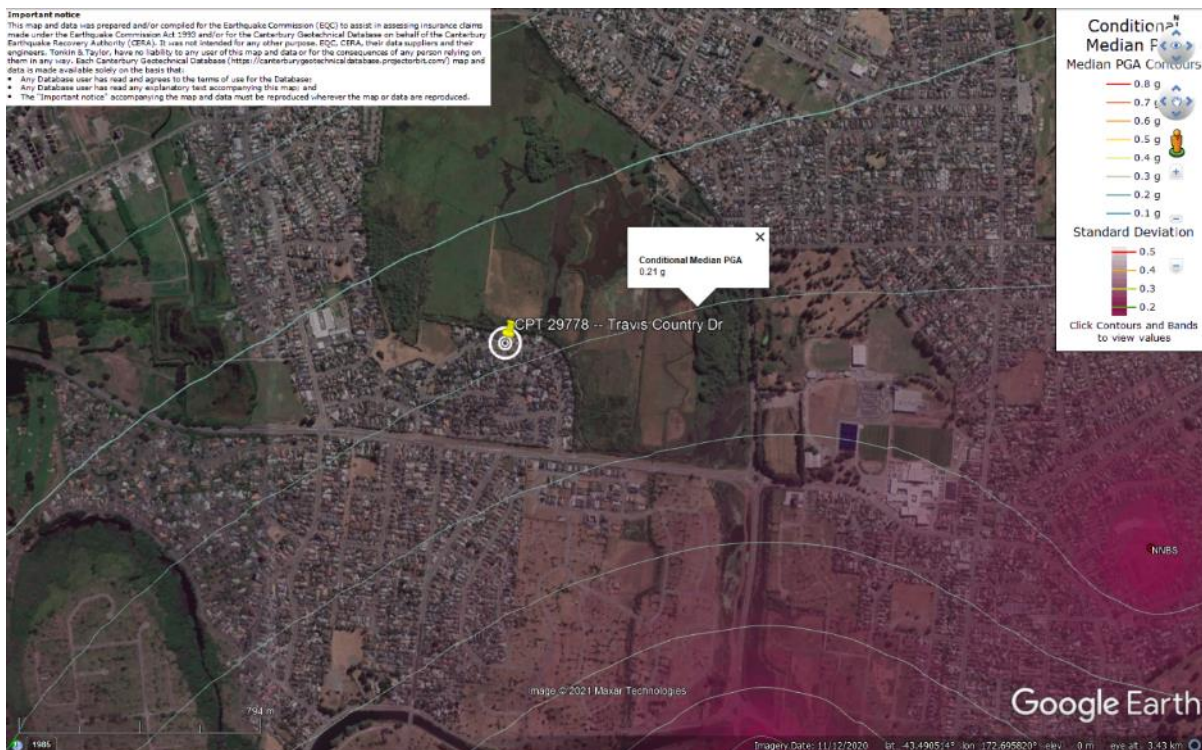
Figure 84: PGA for Jun-11 EQ (st. dev. = 0.375-0.400 ln units).

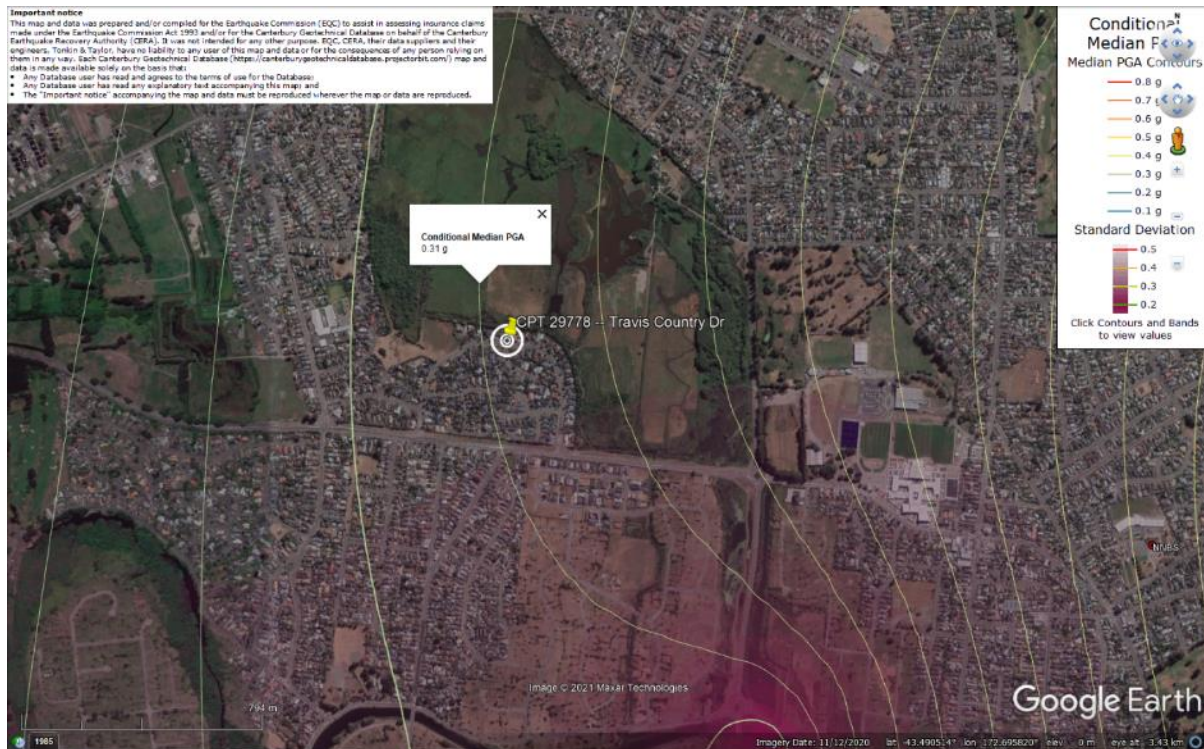
Figure 85: PGA for Dec-11 EQ (st. dev. = 0.375-0.400 ln units).

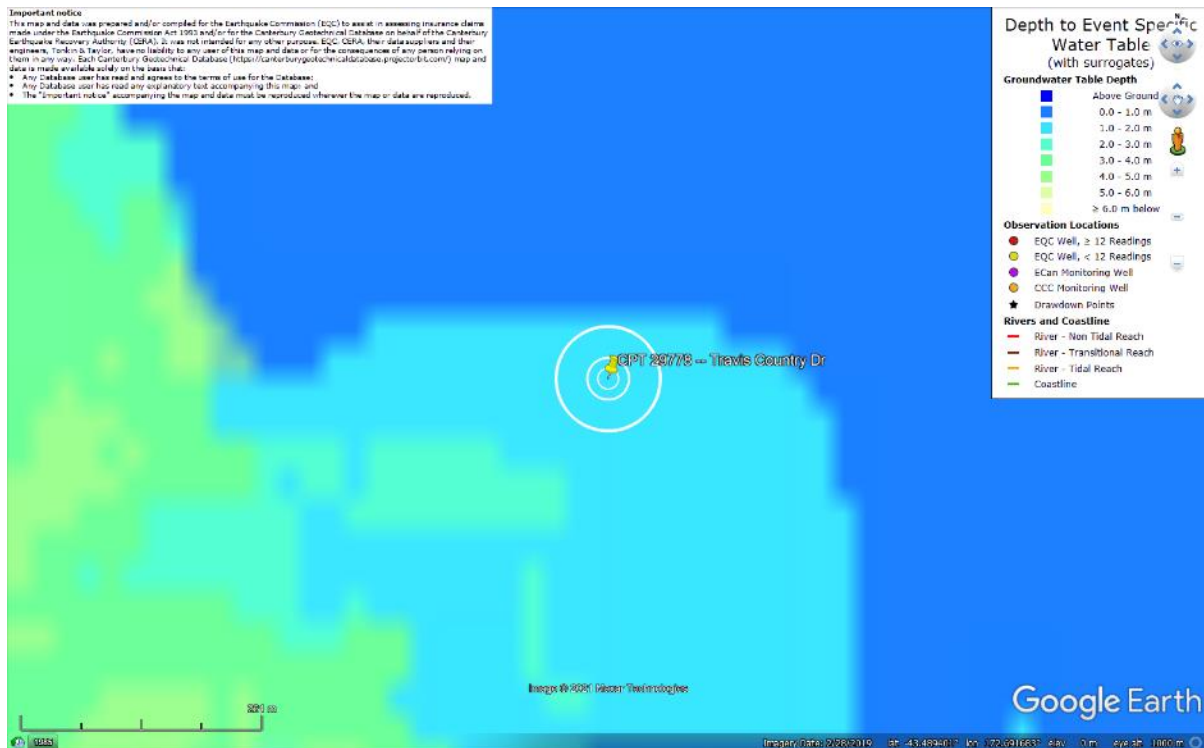
Figure 86: Depth to groundwater table for Sep-10 EQ.

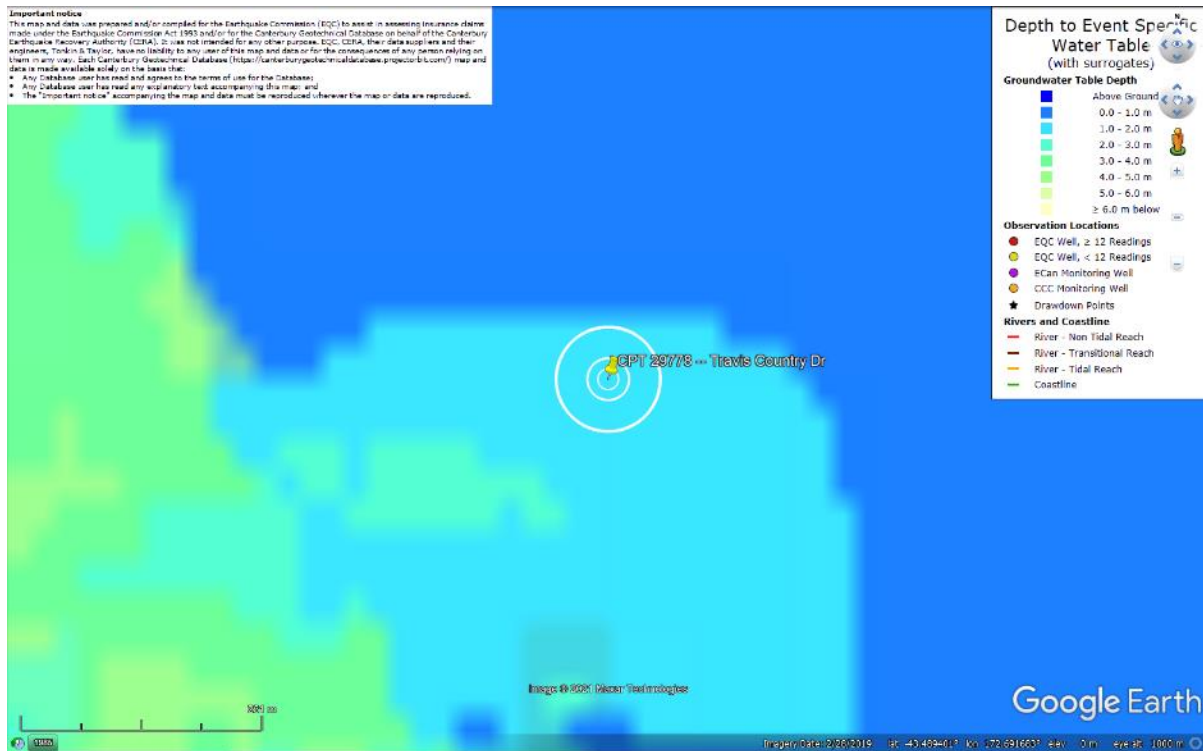
Figure 87: Depth to groundwater table for Feb-11 EQ.

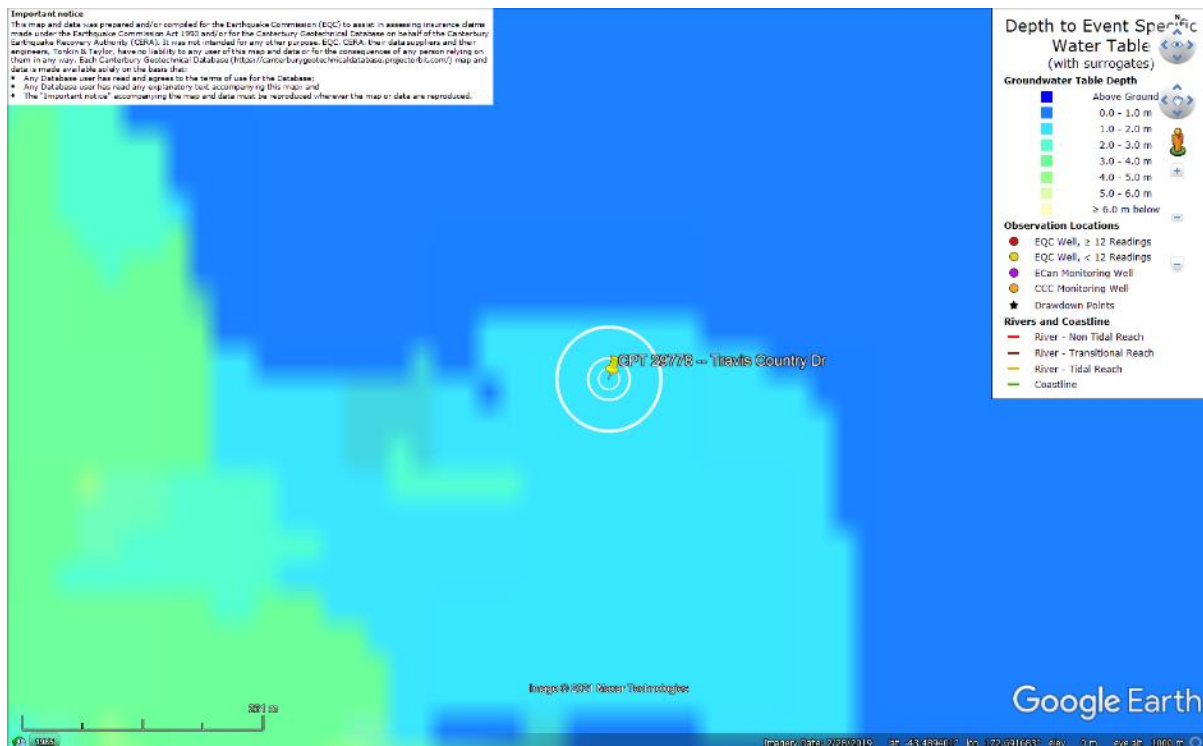
Figure 88: Depth to groundwater table for Jun-11 EQ.

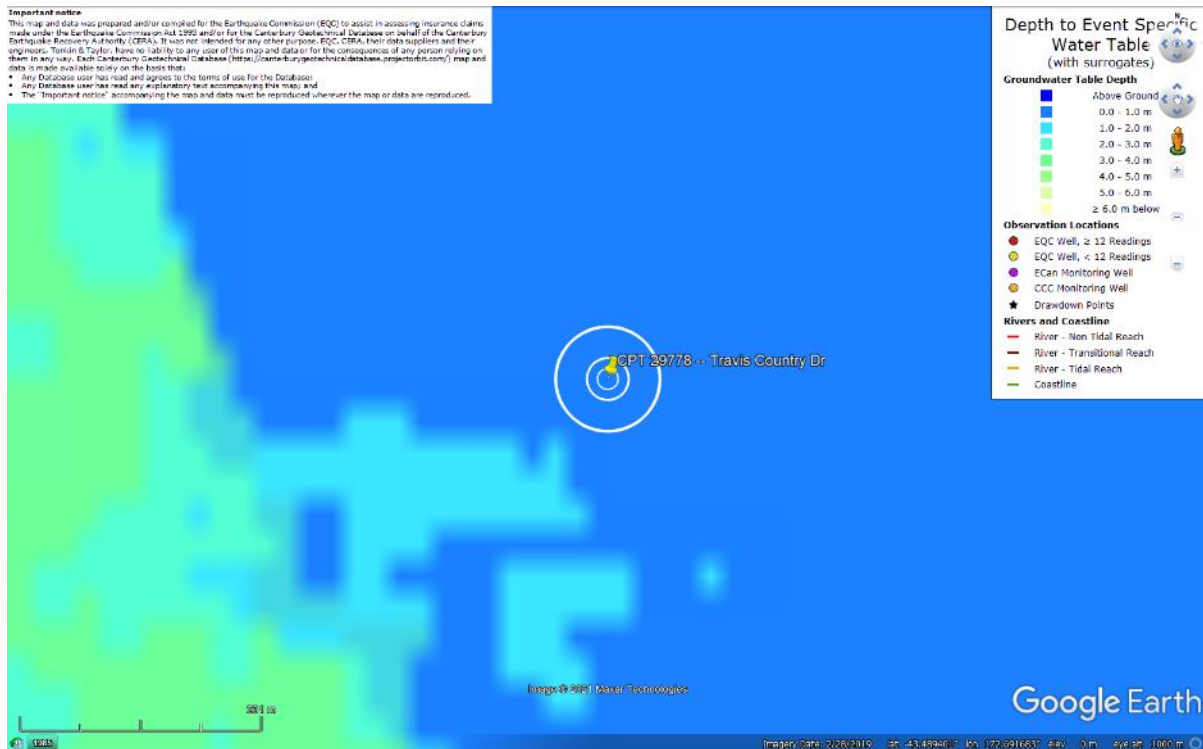
Figure 89: Depth to groundwater table for Dec-11 EQ.

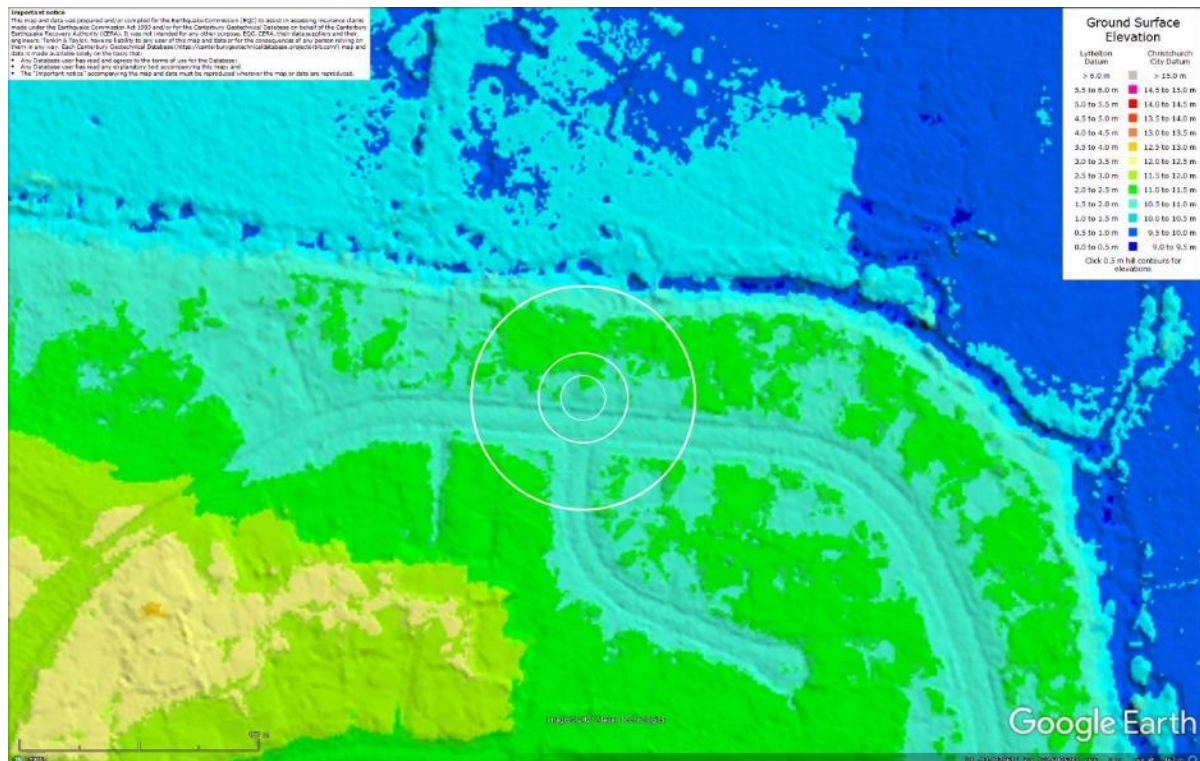
Figure 90: Ground surface elevation according to the Sep-11 LiDAR survey.

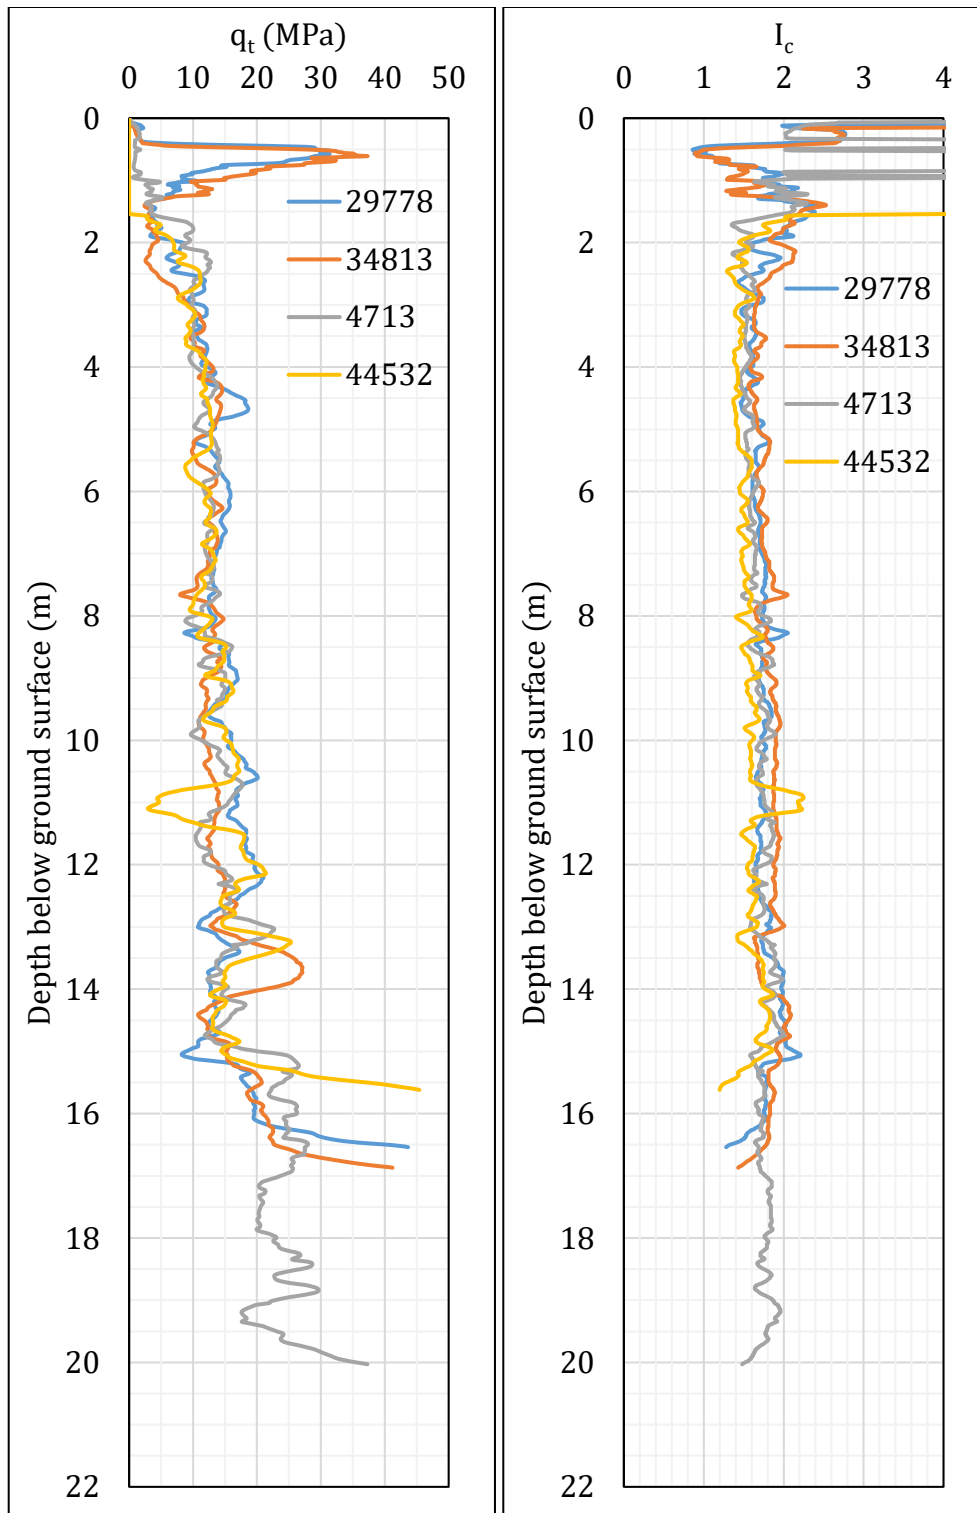
Figure 91: q_t and I_c profiles.

Note 9: The selection of CPTs for the area considered for settlement assessment (Figure 1) is based on the proximity of the CPTs to the considered areas. In accordance with that, the following table shows CPTs that were used for the volumetric settlement analysis in *Cliq v.3.0.3.2*, a CPT soil liquefaction software developed by GeoLogismiki. (The average volumetric settlements were reported in Table 8.)
