Appendix A.21:

15b Royds Pl – VsVp 57326

Liquefaction Ejecta Case Histories for 2010-11 Canterbury Earthquakes

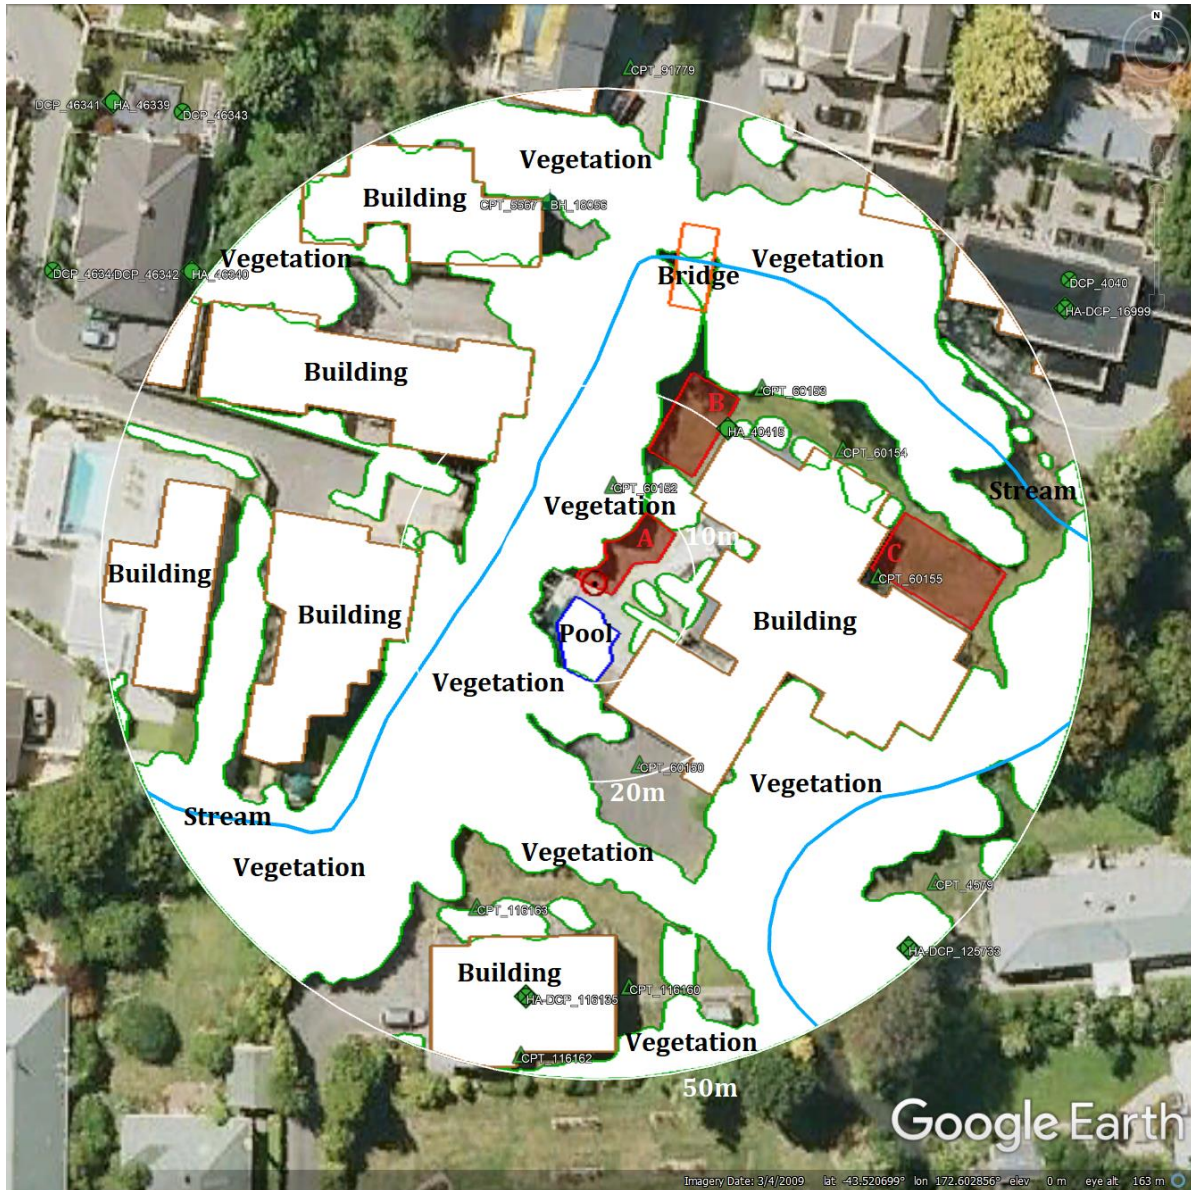
Figure 1: Site plan with areas where ejecta-induced settlement is considered.

Note 1: Three patches (outlined in red) in free field were initially selected for settlement assessment as areas free of vegetation and structures. Further analyses such as proximity of a patch to a CPT, proximity of a patch to a property subjected to addition and/or demolition of a structure and the sloping ground, front yard/backyard alterations (e.g., ploughing, rubble, scrap), and aerial distribution of sediment ejecta resulted in all three patches being selected for detailed settlement assessment.

- $A_{E,thick,i}$ and $H_{E,thick,i}$ are the area and the height of a thick ejecta layer, respectively;
- $A_{E,thin,j}$ and $H_{E,thin,j}$ are the area and the height of a thin ejecta layer, respectively;
- A_T is the total assessment area for a buffer being considered (Figure 1).

Note 6: The selection of CPTs for the area considered for settlement assessment (Figure 1) is based on the proximity of the CPTs to the considered areas. In accordance with that, the following table shows CPTs that were used for the volumetric settlement analysis in *Cliq v.3.0.3.2*, a CPT soil liquefaction software developed by GeoLogismiki. (The average volumetric settlements were reported in Table 8.)

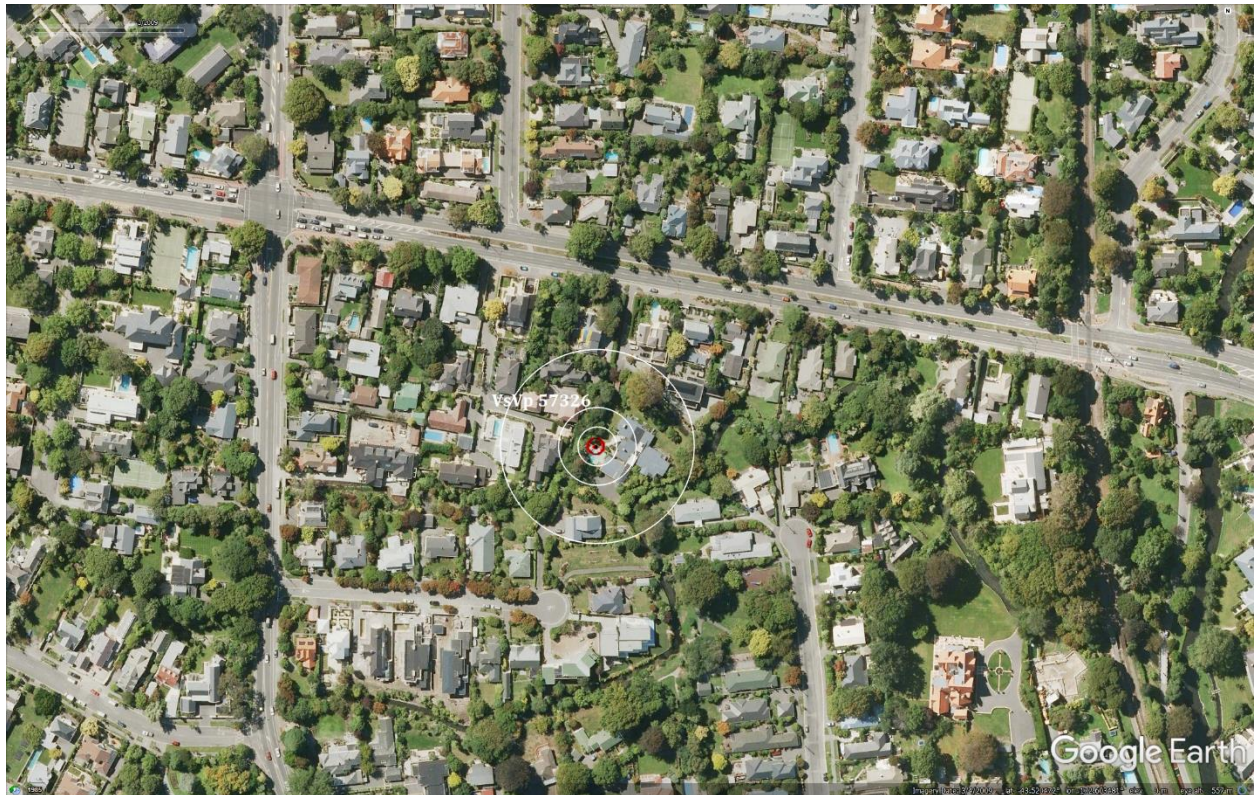
Figure 3: Position of the site relative to nearby buildings, vegetation, and free-face features.

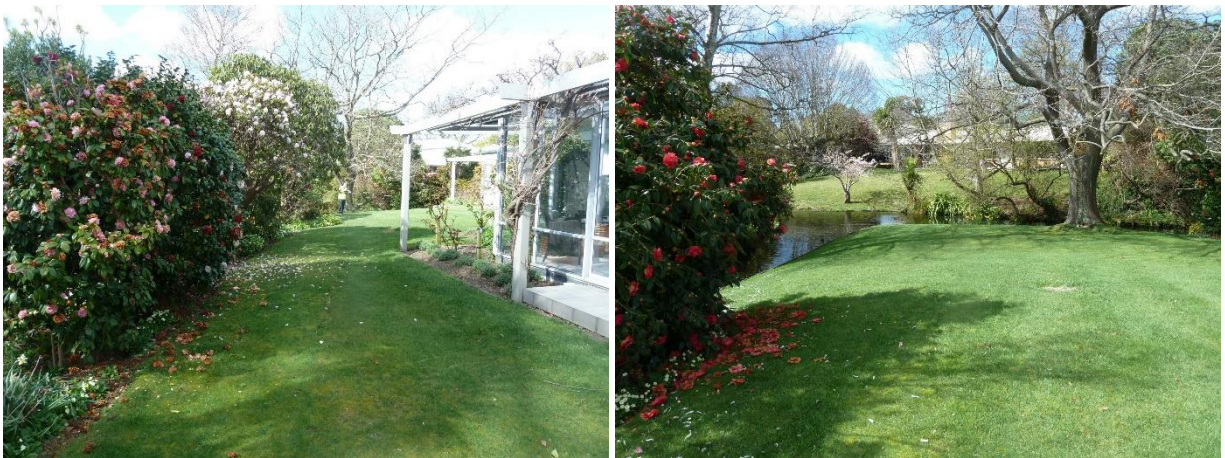
Figure 4: Ground photographs of slightly sloping ground near and toward the stream. The photograph on the right also shows the step change in the ground surface due to the stream.

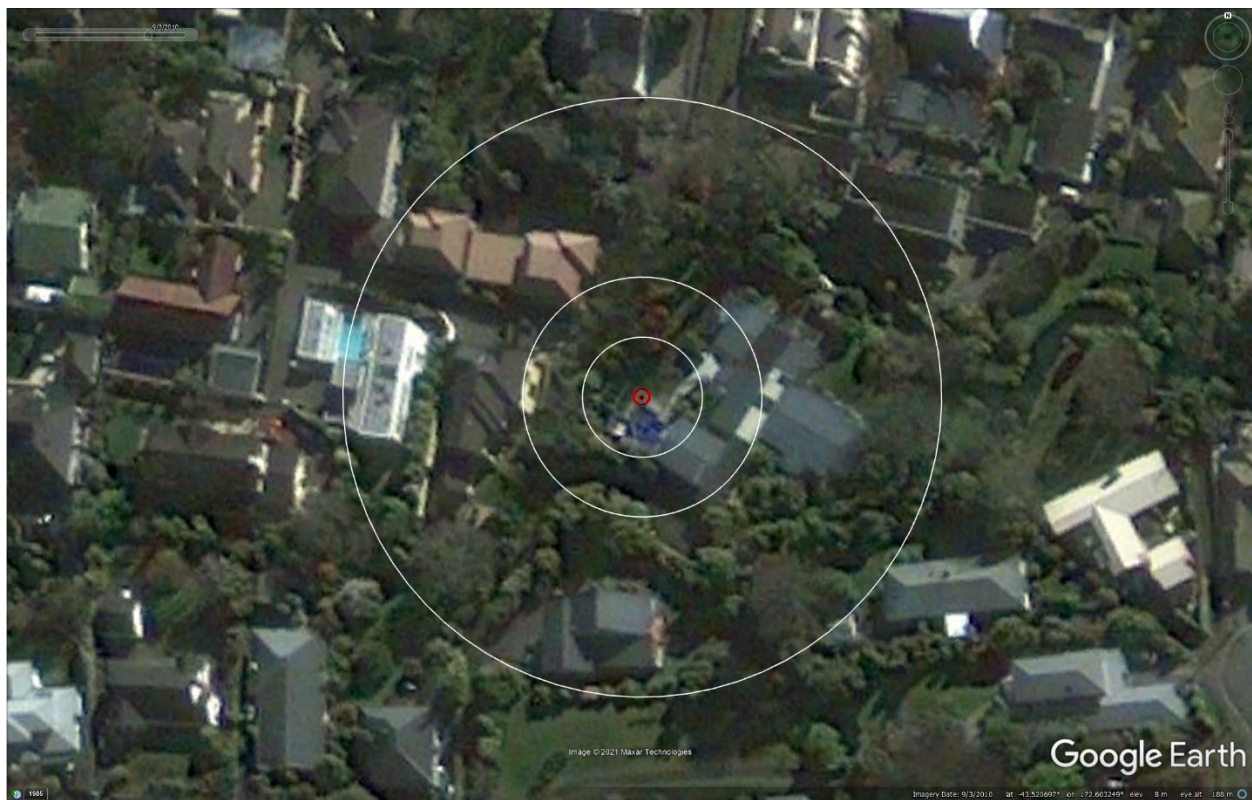
Figure 8: Satellite image of the site taken on 3 Sep 2010.

Note 4: The Sep-10 ejecta-induced settlement values in Table 9 are based on the satellite images of the site (Figures 8 and 9) showing no ejecta and the Cubrinovski et al. (2011)³ liquefaction map. The ejecta-induced settlement using photographs and engineering judgment, $S_{E,P}$, is estimated as

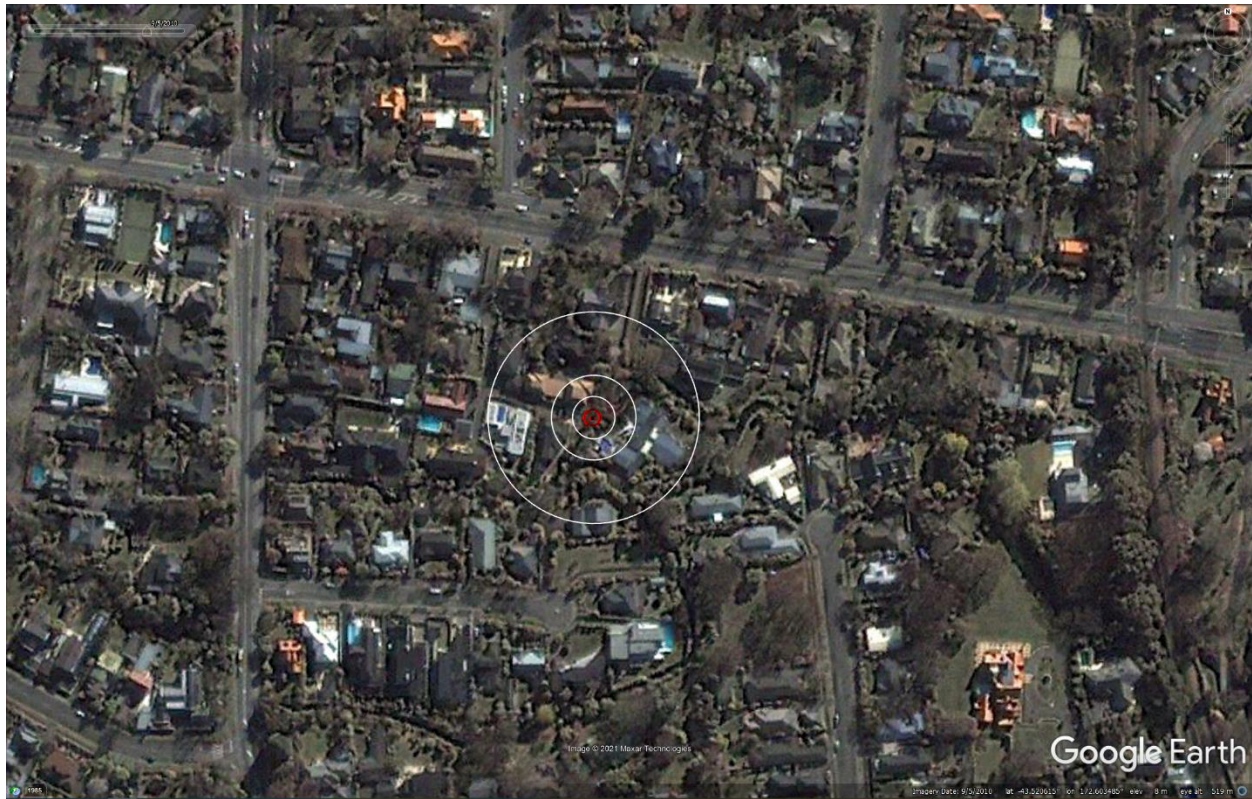
Figure 9: Satellite image of the site taken on 5 Sep 2010.

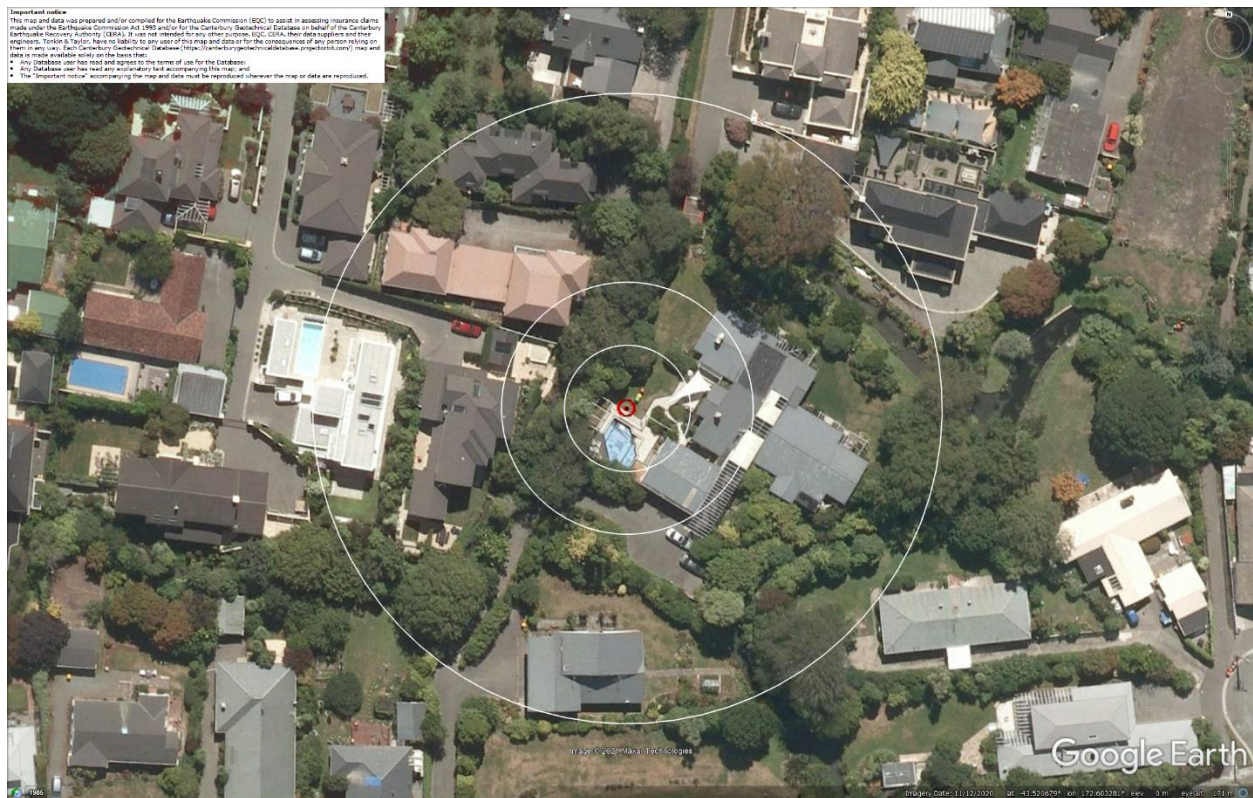
Figure 12: Aerial photograph of the site taken on Feb 24, 2011.

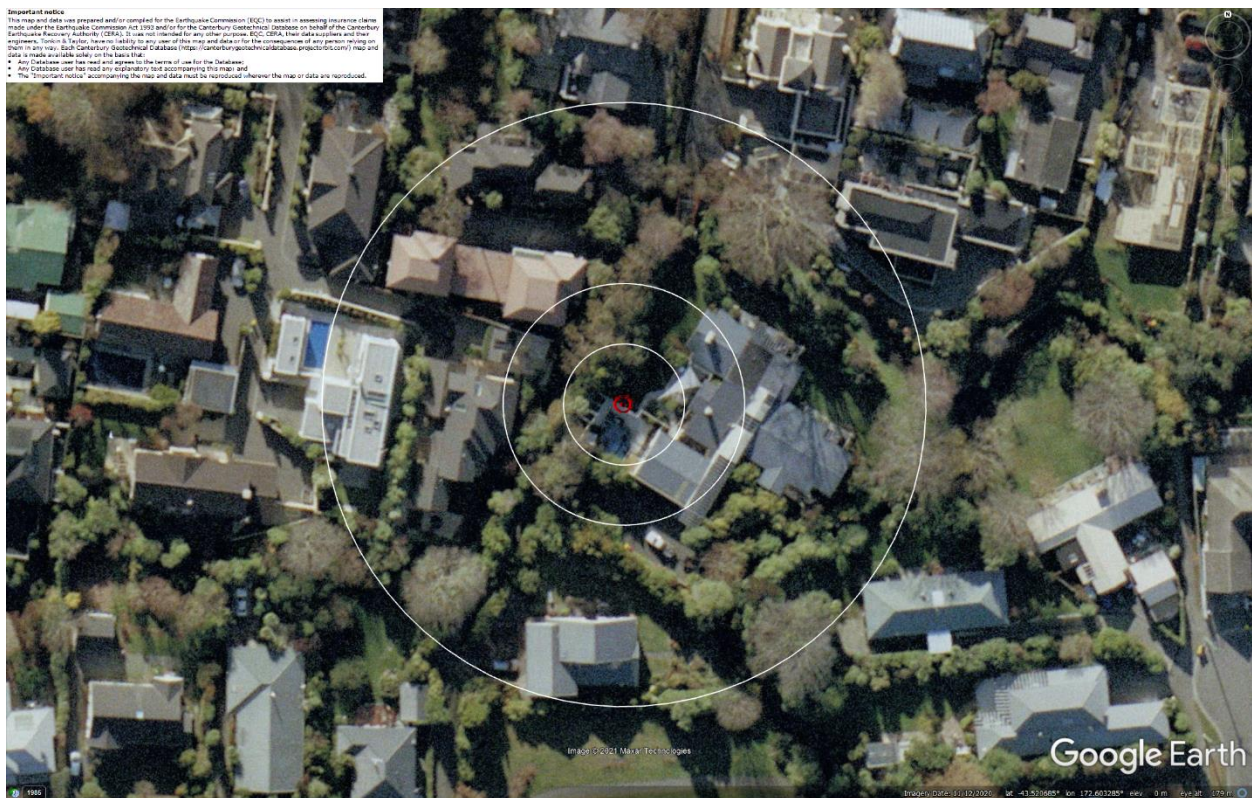
Figure 14: Aerial photograph of the site taken on June 16, 2011.

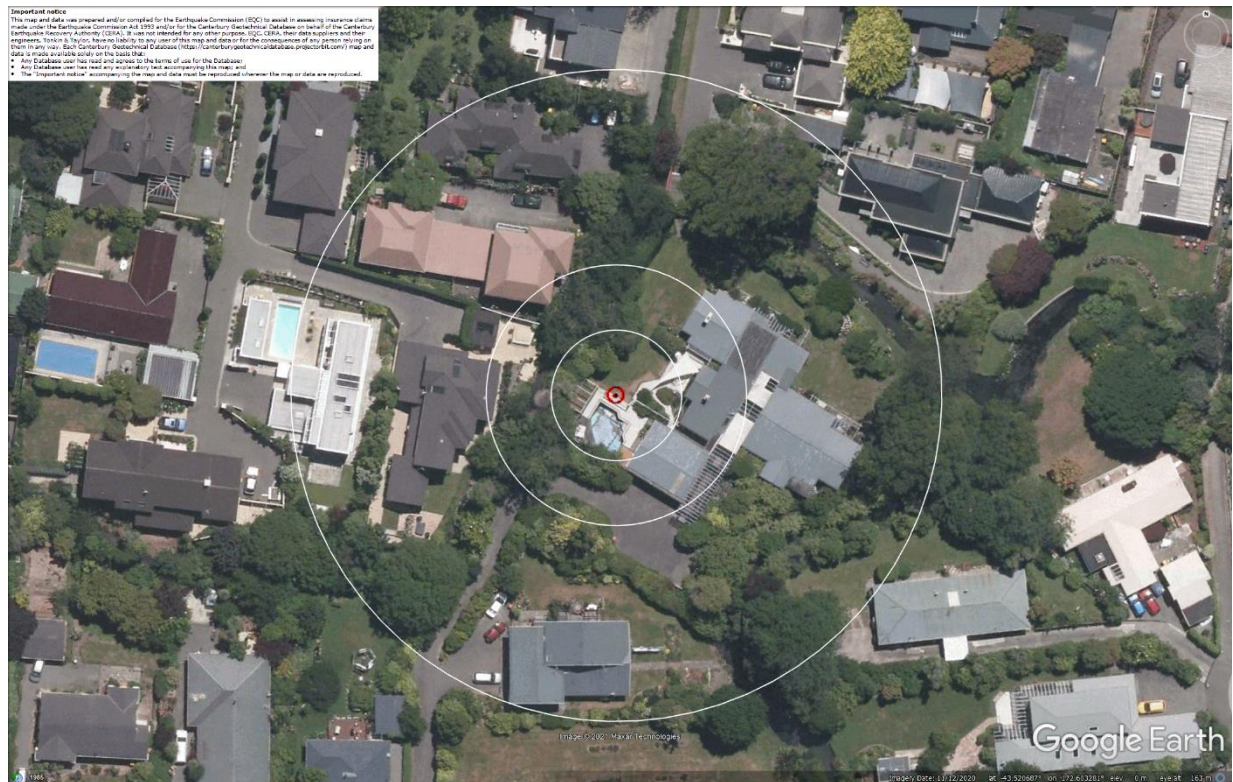
Figure 15: Aerial photograph of the site taken on Dec 24, 2011.

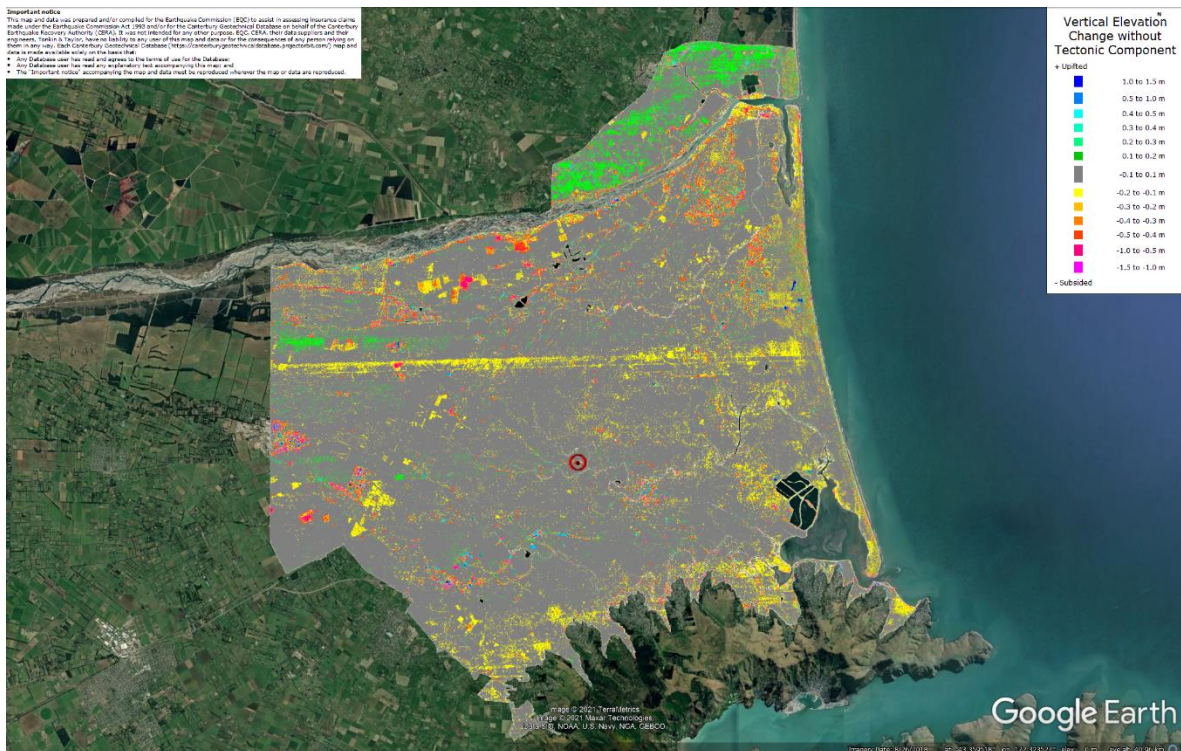
Figure 18: Vertical Ground Movements (Surface – Tectonic) for June 2011 Earthquake – the site is not in the apparent zone of overestimated or underestimated ground surface subsidence.

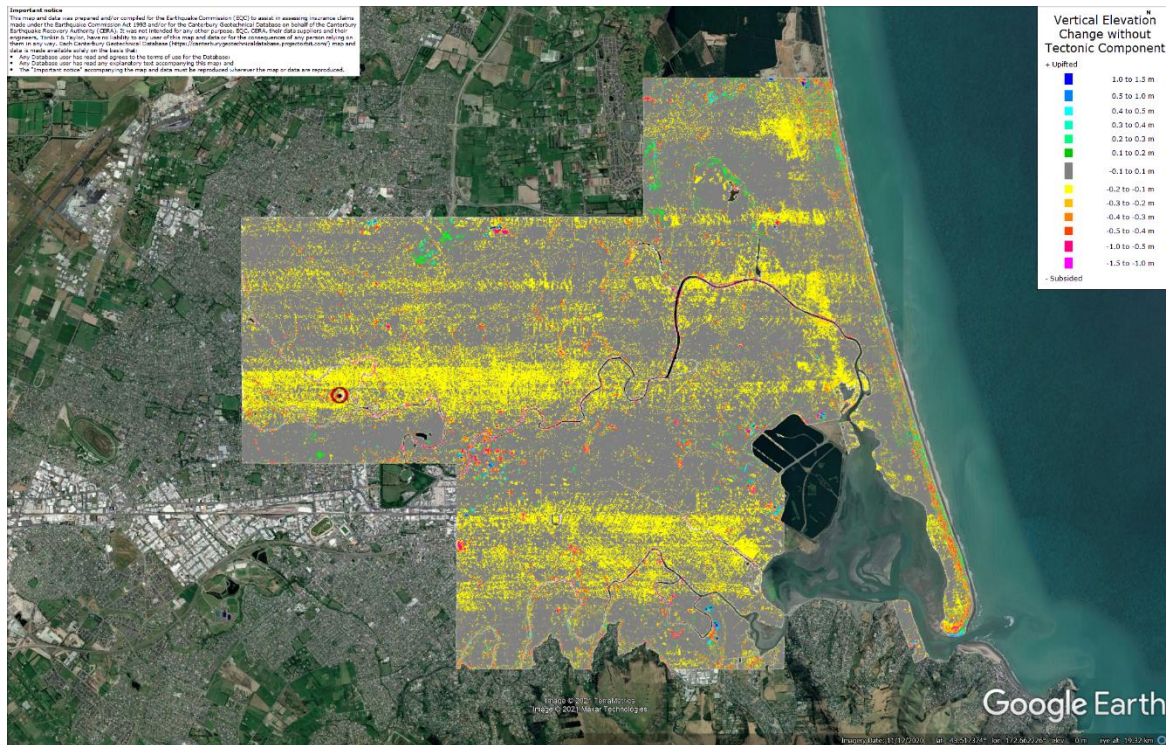
Figure 19: Vertical Ground Movements (Surface – Tectonic) for Dec 2011 Earthquake – the site is in the apparent zone of overestimated ground surface subsidence due to the underestimated ground surface elevation by the Oct 2012 LiDAR survey.

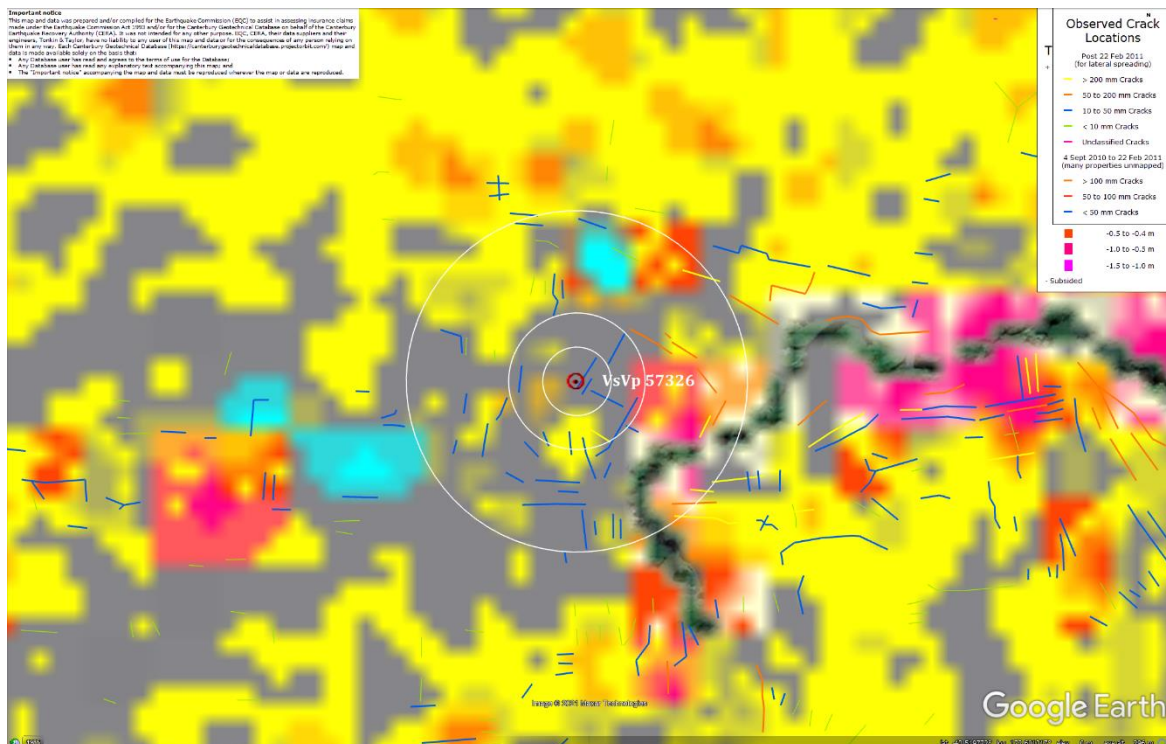
Figure 20: Lateral spreading for Canterbury Earthquake Sequence (no lateral spreading for Sep-10 EQ but Feb-11 EQ).

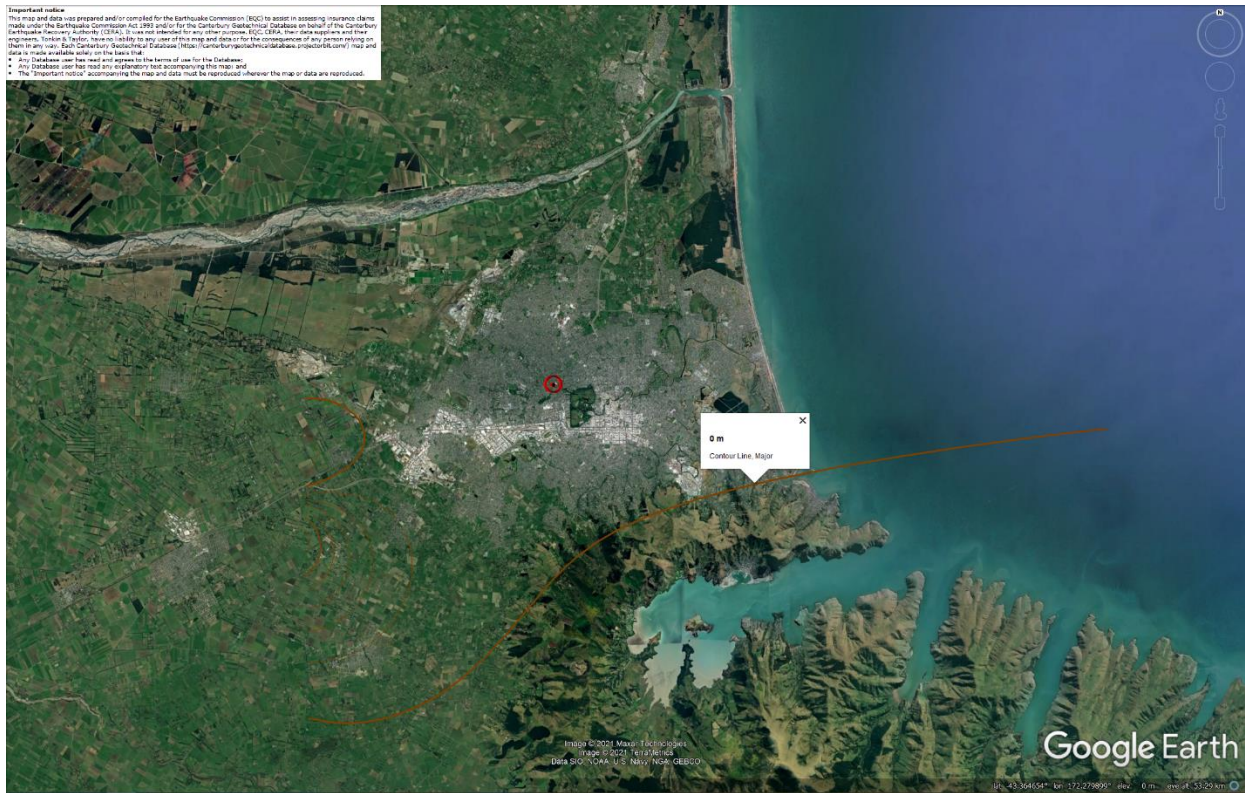
Figure 21: Vertical tectonic movements for Sep 2010 Earthquake.

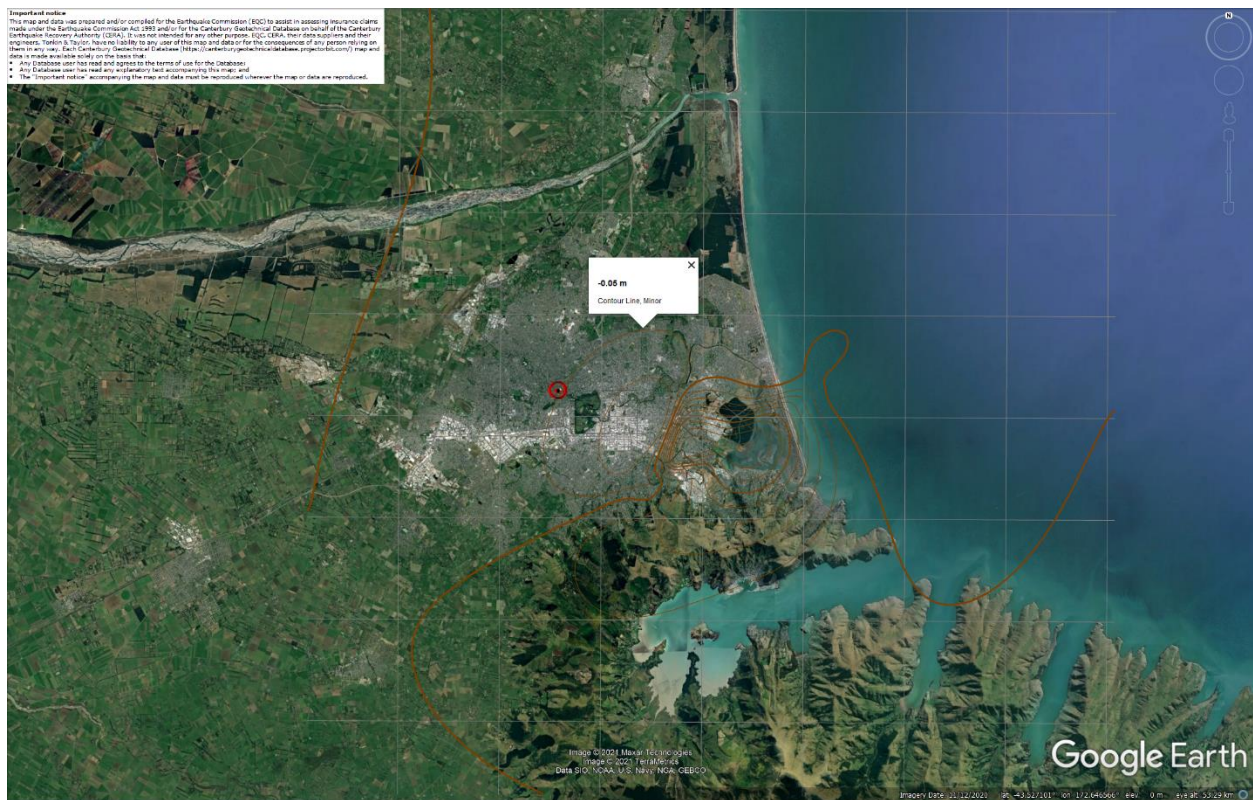
Figure 22: Vertical tectonic movements for Feb 2011 Earthquake.

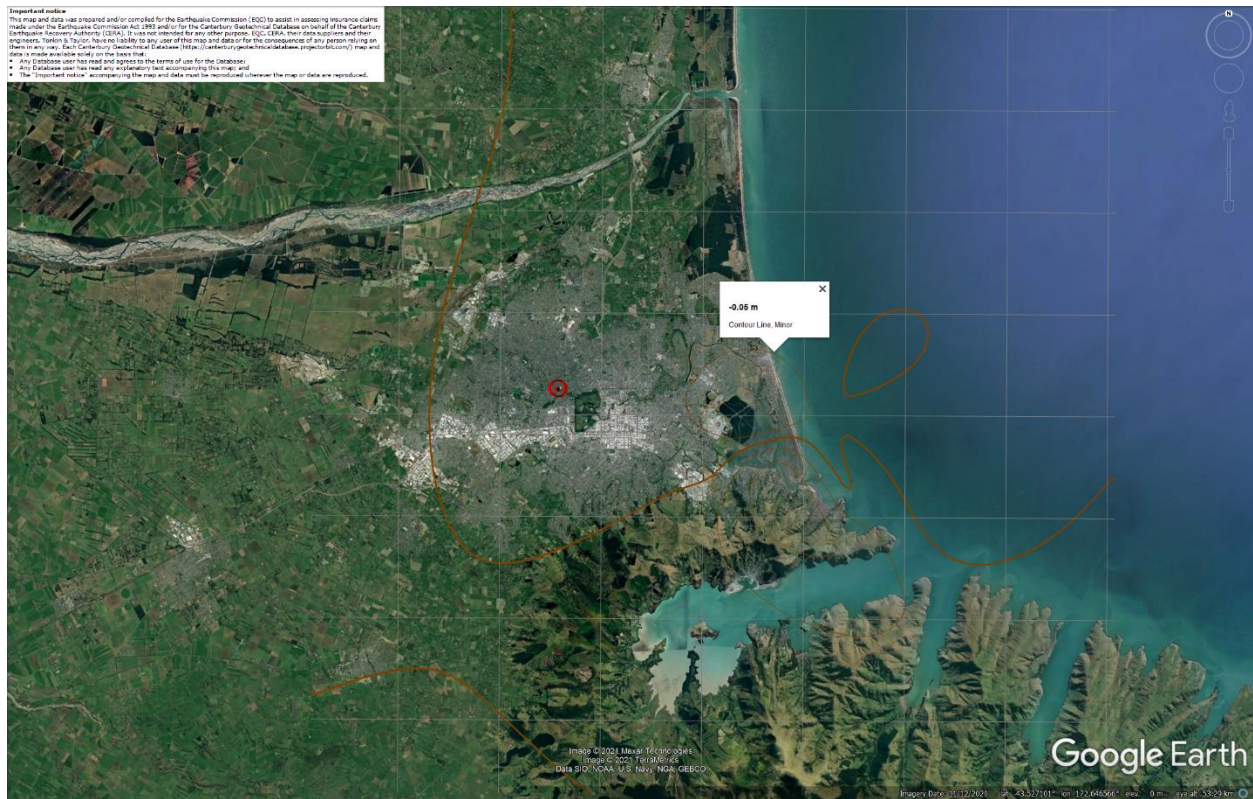
Figure 23: Vertical tectonic movements for June 2011 Earthquake.

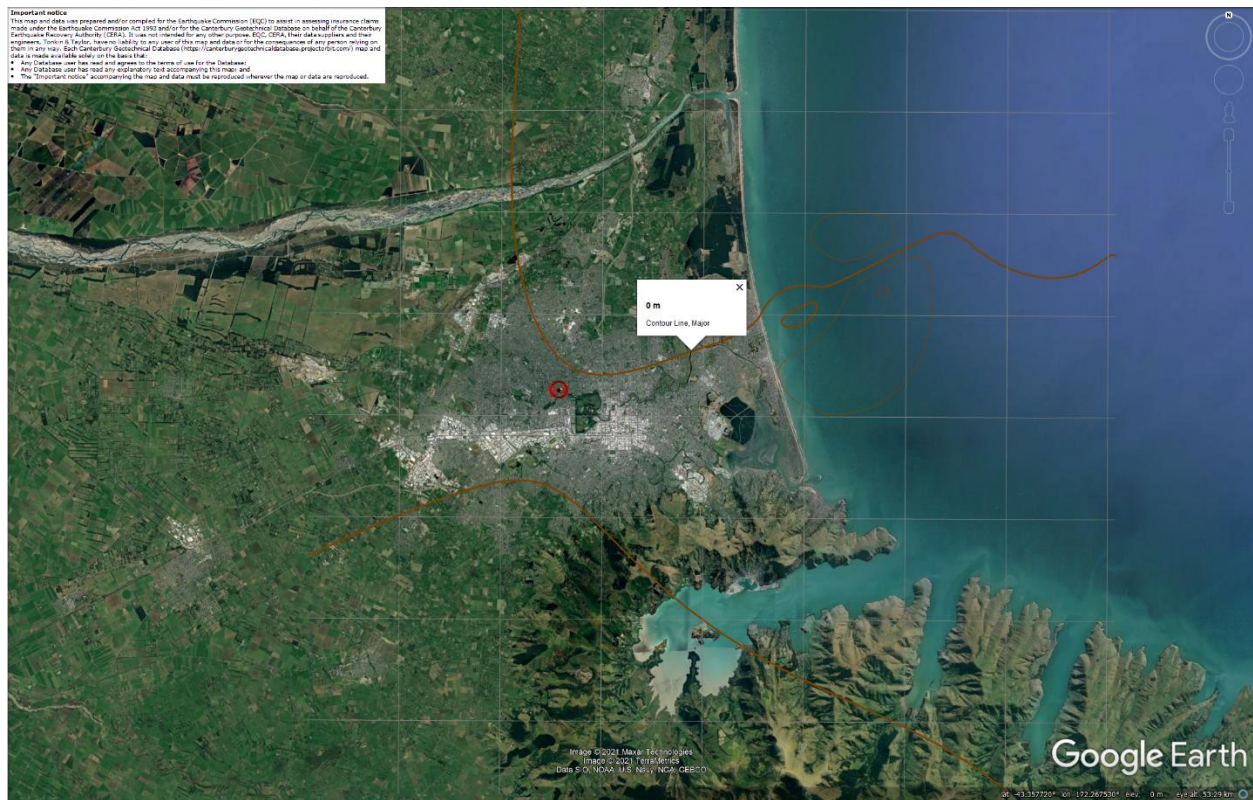
Figure 24: Vertical tectonic movements for Dec 2011 Earthquake.

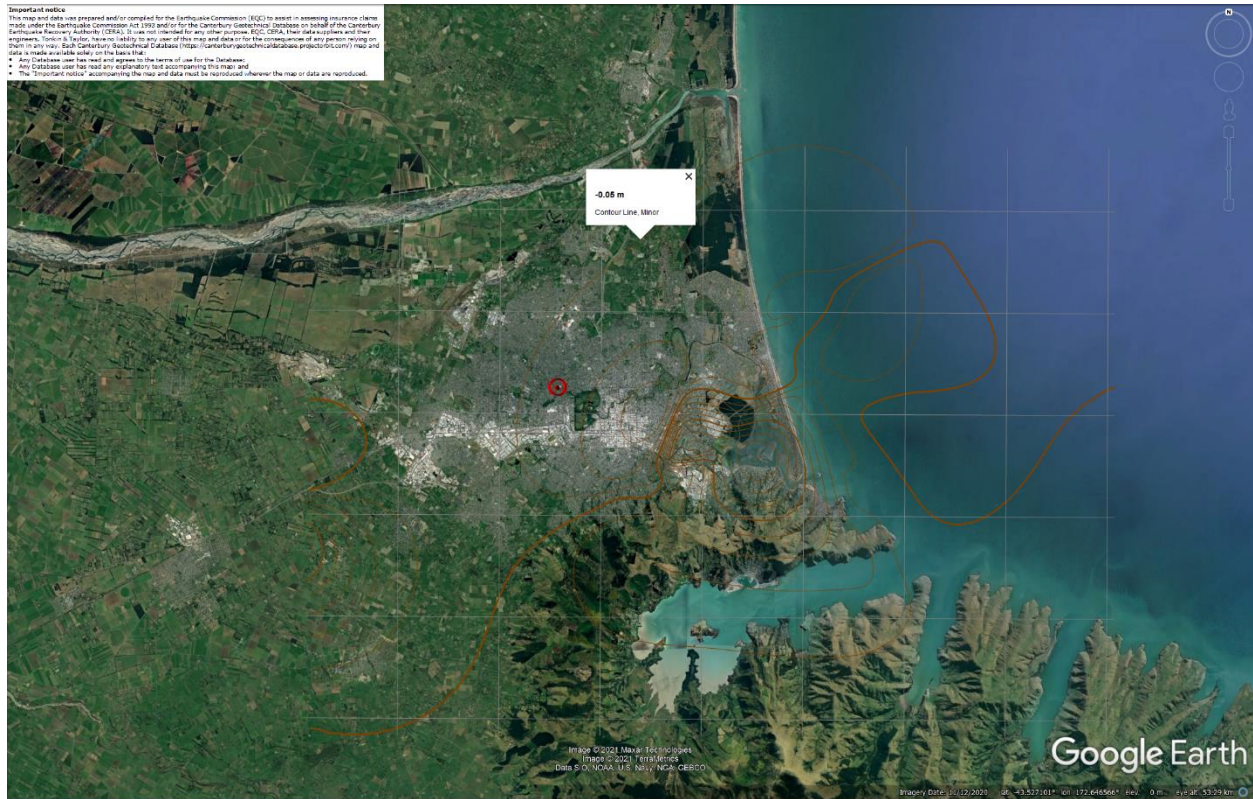
Figure 25: Vertical tectonic movements for Canterbury Earthquake Sequence.

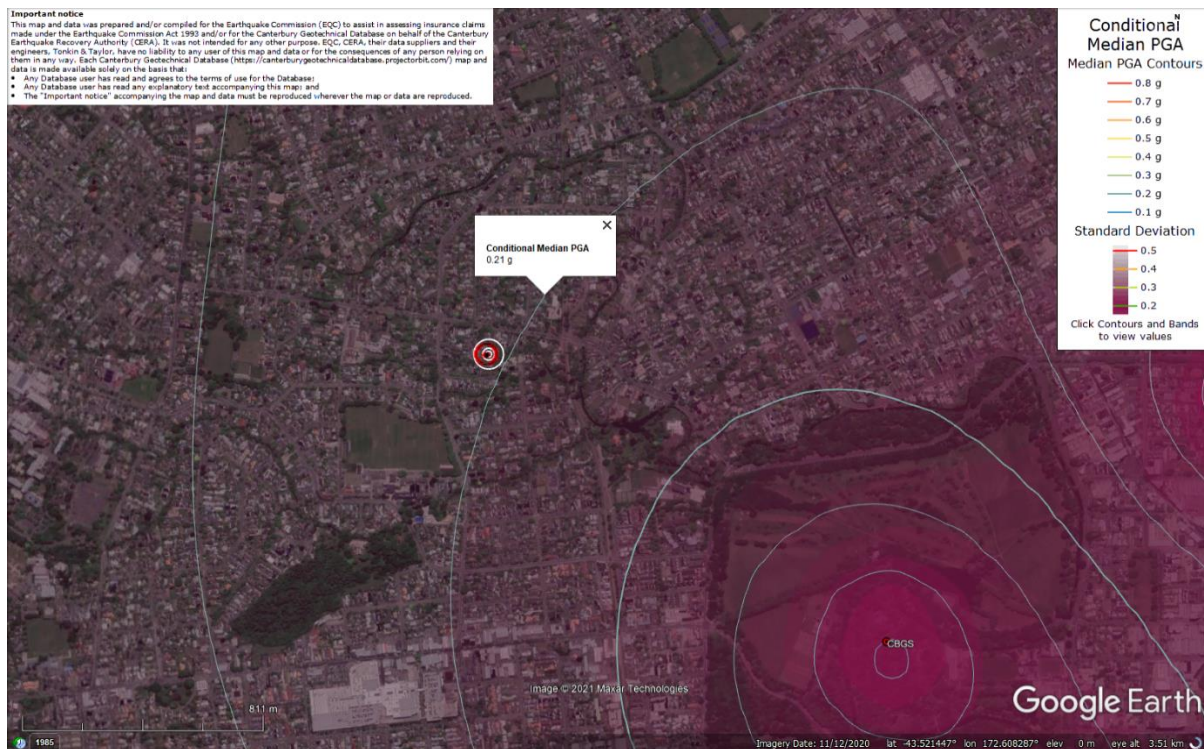
Figure 26: PGA for Sep-10 EQ (st. dev. = 0.325-0.350 ln units).

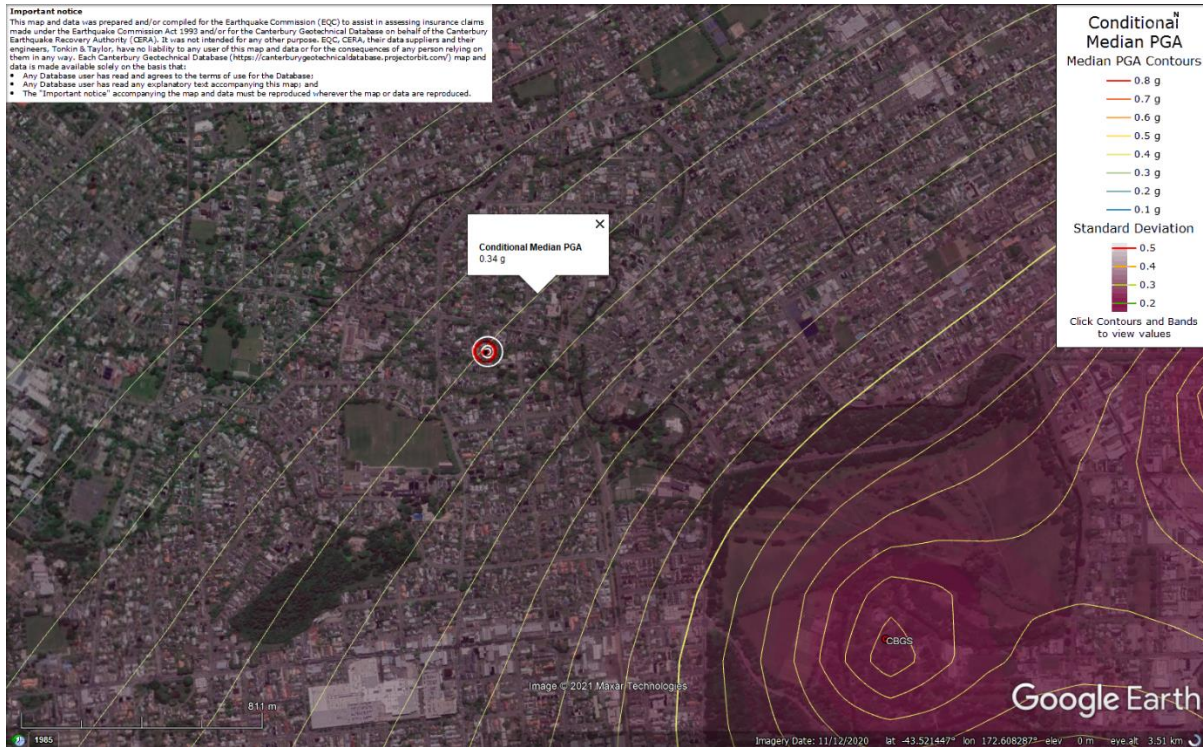
Figure 27: PGA for Feb-11 EQ (st. dev. = 0.350-0.375 ln units).

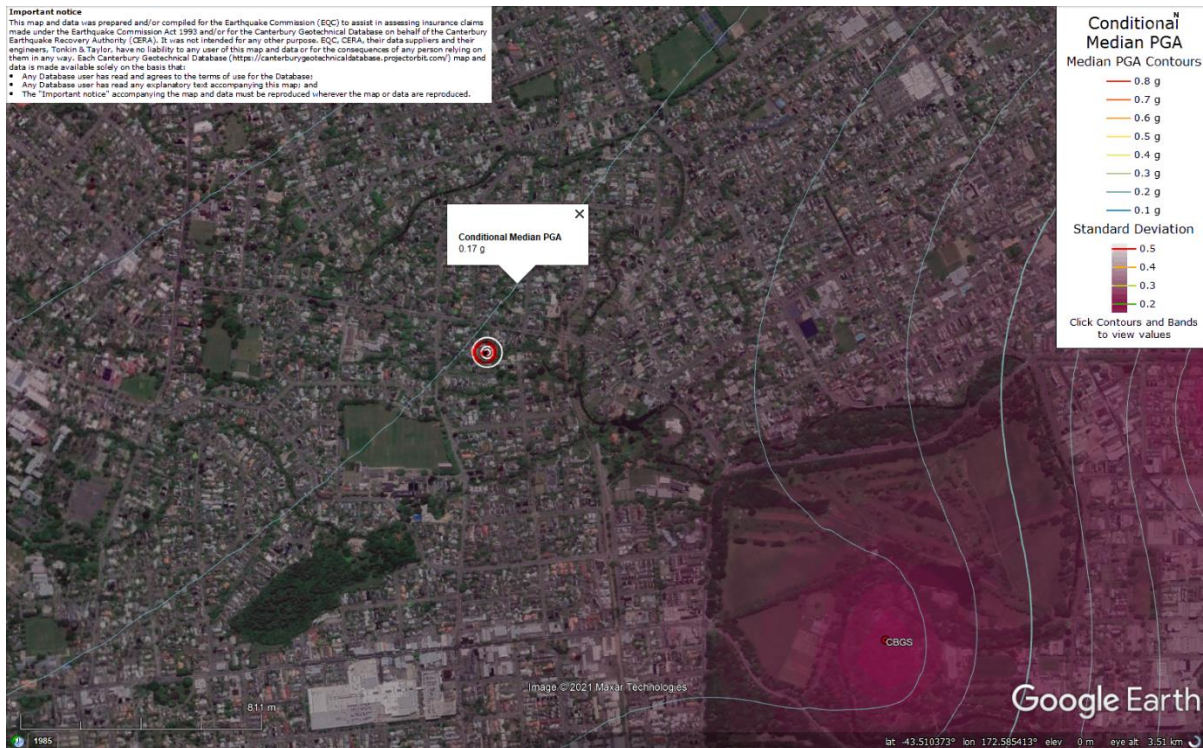
Figure 28: PGA for Jun-11 EQ (st. dev. = 0.375-0.400 ln units).

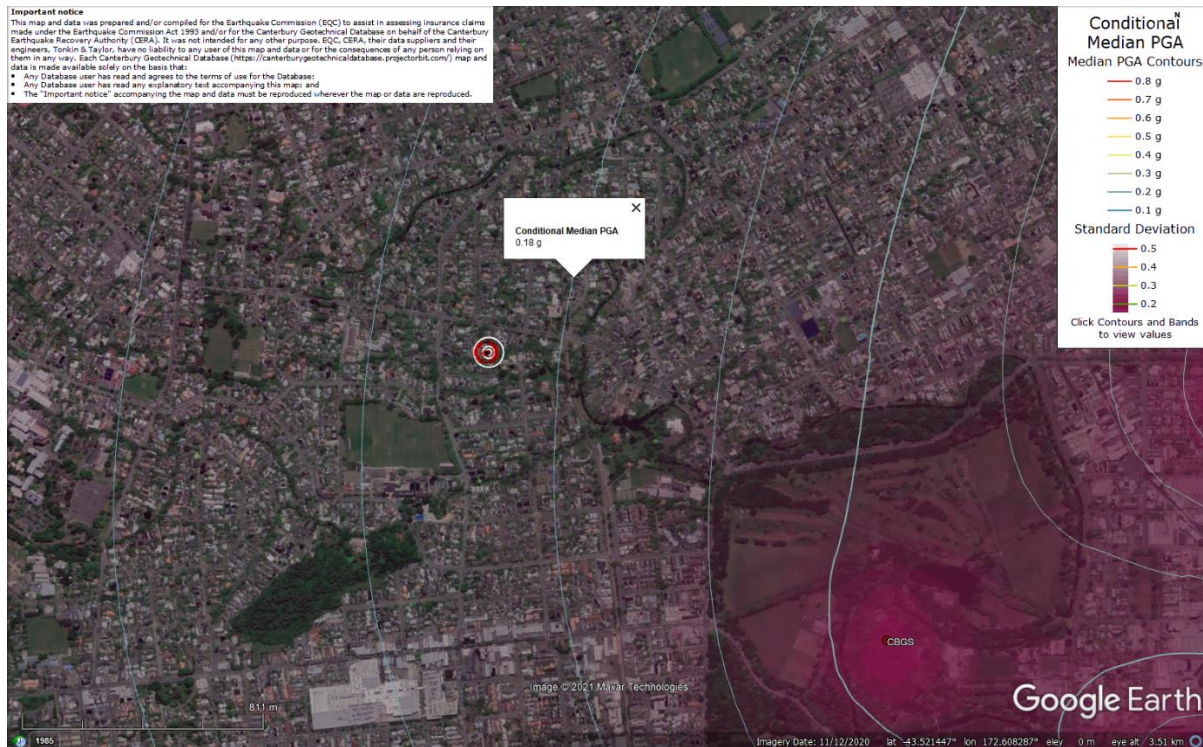
Figure 29: PGA for Dec-11 EQ (st. dev. = 0.375-0.400 ln units).

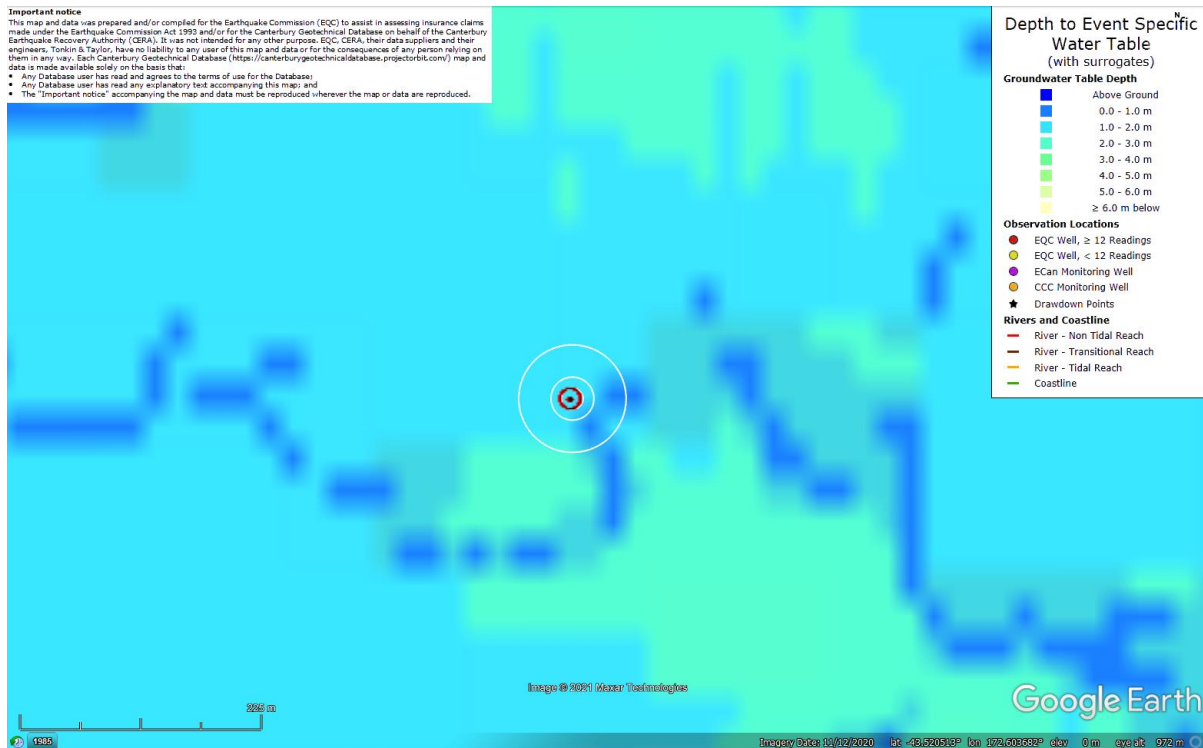
Figure 30: Depth to groundwater table for Sep-10 EQ.

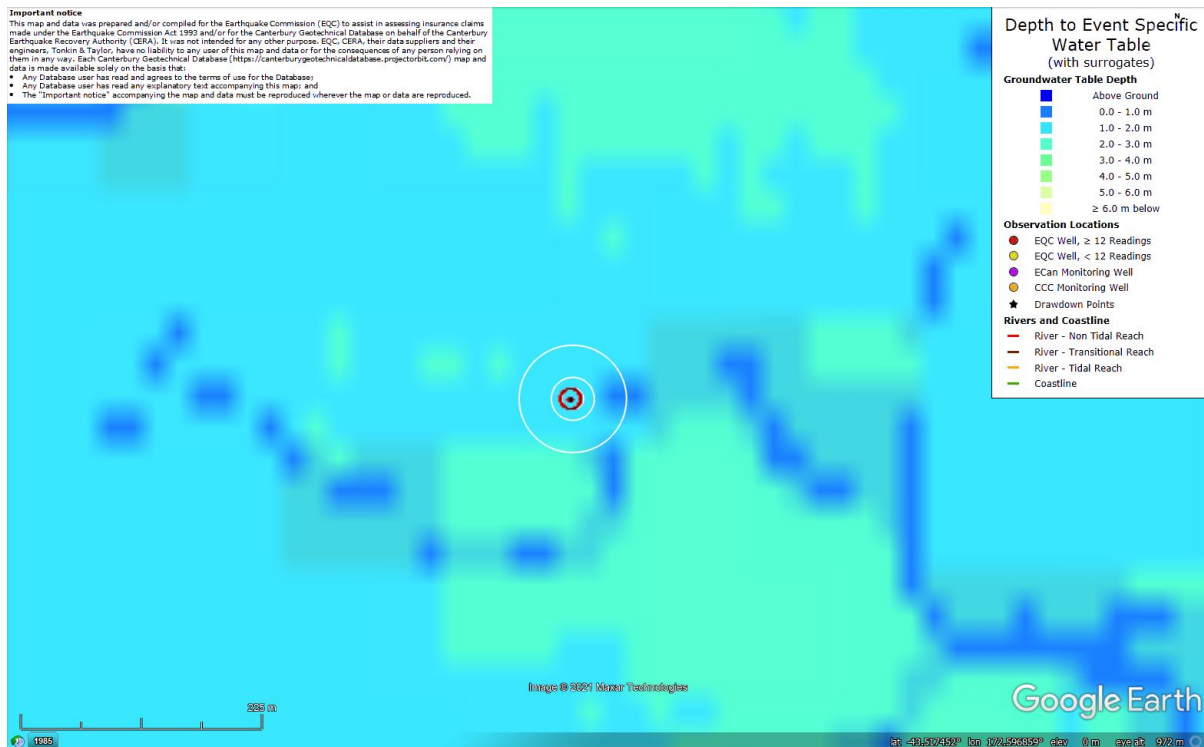
Figure 31: Depth to groundwater table for Feb-11 EQ.

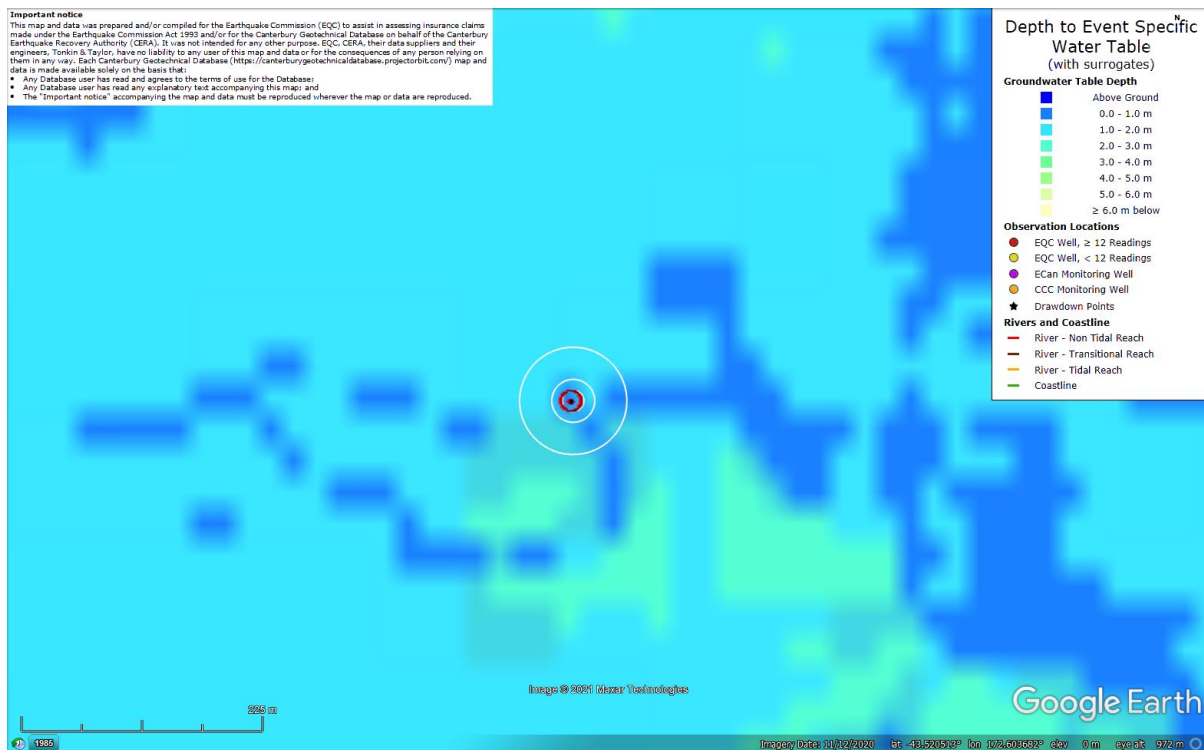
Figure 32: Depth to groundwater table for Jun-11 EQ.
